Economic and energy loss minimization: design and repair works after failure of the Pucará headrace tunnel in Ecuador

F. Micheli⁽¹⁾, N. Moncayo⁽¹⁾, V.H. Jacome⁽²⁾, P.F. Bertola⁽¹⁾

⁽¹⁾Lombardi Ltd, Minusio, Switzerland

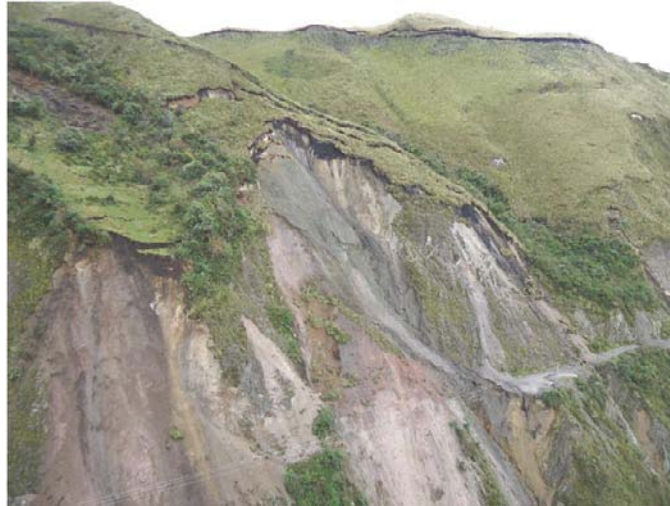
After 34 years of normal operation, the plant had to be shut down in September 2011, after being affected by a landslide of large scale of the slope located adjacent and parallel to the final stretch of the headrace tunnel, associated to a geological fault. The landslide affected about 300 m of the final stretch of the headrace tunnel.

Figure 1. The landslide that affected the headrace tunnel

The area in which the landslide occurred (Figure1) is characterized by a very complex geology with the presence of many faults, discontinuities and open fissures. In general, the rock in this zone shows to have a high degree of alteration and low resistance characteristics. Additionally, the zone is situated in the so called “Pisayambo Seismic Nest”, in which more than 400 seismic events with magnitudes less than 4 degrees in Richter’s scale and low hypocentre depth are registered annually.

It appears that actually seismic loads, excessive loads caused by water losses due to filtration, as well as intensive rainfalls, had also contributed to the slope instability.

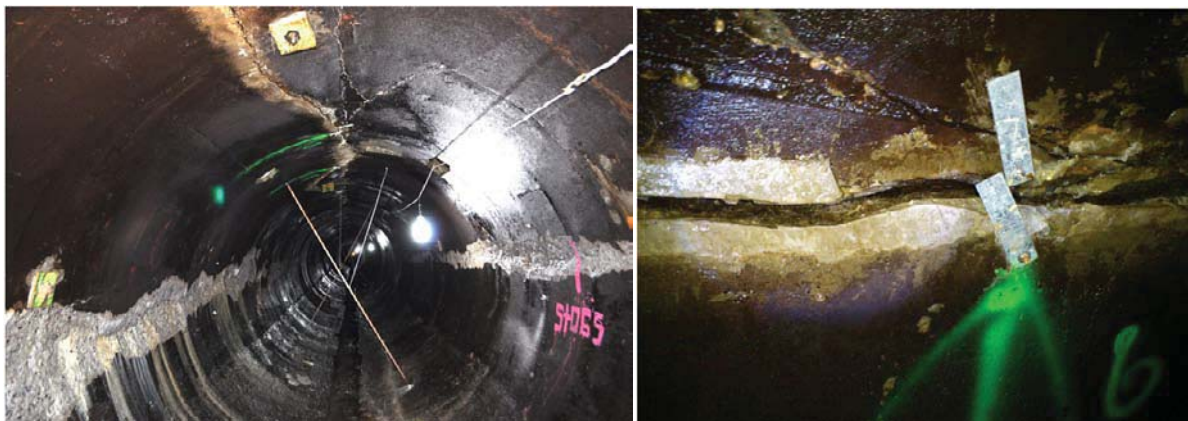
In this geological environment, characterized by a fractured rock mass, the location and shape of the fissures recognized along the damaged tunnel stretch indicate that their presence is due to tensile stresses caused by the internal water pressure.

The proceeding fissure propagation, destroyed/affected the arch effect in the concrete lining of the tunnel. As consequence, a compression of both semi-circumferential concrete parts occurred, which finally caused rock spalling at the tunnel roof, where the maximal compressive stresses developed (Figure 3).

Figure 3. Stretch of damaged headrace tunnel and fracture detail

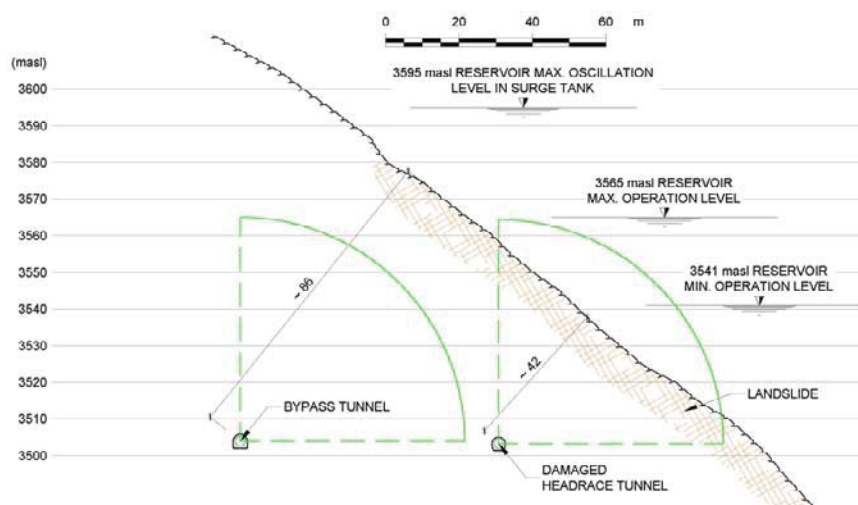
In addition the actual rather superficial tunnel position with only 40 m of lateral rock coverage and a vertical overburden as low as 55 m, leads to a geomechanical rather unfavourable situation.

According to the technical experts of Lombardi Ltd., the position of the affected headrace tunnel was not adequate particularly with respect to its limited distance to the slope surface (Figure 4). It appeared that the actual lateral and vertical rock thickness was not sufficient to guarantee the long term stability of the tunnel. Furthermore, due to the water circulation, the strength and deformation characteristics of the surrounding rock mass had been progressively reduced.

Figure 4. Stretch of damaged headrace tunnel

Because of the urgency for a rehabilitation design of the tunnel, taking the present and future slope stability into account, and based on several technical site visits as well as variant studies, Lombardi specialists proposed the construction of a bypass to the affected tunnel.

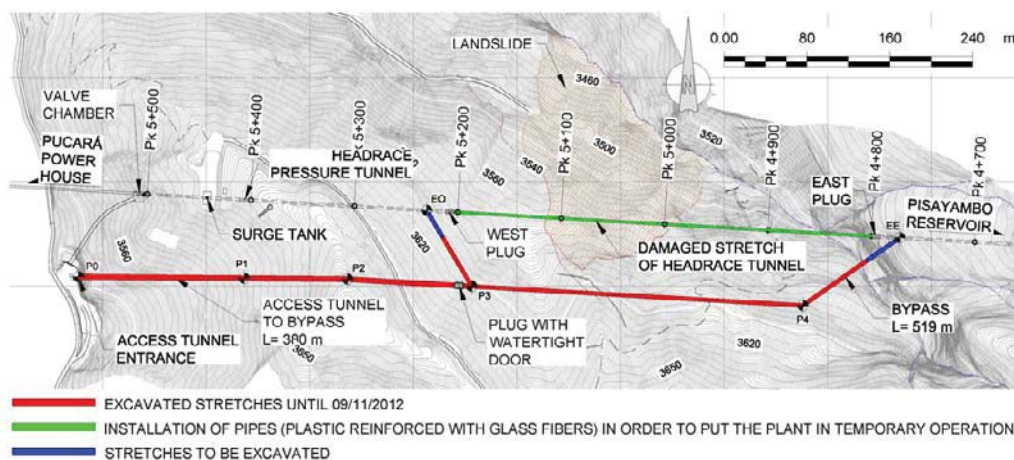
Figure 5. Working scheme during construction phase

Taking into account the results of the field investigations (topography, geological and geotechnical rock characteristics) the basic concept for the bypass was optimized (Figure 5).

To avoid the risk of hydro-fracturing, the main stretch of the bypass runs parallel to the affected tunnel, displaced 70 m into the mountain, providing enough lateral and vertical rock overburden to the bypass tunnel.

The optimized rehabilitation solution involves the construction of a bypass with a total length of 519 m, concrete lined with an internal circular section of diameter 2.70 m. These characteristics and dimensions were chosen in such a way that the plant works with the same hydraulic performance during normal operation like the pre-existing pressure tunnel before. Because of its design, the bypass requires the excavation of a 380 m long access tunnel with a D-shaped cross section of 5.00 m x 5.00 m .

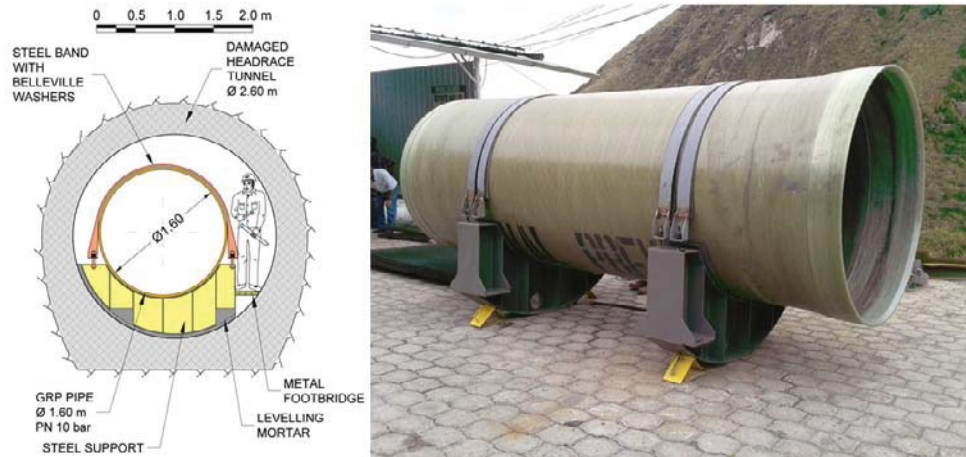
Figure 6. Mounting and adjusting of GRP pipe on steel supports

The pipes were 4.50 m long, resting each one on two steel prefabricated supports. The supports were anchored to the concrete lining with steel bolts. Furthermore, they were equipped with openings in their bottom to let the infiltrating water enter the drainage system. The pipes were fixed to the steel supports by means of a special rubber band provided with a steel adjustment band and bolts, as shown in Figure 6.

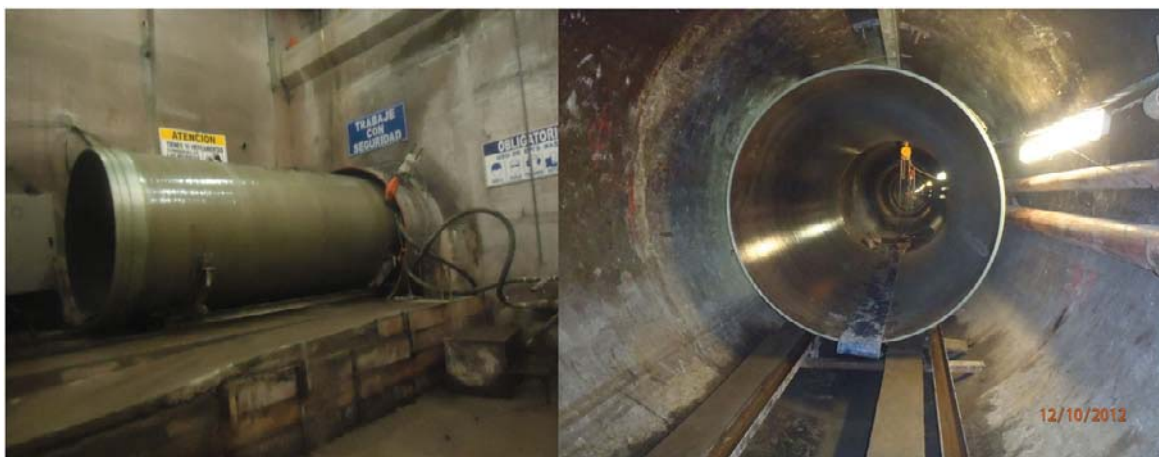
Figure 7. Transportation of pipes to the installation site

Trucks transported the pipes to the valve chamber, where they were introduced into the tunnel by means of the chamber bridge crane. A special steel platform on wheels transported the pipes on two rails to the site, where a rail hanging from the roof allowed the tubes to be transported to the installation site (Figure 7). This transportation solution was chosen since there was only limited free space between the tunnel and the pipe available. In order to allow the installation of a small walking platform, on one side of the pipes, to facilitate the inspection or reparation work, the pipes were fixed eccentrically to the tunnel axis.

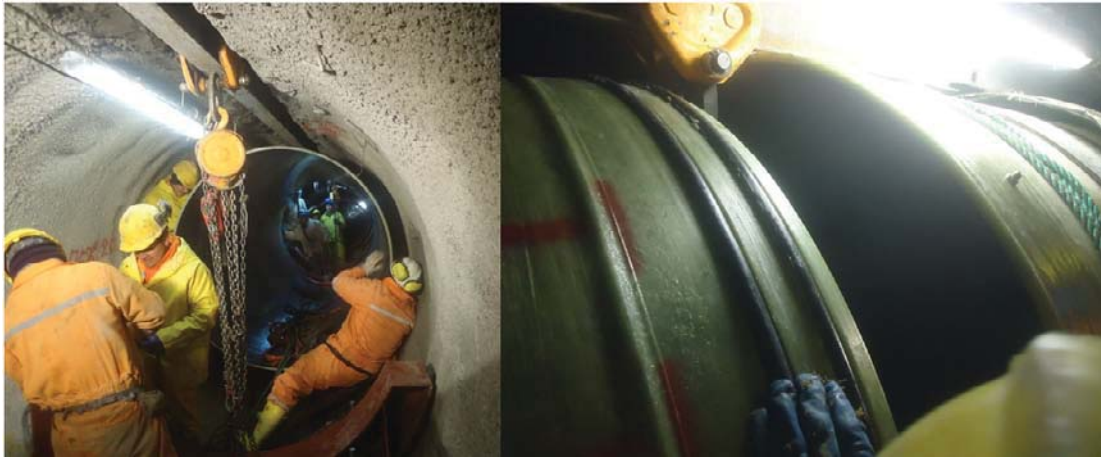
Figure 8. Connection between pipes and the water tightness of the O-ring

Once the connection between pipes was realized the water tightness of the O-ring (Figure 8) seals was inspected to detect any leakage and subsequently implement proper counter measures, if required.
