Lining of pressure tunnels

Kolloquium «Untertagbau für Wasserkraftanlagen»
ETH Zürich, Professur für Untertagbau

Zürich, 12.12.2013

Rehabilitation of Estí pressure tunnel (Panamá)

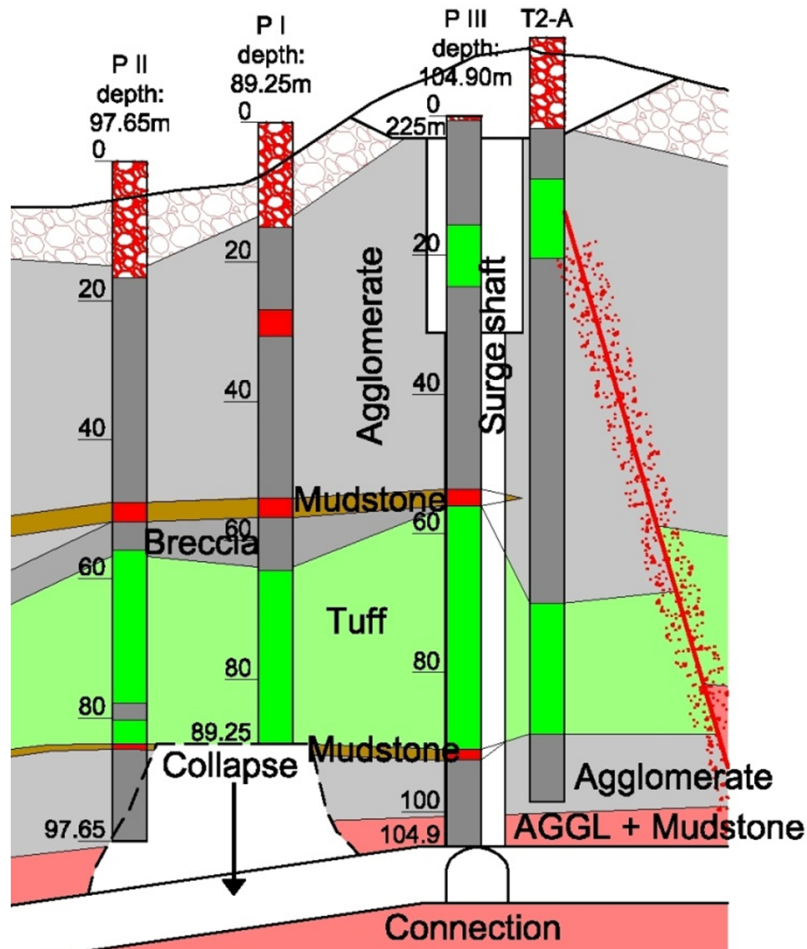
Geological setting in the main collapse zone

Main collapse probably due to a combination of:

- sub-vertical faults and
- horizontal water-sensitive rock layers

Main collapse estimated dimensions:

Length: ≥ 40 m

Width: 23 m

Height: ≥ 15 m

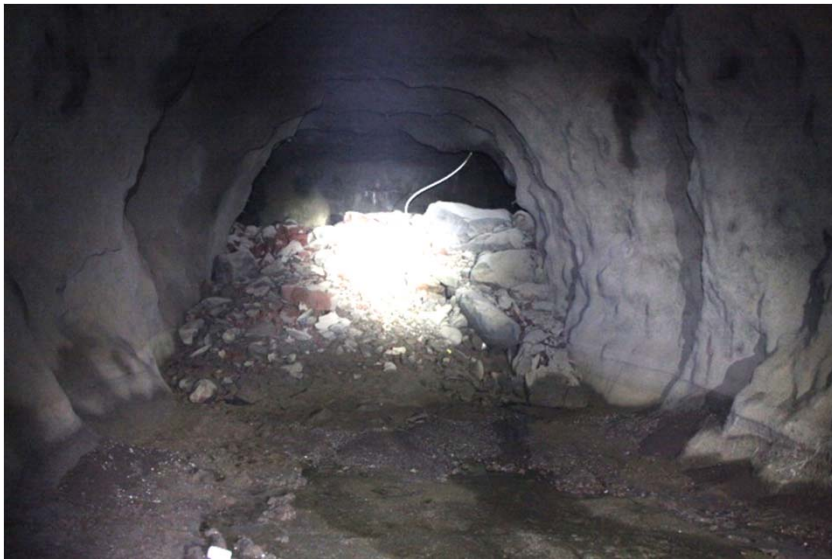
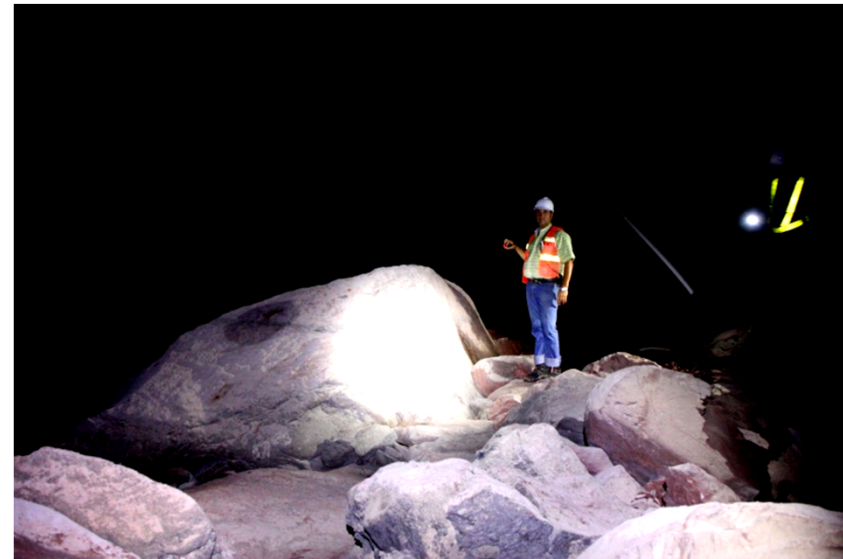
Main tunnel collapse in 2010 (after 7 years of regular operation)

Huge rock blocks in the main collapse zone

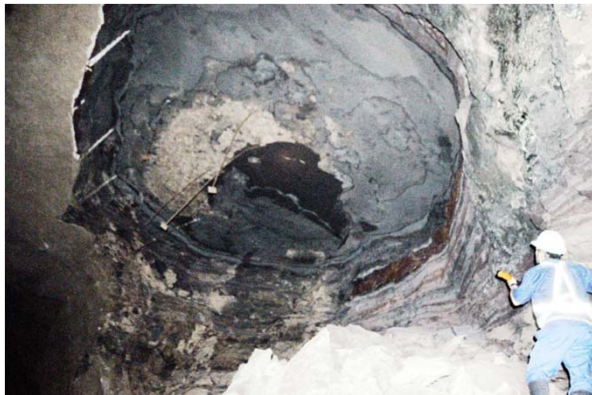
Collapses in tunnel roof controlled by rock-mass stratification. Sub-horizontal rock layers were separated by water-sensitive mudstone layers. Maximum collapses height: 5 m.

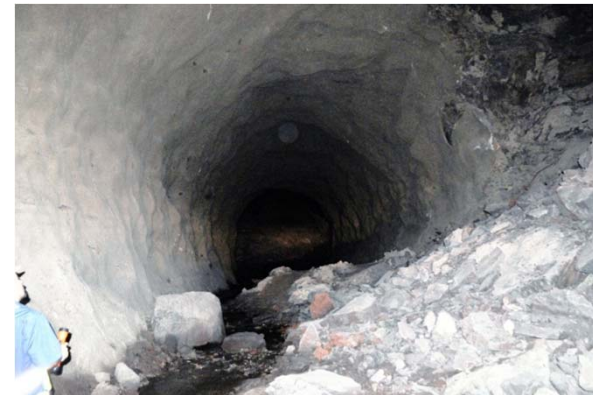
Collapses at tunnel walls probably occurred in the dewatering operation consequent to the main collapse.

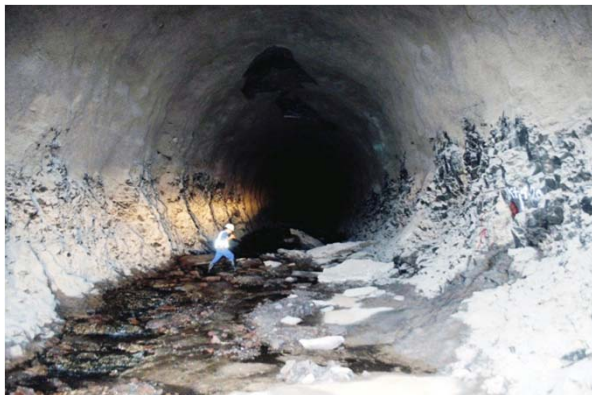
Lining (shotcrete) detachments probably occurred in the dewatering phase

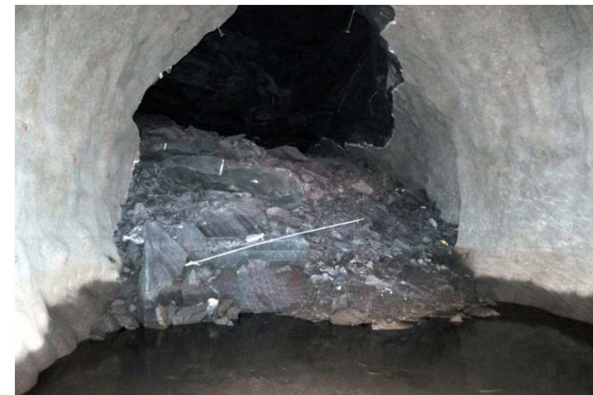
Complete obstruction of the tunnel section due to a collapse

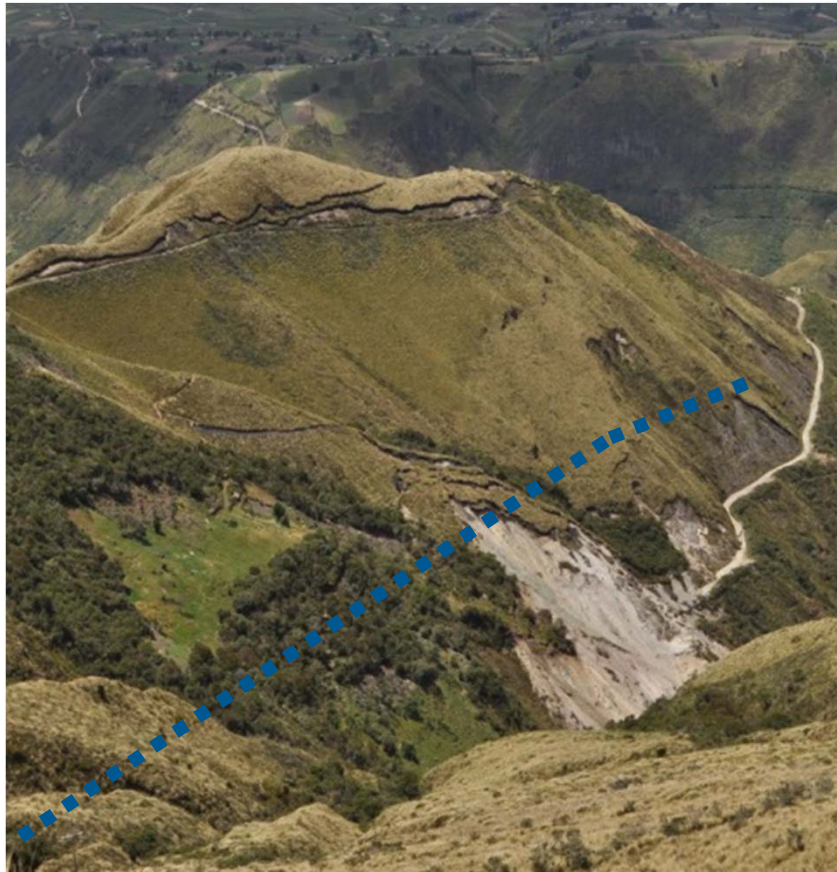
Landslide occurred in September 2011

- After 34 years of operation a landslide occurred in 2011 at the final part of headrace tunnel
- Very complex geology contest with many faults, discontinuities an open fissures
- Zone with high seismic activity called “Pisayambo Seismic Nest”
- After tunnel dewatering and inspection damages in the concrete lining were observed

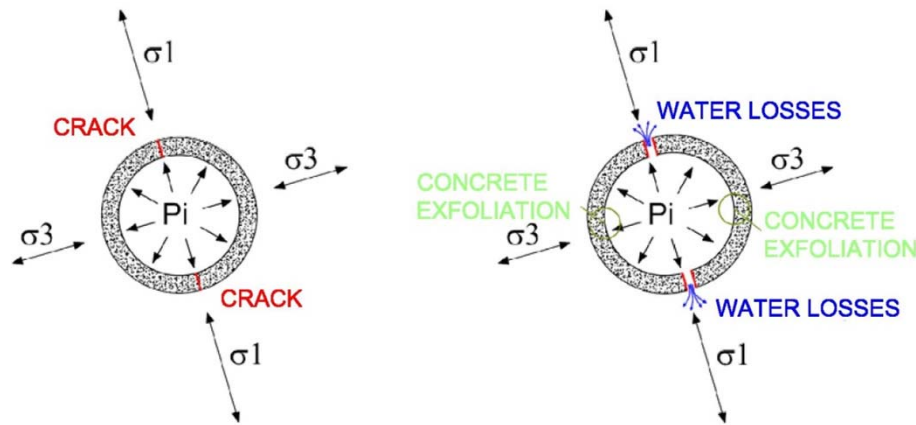
- Location and shape of the fissures indicate tensile stresses caused by internal water pressure

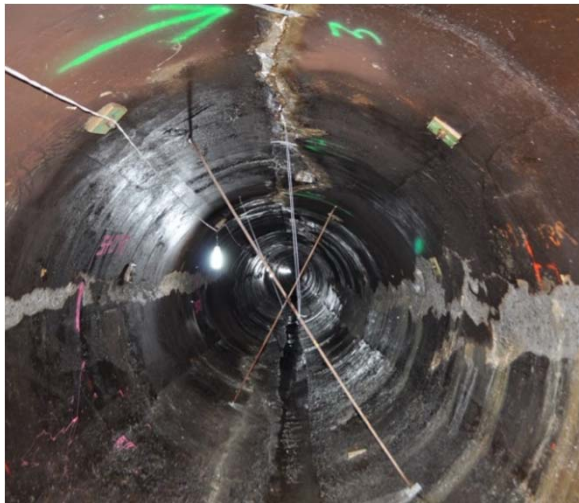
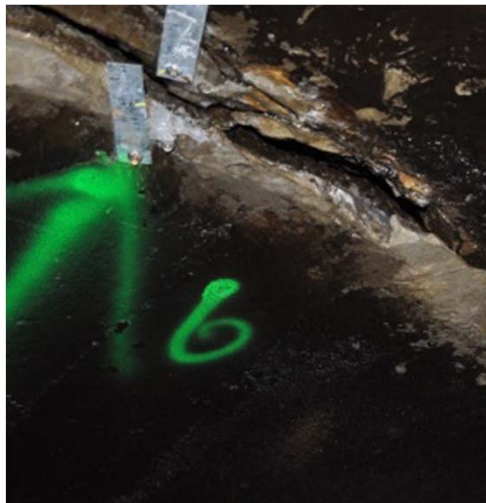
- Fissure propagation destroyed/affected arch effect in the concrete lining
- Compression of semi-circumferential concrete parts
- Rock spalling at the tunnel roof

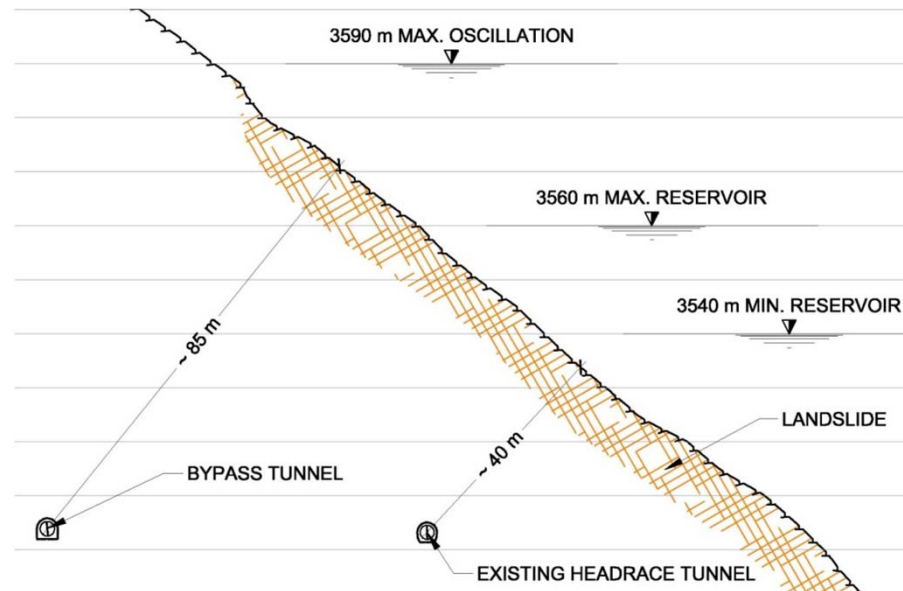
- Position of the affected headrace tunnel not adequate with respect to the distance to slope surface
- Lateral and vertical rock thickness not sufficient to ensure long term stability
- Rock mass characteristics progressively reduced due to water circulation

→ Construction of a bypass tunnel to the damaged section
