Characterization of ageing failures on power MOSFET devices by electron and ion microscopies

D. Martineau^{a,*}, T. Mazeaud^b, M. Legros^a, Ph. Dupuy^b, C. Levade^{a,c}, G. Vanderschaeve^{a,c}

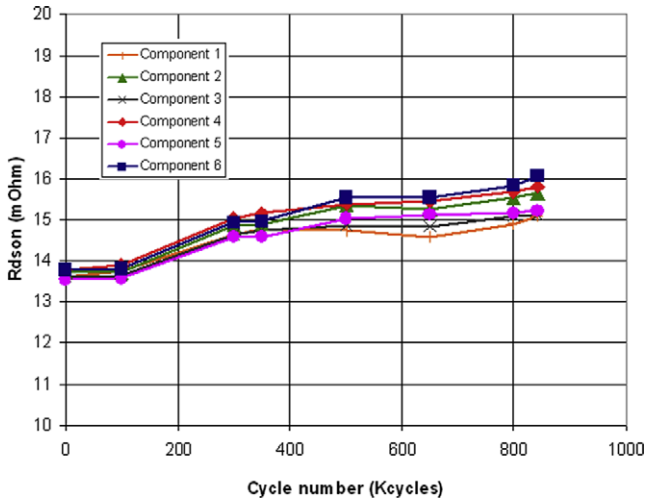
Fig. 1. Distribution of R_{dson} evolution for six different stressed devices which have undergone a 100 mΩ short circuit after 842,000 cycles at 40 °C. These components were still operative but their R_{dson} increased from 11% to 16%.

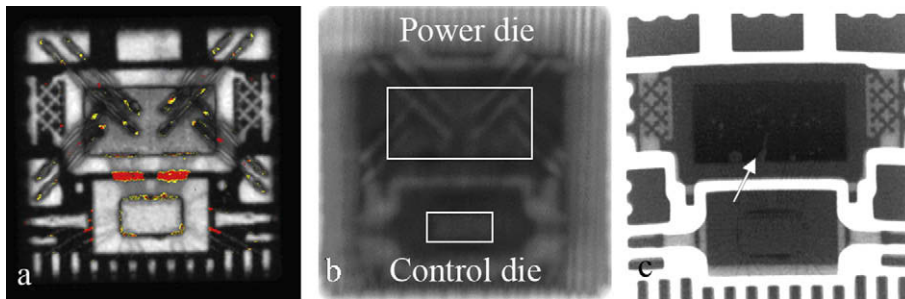
Fig. 2. Acoustic microscopy images of an aged device. Delaminations are observed by SAM at the mold (a) and by SAT at the die attach (b). The control and power die are indicated by white lines. Red zones in (a) correspond to delaminated area between the mold and the power die and black zones in (b) correspond to delaminated area between the power die and the leadframe. In (c) the white arrow points to a void in solder between the power die and the leadframe. (For interpretation of the references in colour to this figure legend, the reader is referred to the web version of this article.)

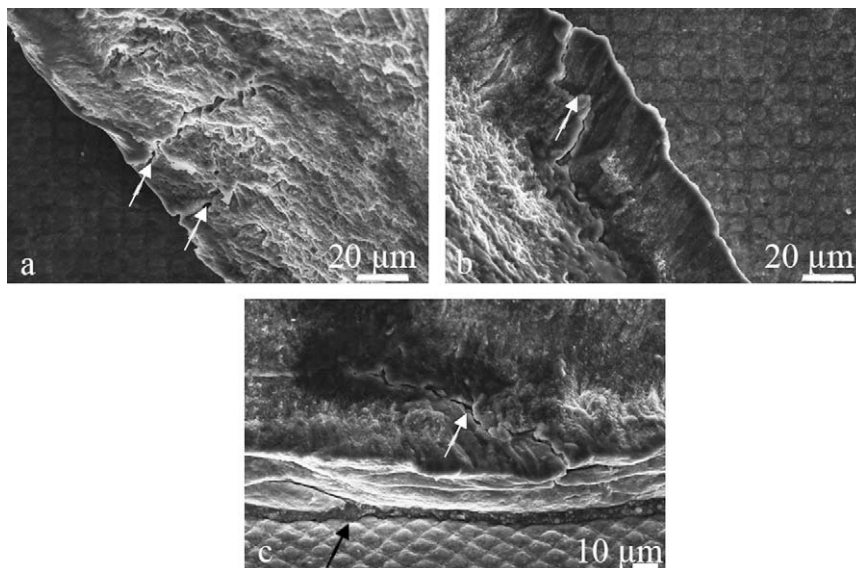
Fig. 3. SEM images of Al metallization and Al wire bonding. White arrows indicate cracks in and under Al wire bonding. In (c) black arrow indicates mold debris present in cracks (those can be the result of a local heating or to the post mortem chemical etching of the mold).

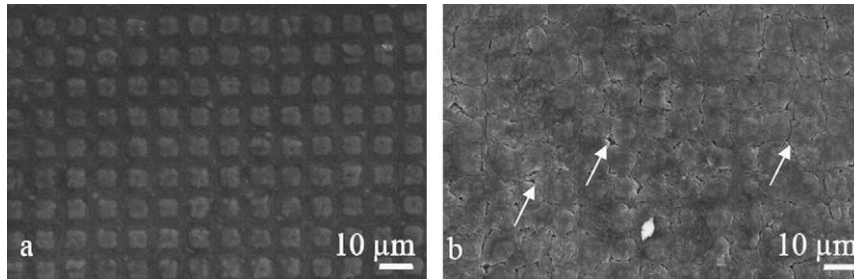
Fig. 4. SEM images of the Al metallization of devices under study. Before tests (a), the Al surface is smooth and individual grains cannot be detected. The destructured metallization in (b) corresponds to a stressed device which has undergone an 85 A square electrical pulse during 250,000 cycles at 85 °C. This component was still operative but its R_{dson} increased about 30%. White arrows show some inter-granular cracks in the metallization layer.

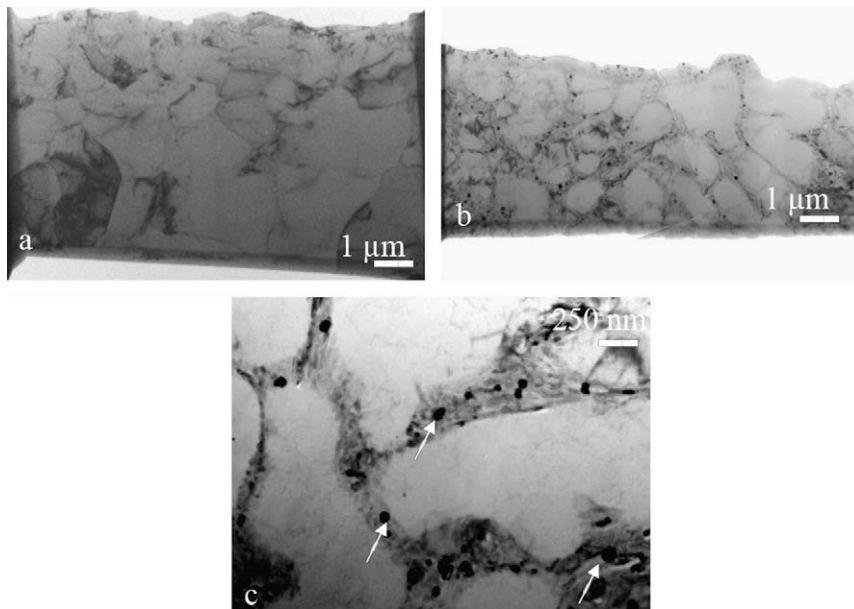
Fig. 5. TEM images of Al wires. Al grains with various crystalline orientations are observed in an untested Al wire (a). In a burned out Al wire a single crystallographic orientation is found for all Al grains and sub-grains (b). White arrows in (c) indicate Si grains between Al sub-grains. This microstructure is typical of a high temperature eutectic alloy formation between Si and Al.
