# **Static-Cyclic Shear Tests on Masonry Wallettes with a Damp-Proof Course Membrane**

Nebojša Mojsilović, Senior Scientist,  
Institute of Structural Engineering, Department of Structural, Environmental and Geomatic  
Engineering, ETH Zurich, Switzerland

Zurich  
November 2009

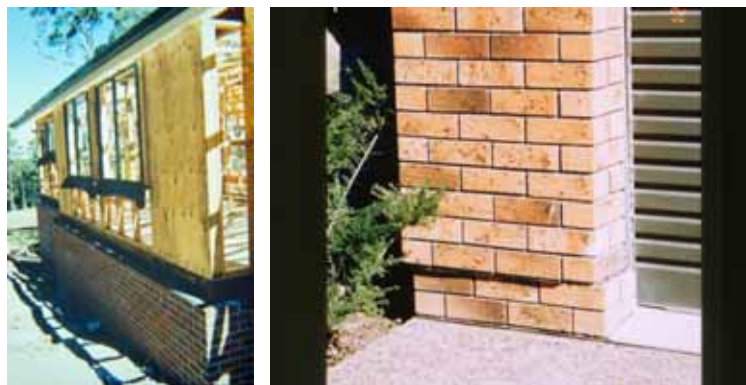
Figure 1: Typical DPC practice and earthquake performance

A damp-proof course (DPC) is frequently placed at the base of masonry walls as a moisture barrier and/or to act a slip joint to allow for differential movements (see Figure 1). Although it is desirable for the DPC to be sandwiched in the mortar joint, in reality it is usually placed in the joint above or below the mortar. In some cases, the DPC alone is used, particularly if it is serving as a slip joint at the interface between a masonry wall and a concrete slab.

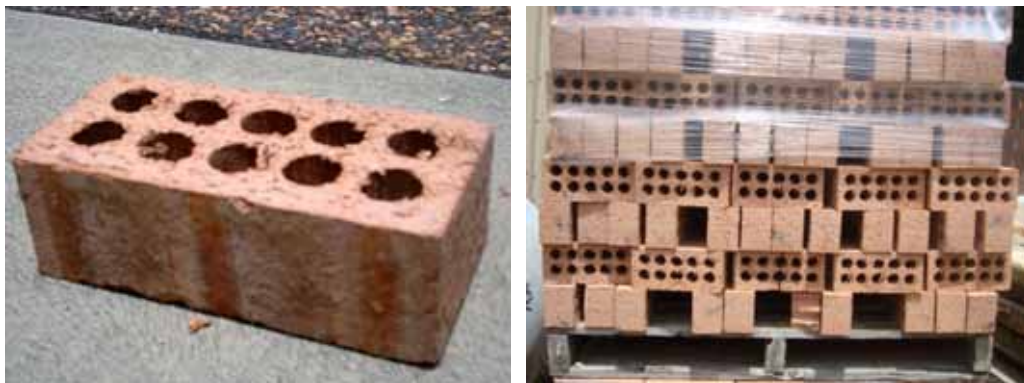
Extruded clay bricks with nominal dimensions of 230x110x76 mm and a void area of 25% (see Figure 2) were used for building the wallette specimens. The compressive strength of brick was determined from 10 brick units in accordance with Australian/New Zealand Standard AS/NZS 4456.4:2003 (5). The mean value obtained from the tests was 39.66 MPa and after applying the aspect ratio factor  $K_a$  a mean brick compressive strength of 28.60 MPa was determined. The characteristic compressive strength obtained from the sample was 19.10 MPa. Full details of the compressive strength results are given in Table A1 of Appendix A.

Figure 2: Extruded cored clay bricks

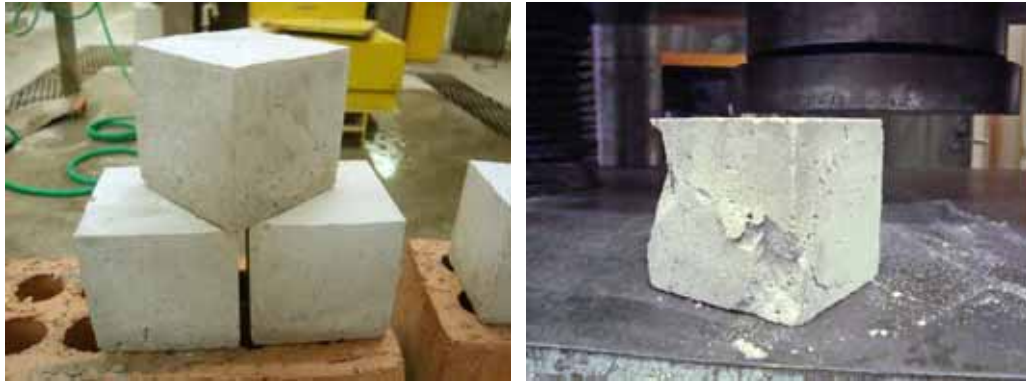
Figure 3: Mortar test cubes and typical failure

A typical 1:1:6 mortar (cement:lime:sand) was used for building the wallette specimens. One batch of mortar was used for each wallette specimen and prepared in the laboratory by an experienced bricklayer. The mortar compressive strength was determined from six cube specimens with 100 mm sides (see Figure 3). The cubes were cured in air in the laboratory and tested after 28 days. A mean strength of 5.65 MPa was obtained. Detailed results are given in Table A2 of Appendix A.

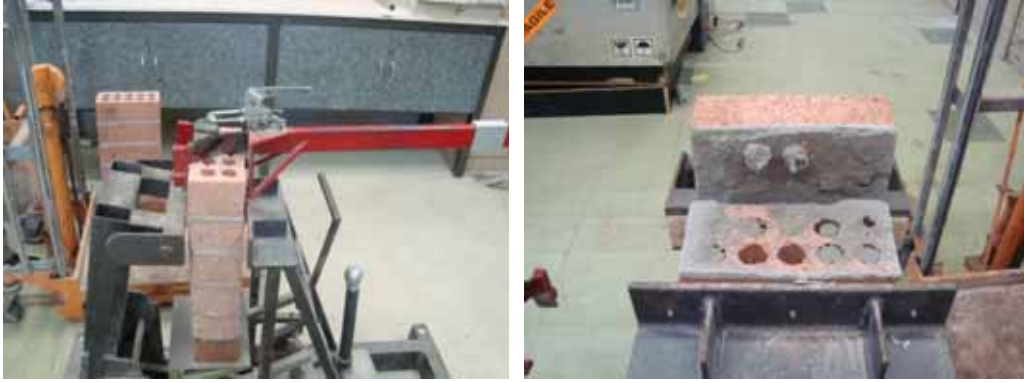
Figure 5: Bond wrench test apparatus and joint failure

The flexural bond strength of the masonry was determined by means of the bond wrench test in accordance with Australian Standard AS 3700:2001 (6). Each joint of two six-unit high specimens was tested. The testing apparatus and typical joint failure are shown in Figure 5. The mean and characteristic flexural tensile strengths were found to be 1.18 MPa and 0.61 MPa respectively. Detailed results are reported in Table A3.

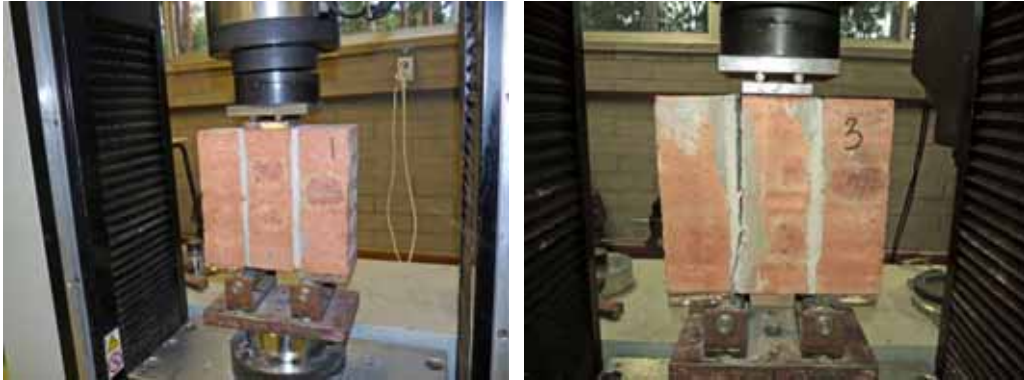
Figure 7: Shear bond test apparatus and shear failure

The masonry shear bond strength was determined using a triplet test in accordance with the European Testing Standard EN 1052-3 (8), see Figure 7. The mean shear strength was found to be 1.27 MPa (coefficient of variation 11.7%). Full results are given in Table A5 in Appendix A.

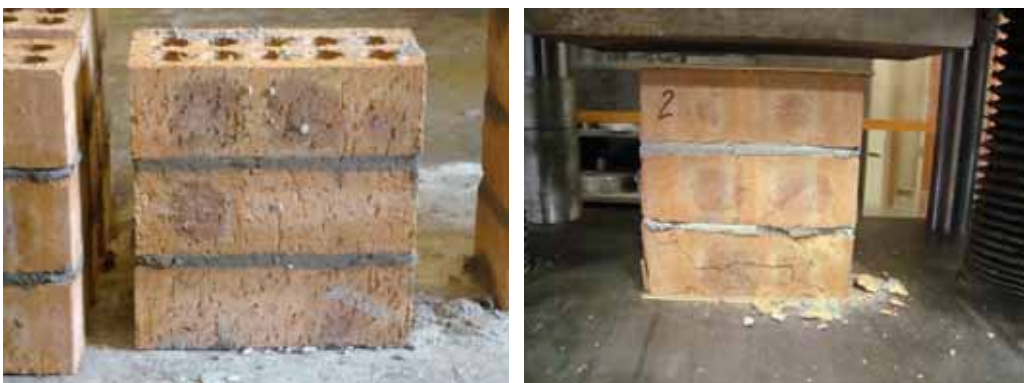
Figure 8: Compression test on a masonry triplet

Masonry compressive strength was determined in accordance with the provisions of Australian Standard AS 3700:2001 (6). Five tests on three-unit specimens were performed, see Figure 8. The mean value obtained from the tests was 17.75 MPa (coefficient of variation 15.0%). After applying the aspect ratio factor  $k_a$ , mean and characteristic masonry compressive strengths of 14.18 MPa and 9.50 MPa were obtained, respectively. The mean value was used to determine the levels of pre-compression for the wallette tests. Detailed results are given in Table A6 in Appendix A.

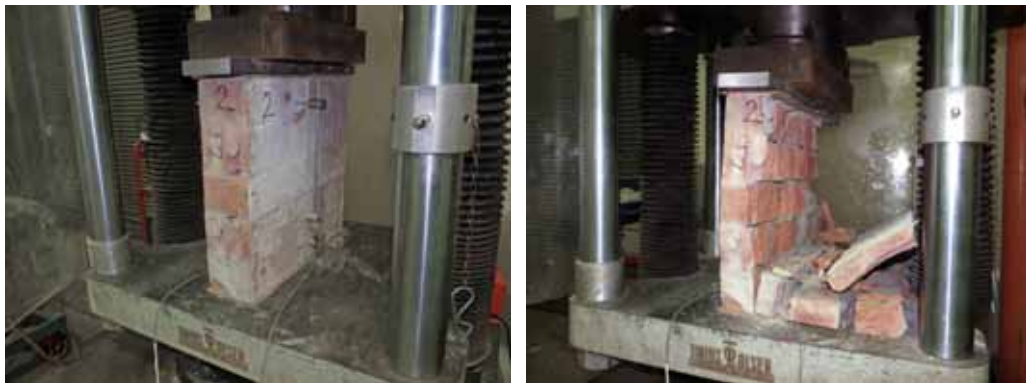
Figure 9: Compression test on cut-out specimen and its failure

In order to obtain information on the in-situ masonry compressive strength of the wallettes, four specimens were cut-out from the undamaged specimen B3\_2 after it was tested (failure occurred by sliding over the concrete base). The size of these four specimens corresponded to those stipulated in the European Standard EN 1052-1 (9) with the specimens being two units long and five courses high. In addition, these four specimens were used to determine the modulus of elasticity of the masonry.

Table A7 in Appendix A shows the specimen dimensions, failure loads as well as the compressive strength and modulus of elasticity (as a secant modulus at the load of 30% of the ultimate) for all four specimens. The mean value for the modulus of elasticity  $E_m$  obtained from tests on specimens 1 and 4 was 6.81 GPa. The mean value for the masonry compressive strength obtained from the tests was only a half of that obtained from the prism tests in accordance with the Australian code (see Table A6). Apart from any size effects, it is also possible that the specimens may have been damaged during the cutting-out process. The failure modes of these specimens (Figure 9) also differed from that of the masonry triplets indicating that the type of specimen may have also played a role.

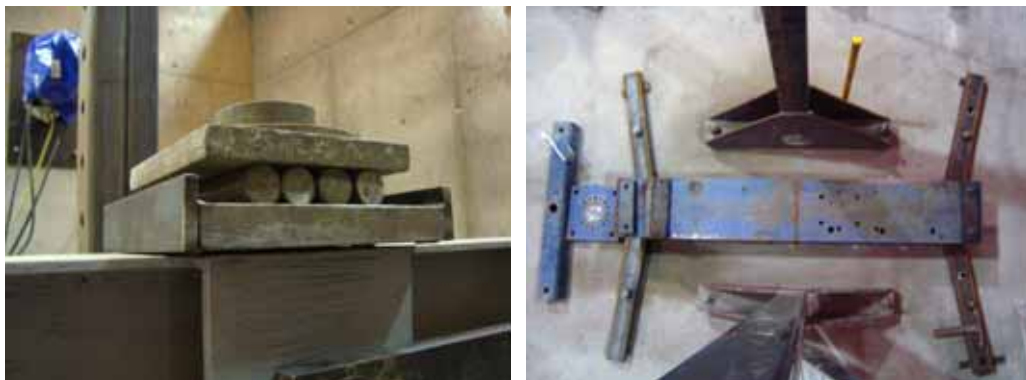
Figure 14: Test set-up: details

specimens were subjected to cyclic shear loading by means of the hydraulic actuator (4) which was fixed to the reaction wall (9). Figure 12 (b) depicts the test principle and Figure 12 (c) shows the damp-proof course positions for both Series A (10) and B (11). A general overview of the set-up is shown in Figure 13. Further details of the test set-up are given in Figures 14 and 15.

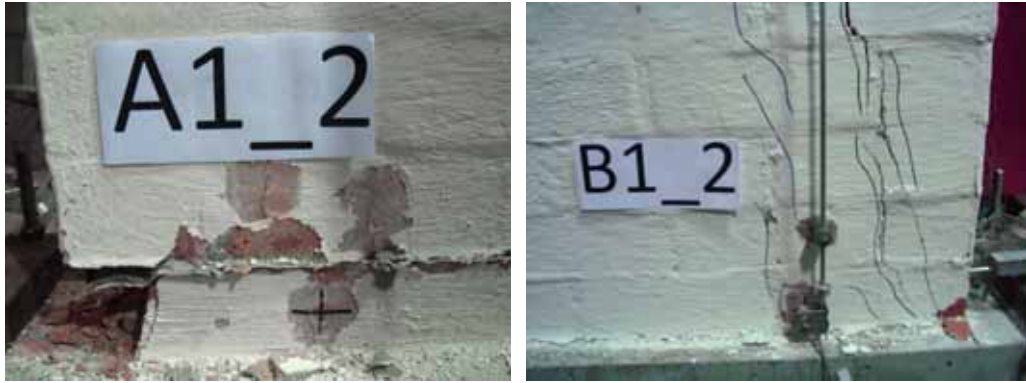
Figure 28: Failure of the specimens A1\_2 and B1\_2

The wallettes of Series A1 and B1 under the middle level of pre-compression failed mostly in a sliding mode, except for walls B1\_2 and B1\_3 which had a combined sliding and compression failure. The corresponding wallette without a DPC, C1, failed in compression. Wallettes which failed in compression developed mostly vertical cracks. The location of these cracks moved towards the wallette toes during the testing as the applied displacements increased. Wallettes which failed by sliding developed horizontal cracks in the bed joint containing the DPC. Wallettes of Series A had additional vertical cracks in the first course (between the concrete base and the bed joint with the DPC) induced by the cyclic movement of the upper part of the wallette over the DPC. Figure 28 shows the failure of the wallettes A1\_2 and B1\_2.
