Lake Mead Intake No 3 Tunnel

Roberto Schuerch, ETH Zurich

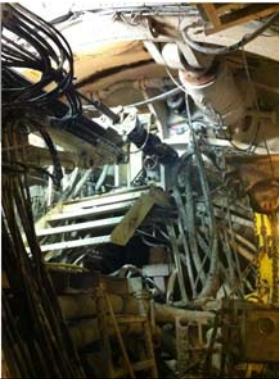
Auxiliary measures:
- *Drainage boreholes*

drainage via 3/6 boreholes

- *Grouting*

permanently
minor disassembly

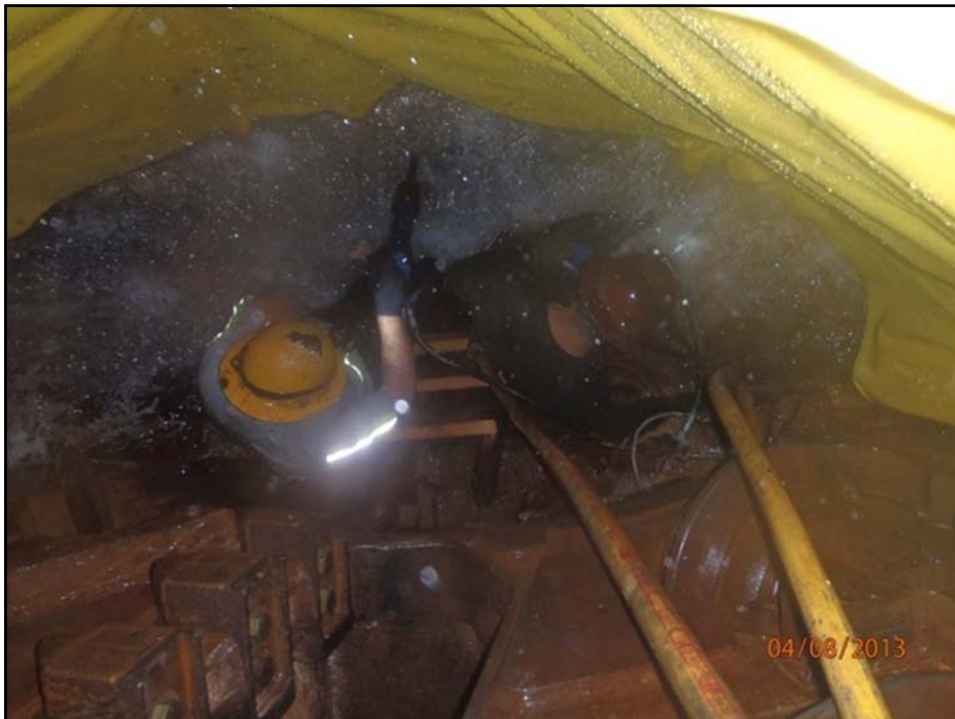
Niche excavation in front of the cutterhead (April 1, 2013 to April 12, 2013)

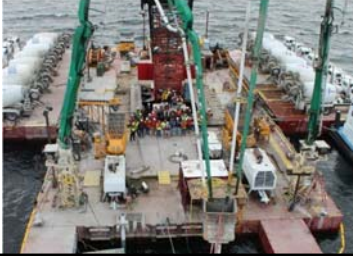
TBM-docking

Final TBM approach to the intake structure:

- Closed mode with full compensation of the hydrostatic pressure during breakthrough (“flooded shaft” principle)
- No advance exploration or grouting (risk of concrete cracking and/or blow-out)
