Mechanized tunnelling in the influence zone of North Anatolian and East Anatolian Faults

By Prof.Dr.Nuh Bilgin
ITU Faculty of Mines

Lecture given in ETH on the 18 May 2017

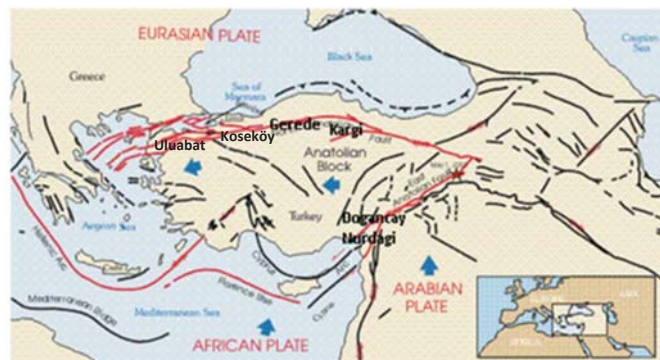
Fig.1 North and East Anatolian Faults

The geology of Turkey is very complex and major North and East Anatolian Fault Zones including minor faults associated to these faults zones create tremendous problems, like squeezing the TBM, excessive water ingress, TBM face collapses. SEGMENT COLLAPSES-LOOSING TBM AND TUNNEL

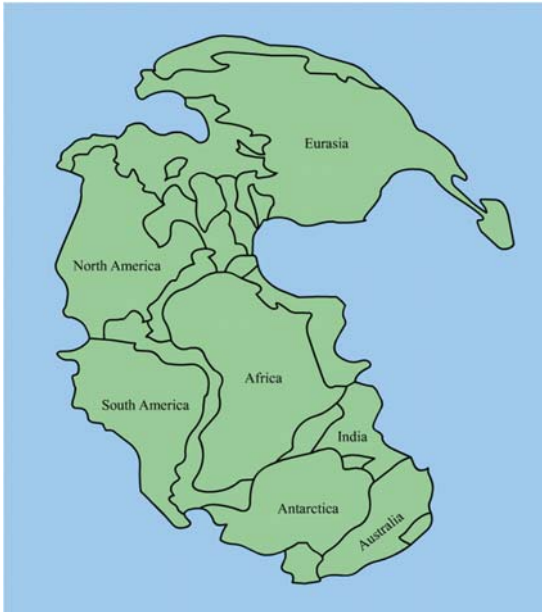
Understanding North Anatolian and East Anatolian Faults / Pangea-Laurasia-Gondwana

Pangaea or Pangea was a supercontinent that existed during the late Paleozoic and early Mesozoic eras. It assembled from earlier continental units approximately 335 million years ago, and it began to break apart about 175 million years ago

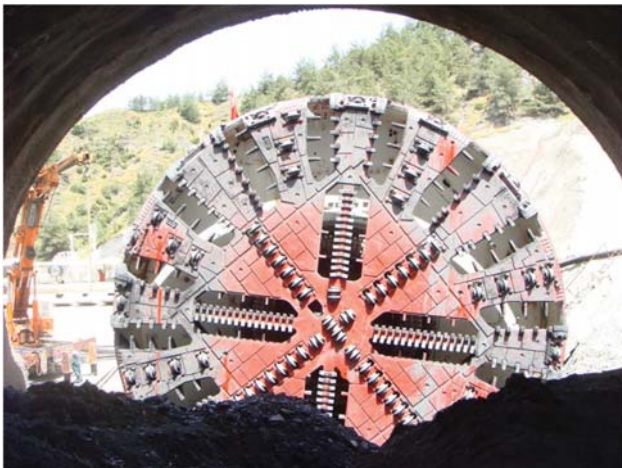
13.7 m diameter
Single shield TBM

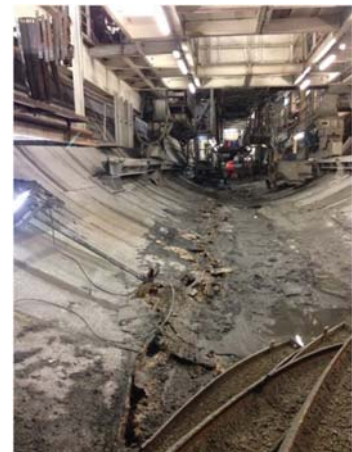
Mixed ground conditions with **ophiolites, graphitic schists** and mélanges with boulders including over excavation were the main difficulties leading to squeezing and blocking of the TBMs or even **causing complete failures of the segments and abandoning of the tunnel**. **Remedial works** are sometimes complex and tedious :**reducing the size of openings, minimal waiting, control of over excavation, lubrication between shield and rock, umbrella arch, increasing torque and thrust and sometimes rescue galleries are necessary.**

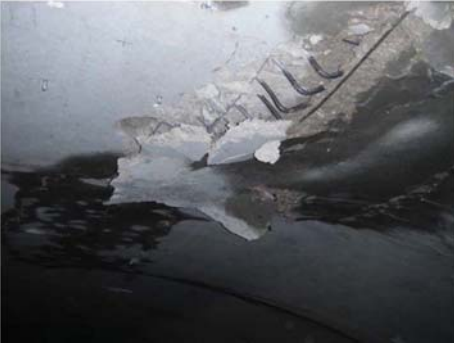
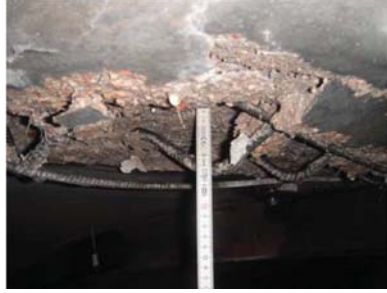
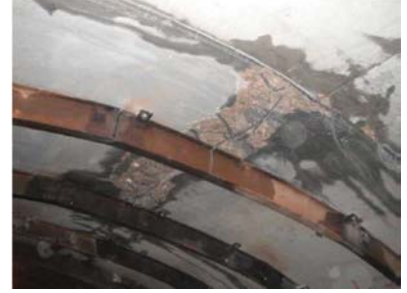
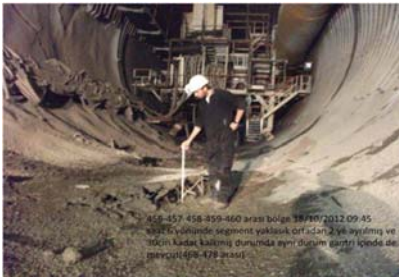
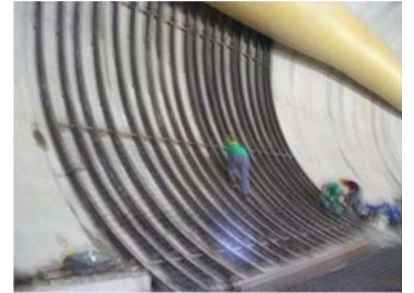
THE COLLAPSE OF SEGMENTS IN KÖSEKÖY RAILWAY TUNNEL

Face collapses, over excavation and jamming of the cutterhead started at chainage 216+300m in May 2012 and continued thereafter. TBM manufacturer decided to close some of the openings within the cutterhead. After several problems occurred during TBM excavation, the thrust of the TBM was increased from 84464 kN to 170000kN (breakout) and the torque was increased from 24083 kN.m (overload) to 36000 kN.m. Face collapsing continues frequently depending on the weak zones developed within shear zones, slowing down tremendously advance rates.

After several discussions between the consultants, the machine manufacturer and the contractor, bentonite and foam were decided to be used to stop face collapses. With several modifications made to TBM, 2 bars of mean face pressure could be obtained. Segments started cracking in May 2012 and tunnels started collapsing gradually damaging the TBM. For the sake of safety all tunneling activities were stopped thereafter. Limited information about this tunnel is given in this speech since the international dispute is still continuing between the machine manufacturer and the contractor.

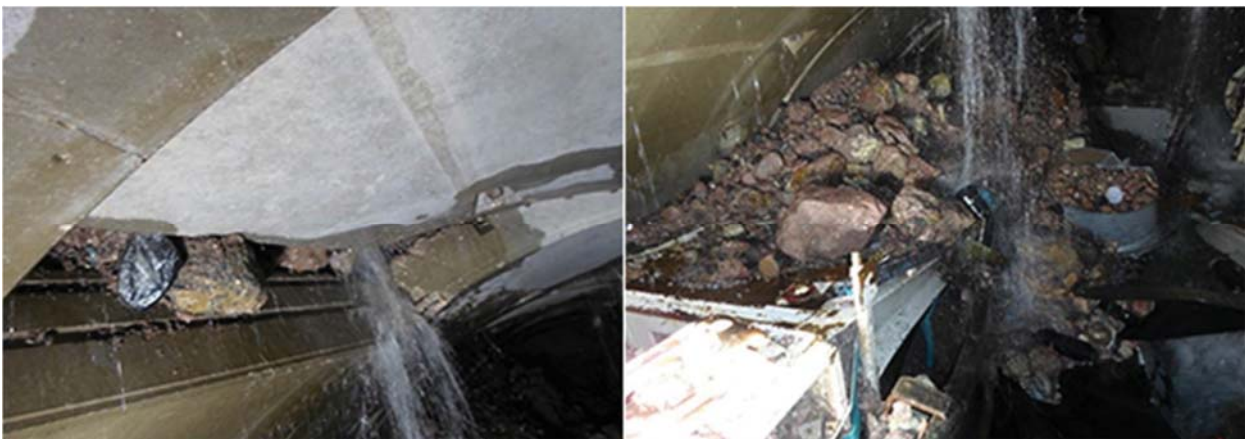
The second drive, which started from the intermediate shaft towards Ankara, was excavated in downstream direction by the S-691 DS TBM. **The TBM became stuck in smectite clay**, which has a tremendous swelling characteristic. **Swelling stresses started breaking the segments**, and the broken segments were then supported by steel arches. **It is thought that the smectite zone is behaving like a pillar zone, protecting the tunnel from the highly stressed pressurized water reservoir ahead of the tunnel** and so the machine was removed from this side, and to continue from the Ankara side to take advantage of the dip of the tunnel for water removal. The third drive, which was being excavated by the S-692 DS, upstream of the Ankaran side, has been constantly hindered by the complex existing geological conditions of heavily altered and weathered volcano-clastic rocks under very high water tables, which even caused one 12-month stoppage and required a bypass tunnel. The S-692 shield was trapped at chainage 24+344.86 km after the tunnel suffered a collapse in July 2014. The pressure deformed the telescopic shield and about 20 m of segmental lining, as can be seen in following Figure causing **a huge water and material inflow, estimated to be around 1250 m³ in 15 minutes**

The Machine was destroyed, the area was collapsed. A new TBM was ordered in 2015, a bypass tunnel was excavated by a new TBM

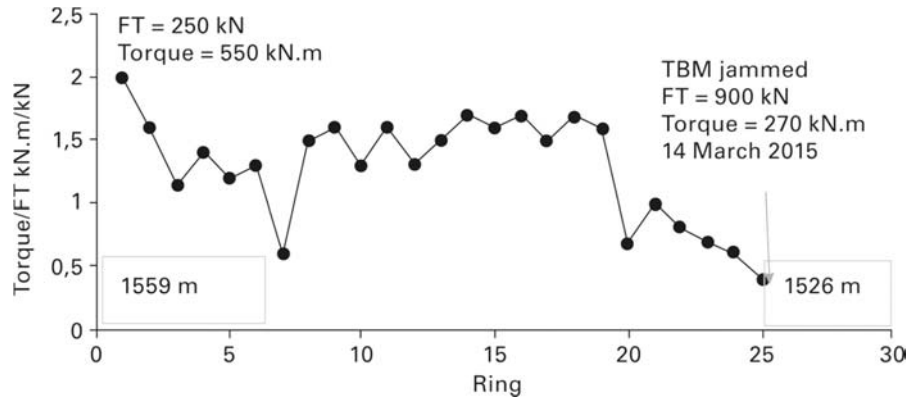
The ratio of torque to thrust force is a good indicator of the squeezing of a TBM. The following Figure shows the variation of this ratio between 12.04.2015 and 14.04.2015. As can clearly be seen from this figure the ratio started at 2, and dropped to 0.5 by the 7th ring, then later increased up to 1.5 and dropped again to 0.5, and the TBM was jammed within the 25th ring.

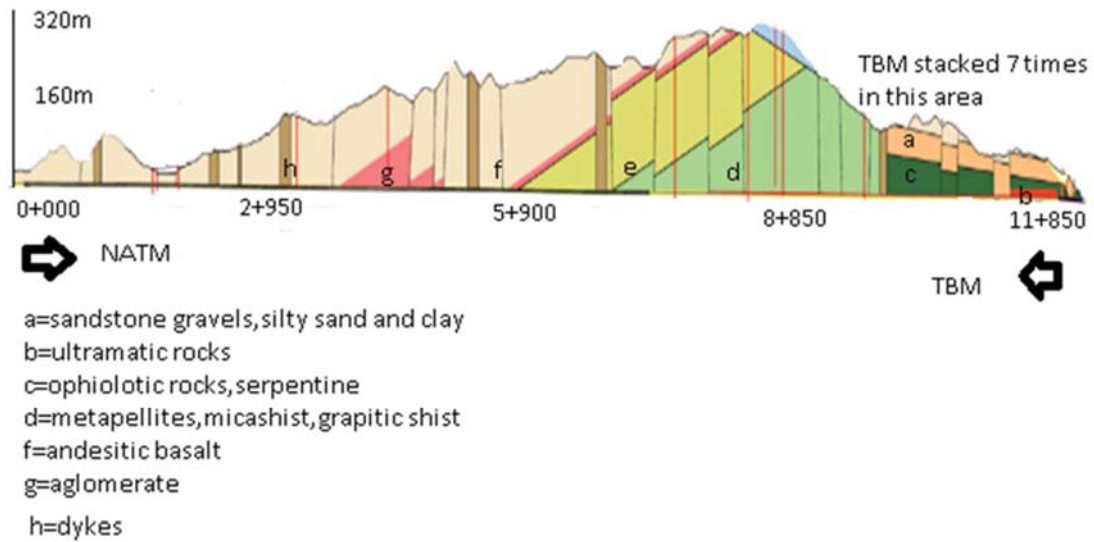
Kargi Hydropower project is situated in the region of Kizilirmak River between the town of Osmancik and the Boyabat reservoir. **The excavation of an 11.8 km tunnel has been recently finished, 7.8 km of the tunnel was excavated with a double shield Robbins TBM of 9.84 m diameter, and 4 km of the tunnel was opened with NATM.** However due to geological difficulties, and North Anatolian Fault Zone the ground became blocky in character, TBM stuck several times and galleries were opened in different places to rescue the trapped cutterhead. **To overcome the difficulties in continuing the project, systematic probe drilling and umbrella arch (UA) were selected as remedial works.**

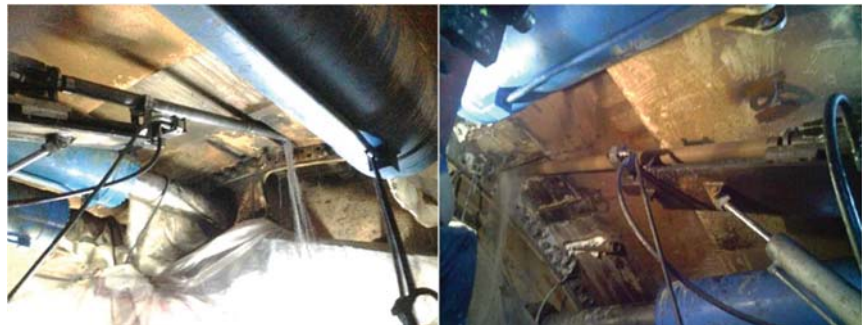
Eleven ports existed in the front shield of TBM. Drillings for UA started approximately 3 meters behind the cutter-head. Drill pipes having diameter of 3 inches were used for UA. At the beginning of the operation the holes were drilled with a drilling bit attached to drill pipes. After removing the drill bit, **a string of perforated pipes for injection**, was placed into drill hole. **Injection was done up to 120 bars pressure**, depending on injection materials properties. For injection fast setting **micro fine Portland cement (Rheocem 650)** was used. Moreover along with micro cement, **two component polyurethane injection resin (MasterRoc MP 355 and Geofom)** were also used. For filling very large voids, two component urea-silicate (MasterRoc MP 367) injection was realized. Generally 15 meters of drill holes having an approximate of 20° angle were realized with 4 meter overlaps between drills. It was seen that one umbrella arch drill, permits to support approximately 4 ring excavations, which is 6 meters in length .

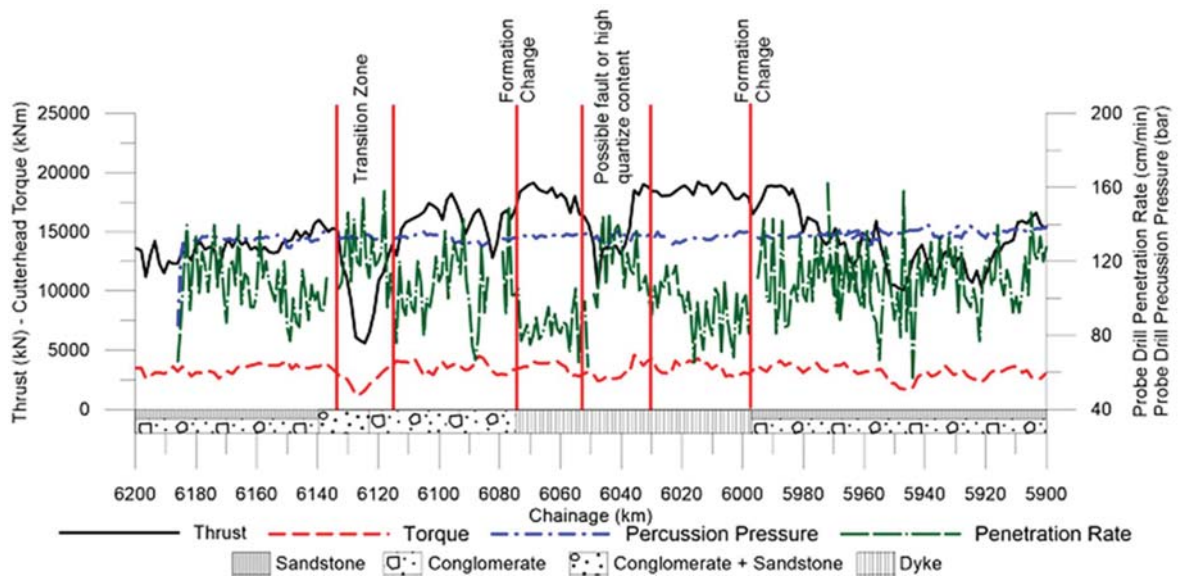
Probe Drilling In Kargı TUNNEL

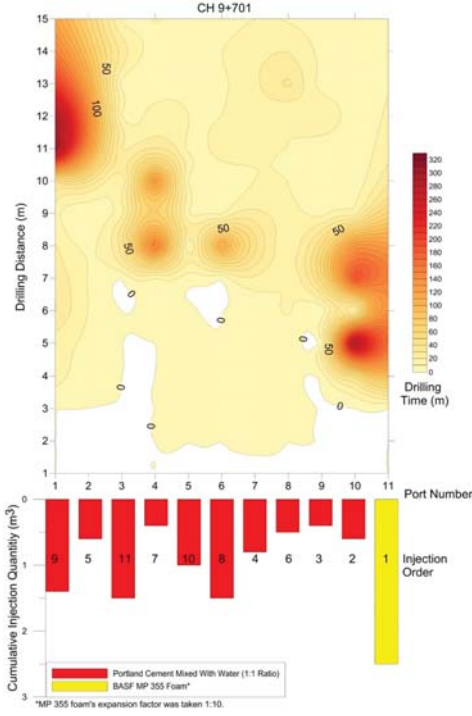
INTERPRETATION OF DRILLING DATA

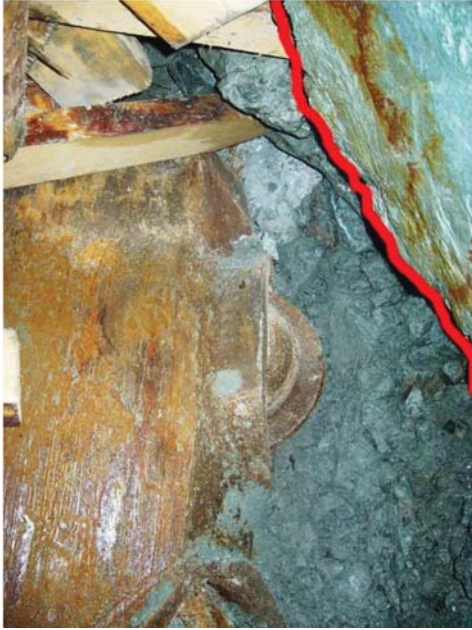
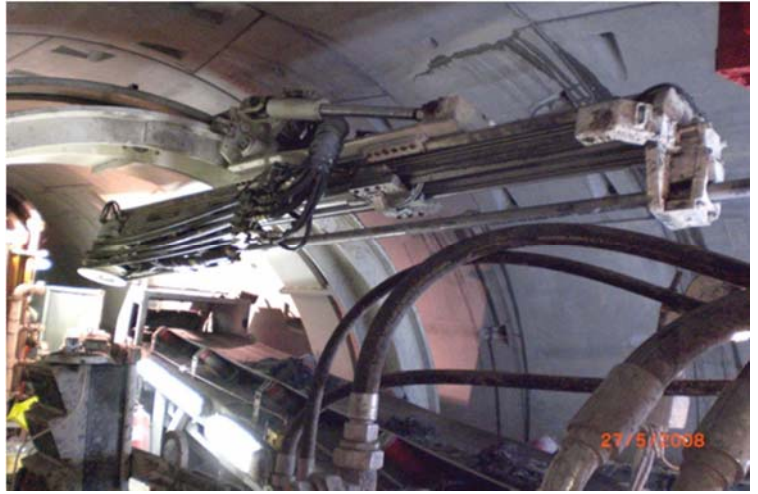
PROBLEMS OF DYKES AND PROB DRILLING

EFFECTS OF DYKES, BLOCKY GROUND AND REMEDIAL WORKS

Dykes cutting the Paleozoic sedimentary rocks in the Istanbul region is known well by practicing tunnel engineers. These andesitic rocks, which are generally considered to be of Cretaceous age, make fractures in the country rock and cause several problems during TBM excavation such as blocking the cutterhead and excessive disc cutter consumption. Typical examples are the Goztepe-Kadikoy Metro tunnels, and tThe folowing Figure shows typical big blocks coming from the interface of a dyke and the main rock formation causing the blockage of the cutterhead in different areas.

The remedial work was to put some grizzly bars within the openings of the cutterhead. Figure 1 shows the cutterhead of TBM used in Goztepe–Kadikoy Metro tunnel and Figure 2 shows the cutterhead after modification with grizzly bars. The effect of remedial work is clearly seen in Figure 3 showing that the mean advance rate was **3 m/day and this value increased up to 7 m/day after the modification of the cutterhead**. However, it is interesting to note that the daily advance rate in-creased to 10 m (day) after installing screw conveyor within the TBM chamber and passing to Earth Pressure Balance (EPB) mode. **Mean time in different tunnels in Istanbul same remedial works were carried out for Beykoz and Marmaray Tunnels** . Figure 3 shows TBM performance before and after TBM modification

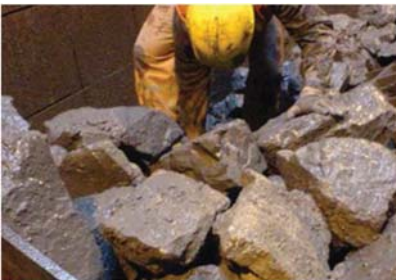
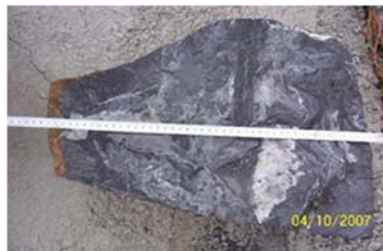
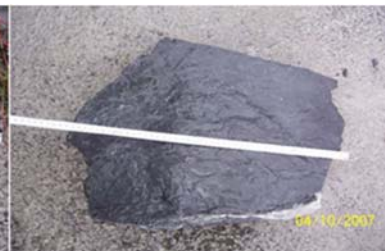
Big blocks coming from the face in Goztepe-Kadikoy Metro Tunnel.

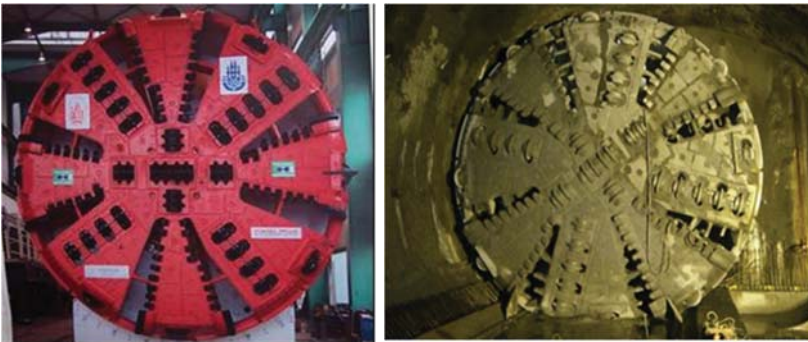
Figure 1-2. Cutterhead before and after modification in Goztepe-Kadikoy Metro Tunnel.

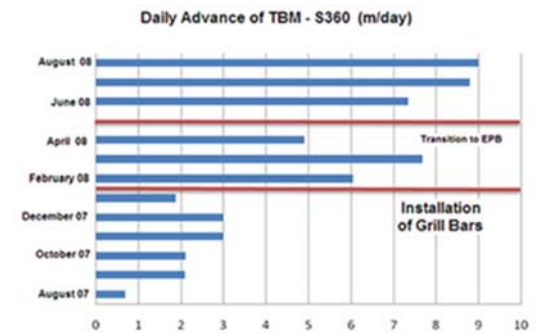
Figure 3. TBM performance before and after TBM modification.

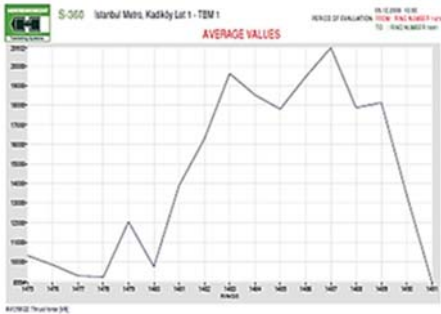
The increase of thrust force due to stalling of disc cutters in blocky ground.

In November 2008, during the excavation of Goztepe-Kadikoy Metro tunnel with a **6.6 m EPB TBM in blocky sandstone** it was reported that thrust **force started increasing from 10000 kN gradually up 19860 kN**, however, **this was reverse for torque decreasing from 2.7 MNm down to 1.6 within the same rings**. This phenomenon is illustrated in the following Figures. This is typical behavior of chisel cutters or rippers where the cutting force (equivalent to torque) is less than normal force (or thrust) in most cases. The operation was stopped to check the cutterhead. It was noticed that 6 center double discs and 4 single discs were flattened as seen in Figure below and one disc were destroyed completely. The careful observation of checking the change in thrust and torque values of TBM prevented demolishing the cutterhead.

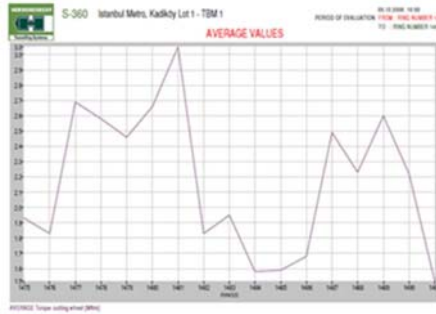
The decrease of torque due of stalling of disc cutters in blocky ground.

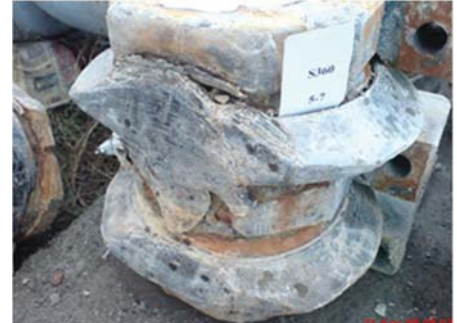
The wear of twin disc cutter due of stalling disc cutter in blocky ground.

The wear of twin disc cutter due of stalling disc cutter in blocky ground.

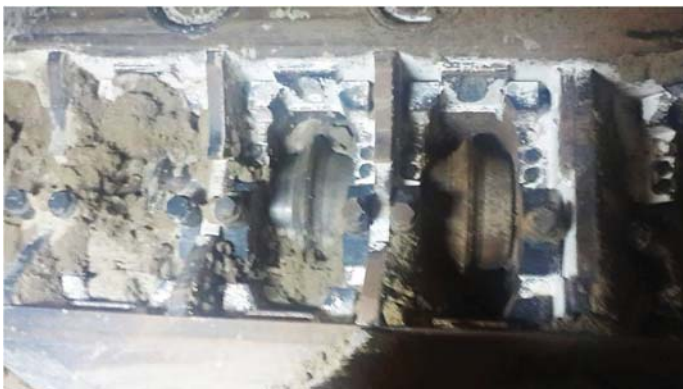
Clogging of the cutterhead in clayey rock formations is one of the major problems which decreases the daily advance rates as encountered in Suruc Water Tunnel. The main rock formation in this tunnel is marl and clayey limestone. XRD analysis showed that clay minerals such as kaolinite caused clogging of the TBM cutterhead. Anti-clogging agents are needed in most case to stop the clogging effect. The Figure given below is a typical example showing the effect of clogging on thrust and normal forces of TBM

Effect of clogging the cutterhead in Suruc Tunnel

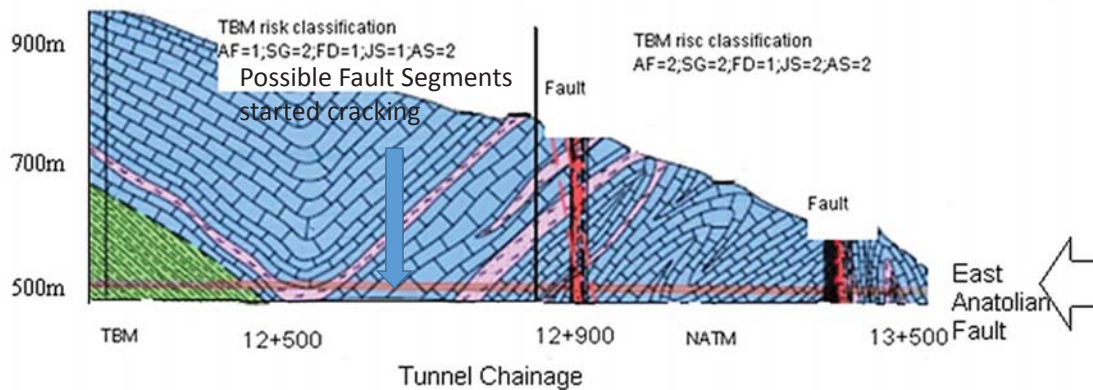
The tunnel is for railway transportation, and the project involves two tubes, each with a length of 9750 m. The excavation is planned to start from chainage 13+450 km and to terminate at chainage 3+700 km. The chainage from 13+450 to 12+400 km involves Karadag limestone of Mesozoic age, which is affected by the East Anatolian Fault (EAF), fracturing the rock formation to a great extent. High water ingress is expected in this area. Karadag limestone discharges the water at the toe of the mountain at the Nurdagi site. Several springs are available along the EAF. Due to technical difficulties and time necessary to procure the TBM, the first 1050 m in limestone is being currently opened using NATM. The geological cross-section of this area, which is planned to be opened by drill and blast method, is seen in the following Figure

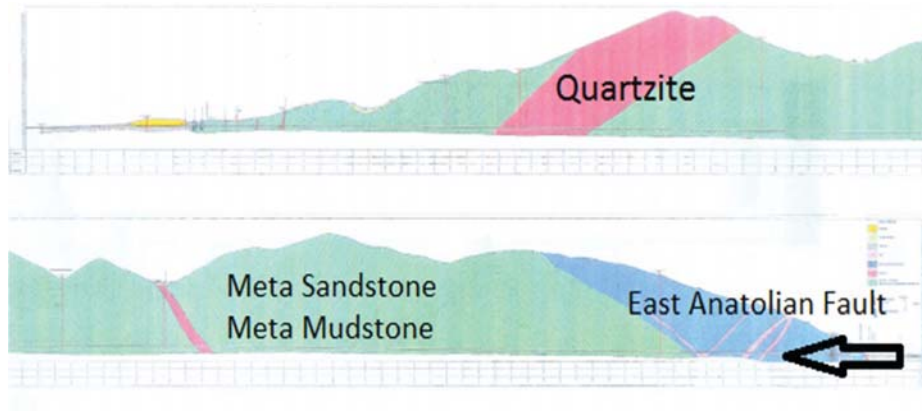
The length of the two tubes railway tunnel is 9750 m and diameter is 8 m
It was decided to open the first 1000 m of the tunnel by NATM since the tunnel was under the influence of East Anatolian Fault

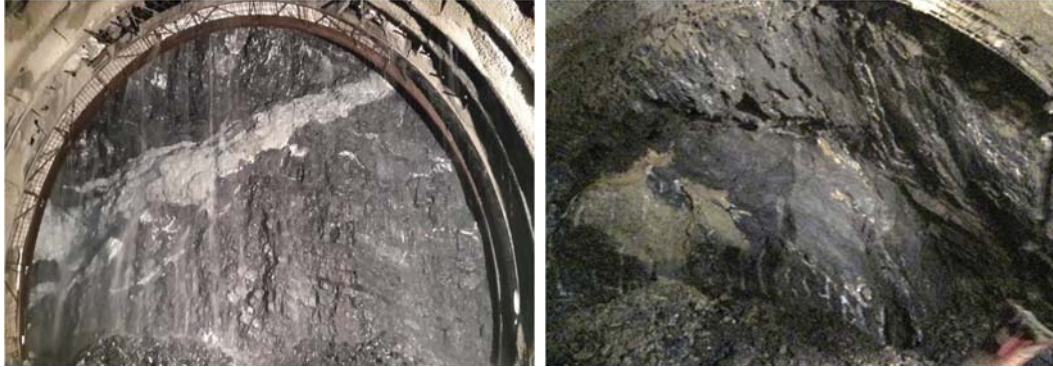
Typical effect of Nort Anatolian Fault in the rock formation

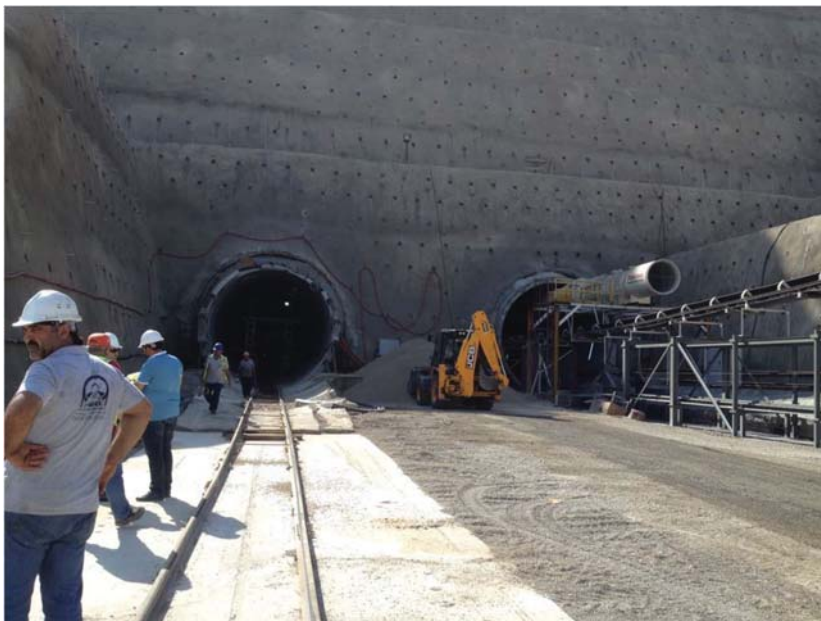
Nurdađı Tünelinde kullanılan tek kalkanlı Robbins TBM
SS268-398
