TBM tunnelling under the Suez Canal – Port Said tunnels in challenging ground conditions

The Port Said Tunnels Project consists of twin road tunnels crossing the Suez Canal with a planned capacity of 2,100 mixed vehicles/hour in each direction. The dual carriageway tunnels are an important part of the Suez Canal Region Development Plan, which will connect the Sinai with other Egyptian provinces to provide a gateway for investment opportunities and speed up the development of Sinai province. The project is located 19 km south of Port Said city, near the northern entrance of the Suez Canal. The tunnels are constructed using slurry shield TBMs in difficult ground conditions, including the presence of methane gas. This paper demonstrates the main challenges encountered during tunnelling and the measures taken to mitigate potential risks during construction and to control long-term differential settlements in the upper, very soft soil. The tunnels are connected by two cross passages which are being constructed using ground freezing and conventional tunnelling.

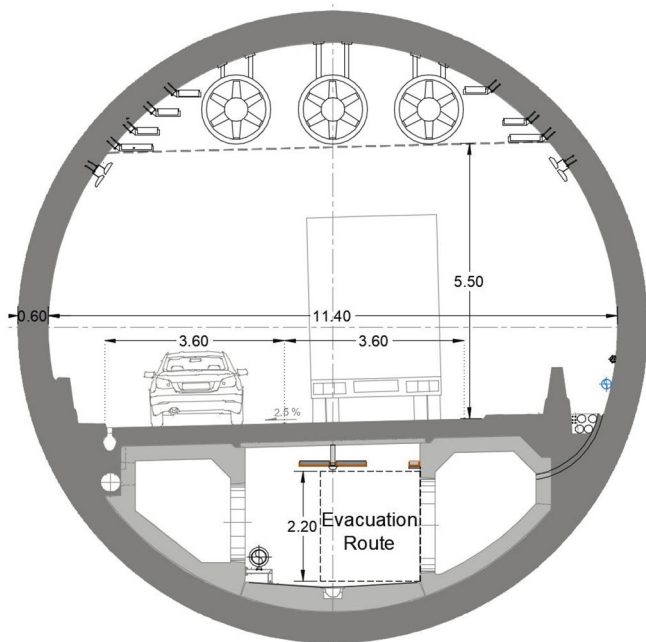
Fig. 2. Tunnel cross-section with precast road deck elements

Tunnel boring was carried out using two slurry shield TBMs with 13.05 m excavated diameter. The tunnels are lined with 600 mm thick concrete segments (8 + key) manufactured on site to give a finished internal diameter of 11.4 m (Figure 2). Later works include the installation of a segmented, precast concrete road deck with associated civil and MEP fitting out, including a permanently installed fire fighting (watermist) system.

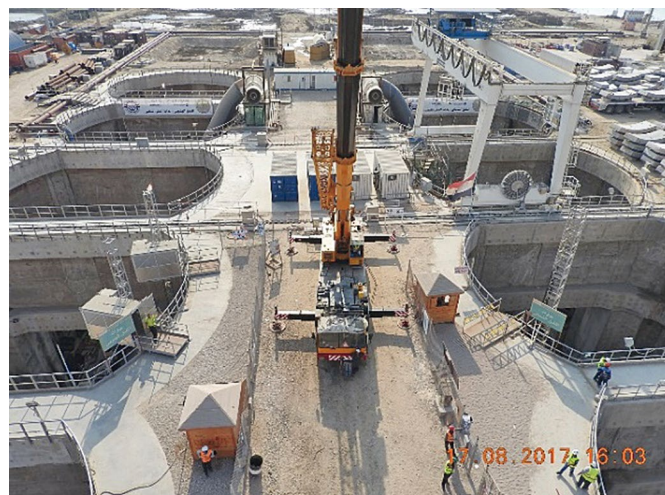
Fig. 3. Launching shafts

The TBMs were launched from the east side of the canal as land was more readily available for site installations, which allowed time for land expropriation on the west side. Both launching shafts (Figure 3) were constructed as five intersecting circular shafts (25 m diameter, diaphragm wall construction) to allow unhindered machine assembly. The reception shafts comprise two similar cells for sequential TBM dismantling and removal. The shaft break-ins and break-outs are secured by soil substitution (plastic concrete) blocks.

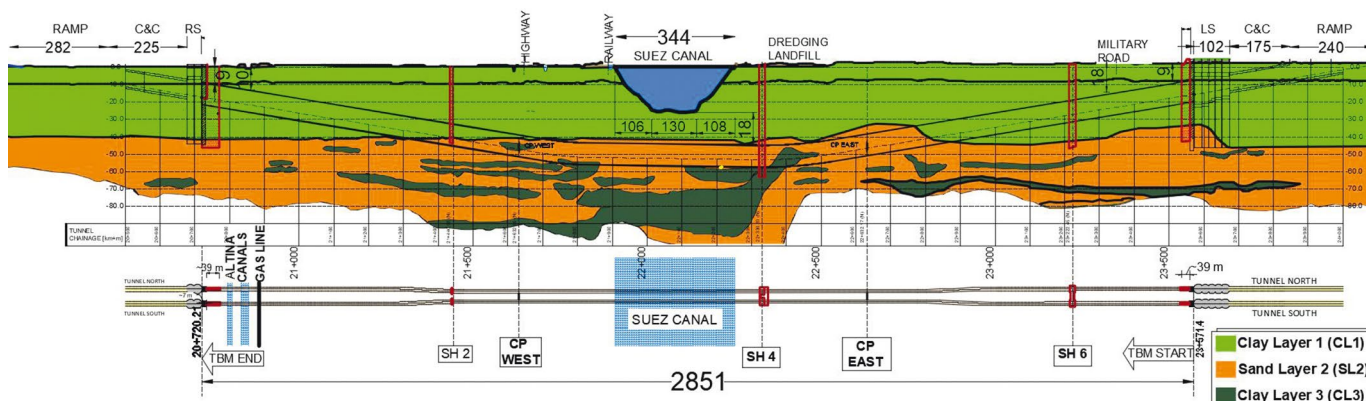
Fig. 4. Geological profile and tunnels layout

The project is located in the eastern Nile River Delta – low-lying (sea level +0.5 to 3.0 m) flat ground underlain by geologically recent thick clay and sand deposits. Three main lithological layers (Figure 4) have been defined comprising (from surface):

The geotechnical profile along the tunnel (see Figure 4) is based on a large number of site investigation boreholes and the holes drilled for gas venting, therefore has a high degree of confidence. It was not possible to conduct any drilling below the Suez Canal due to restrictions imposed by the Suez Canal freight traffic rules. For the first 0.8 km, the tunnels are driven with a downhill gradient in the CL 1 horizon, followed by 1.15 km mainly in the SL 2, then 0.35 km in mixed soil conditions (CL 1/SL 2) and finally 0.55 km again in CL 1. The tunnels below the Suez Canal were mostly excavated in SL2, with occasional lenses of CL 3 encountered in the lower tunnel profile and also sections with the CL1 in the upper tunnel profile.

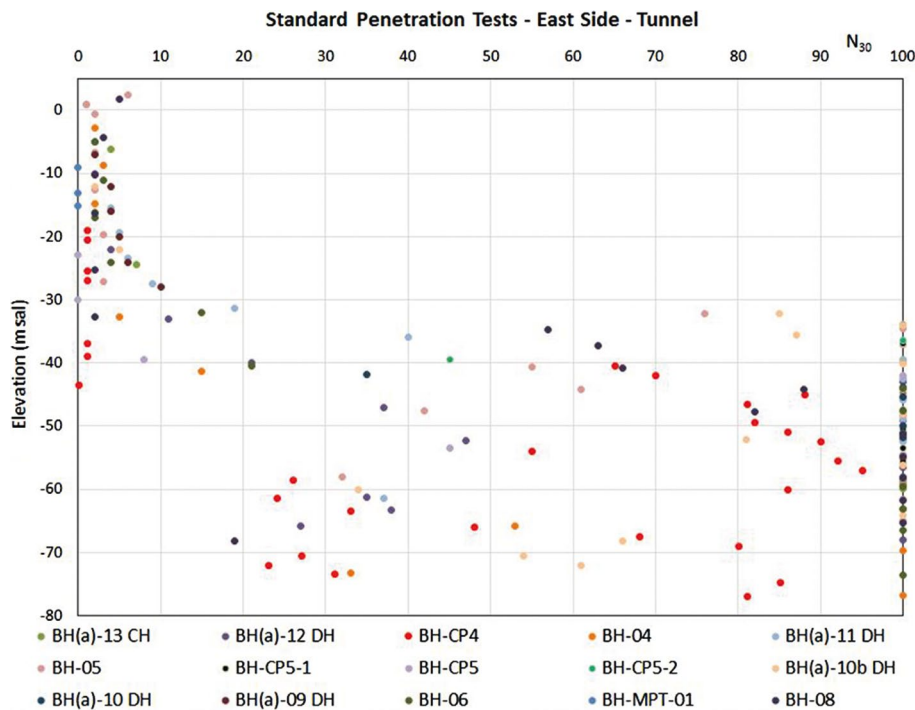
Fig. 5. N_{spt} values against depth (m b.s.l.) – eastern side

Figure 5 shows the results of standard penetration tests; N_{spt} values increase with depth. The upper 10 to 15 m of CL 1 (into which the TBMs were launched) have N_{spt} values below 5 and remain consistently low down to 20 to 25 m depth, then gradually increase significantly to the contact with the SL 2 (>40 m depth). This reflects the low mechanical parameters of CL1. Specifically, the undrained shear resistance of CL1 varies from $C_u = 10$ to 40 kPa (average < 20 kPa) in the upper 12 m, gradually increasing to 80 kPa at the contact with the SL 2. Similarly, the modulus of elasticity which is constant for the

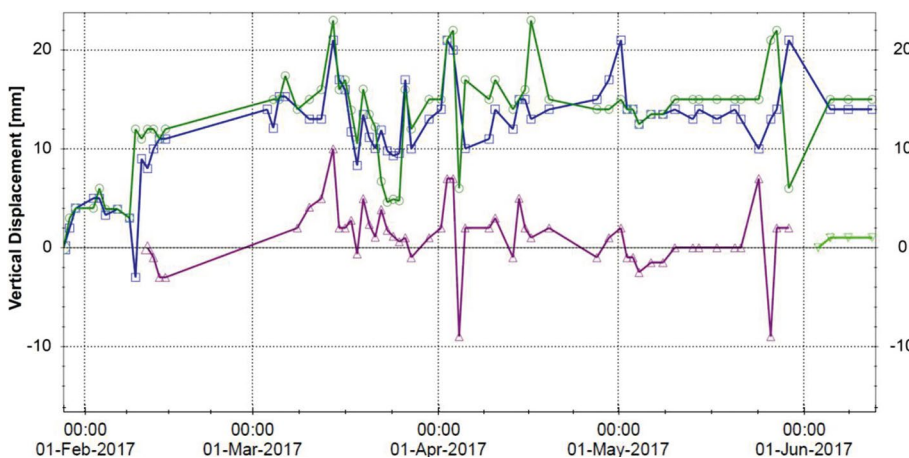
Fig. 7. Tunnel heave in the free field in front of the starting transition zone

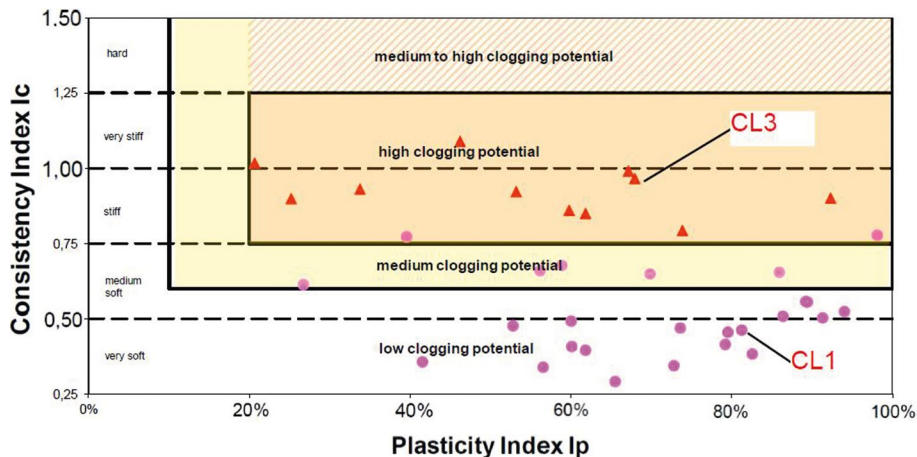
Fig. 8. Clogging potential of CL 1 and CL 3 (according to [4])

The clogging potential was investigated for both clay layers CL 1 and CL 3 (Figure 8). The results showed that the CL 1 has, in general, low consistency and despite its high plasticity index, low clogging potential. A higher clogging potential was recognised for limited sections of the deeper part of CL 1.

For CL 3, all test results indicated a high to very high plasticity, which, combined with a stiff to very stiff consistency, gave a high clogging potential. Based on previous experience in tunnel sections where clays with high clogging potential (such as CL 3) represent more than 20% of the tunnel face, the risk of massive clogging of the cutter-

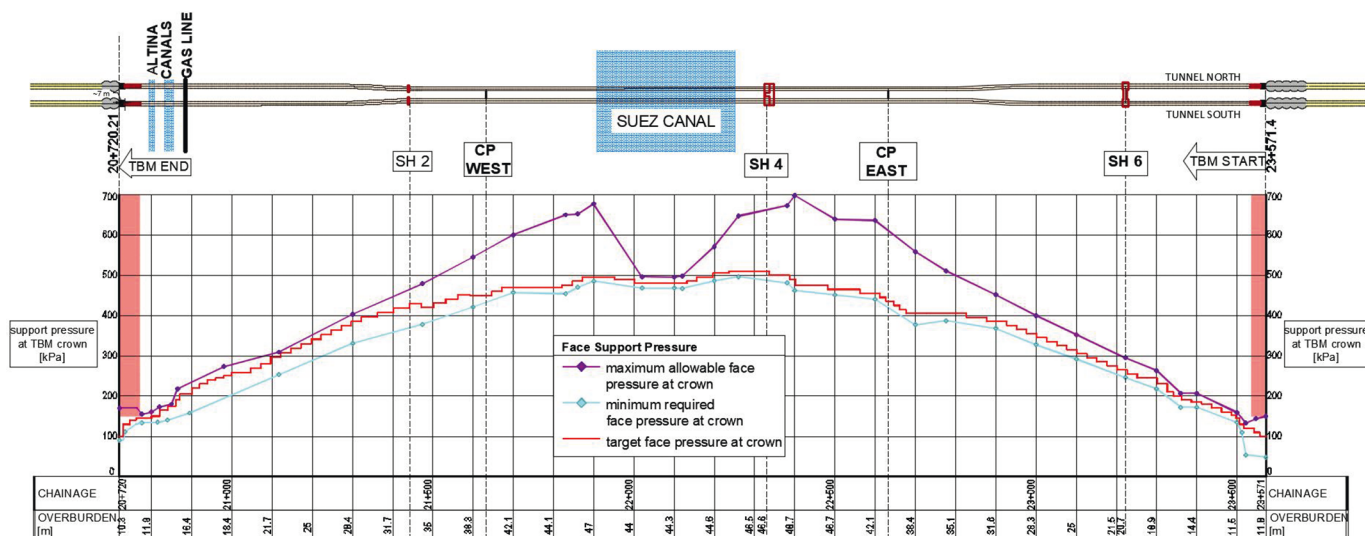
Fig. 9. Face pressure along the tunnel alignment – minimum required; maximum allowed; target value for safe operation

The recent bathymetric survey revealed the canal bed is 2 m deeper than anticipated during the finalization of the tunnel alignment – the cover below the canal being 18 m rather than the assumed 20 m. This resulted in a maximum allowed slurry pressure very close to the minimum required for face stability. Figure 9 shows the very small bandwidth of the design operational parameters with the minimum pressure at the upper pressure cell equal to 472 kPa and the maximum allowed pressure of 502 kPa (540 kPa with a reduced safety factor). Clearly careful control of the face pressure was required and special training sessions held to prepare the TBM operation team.

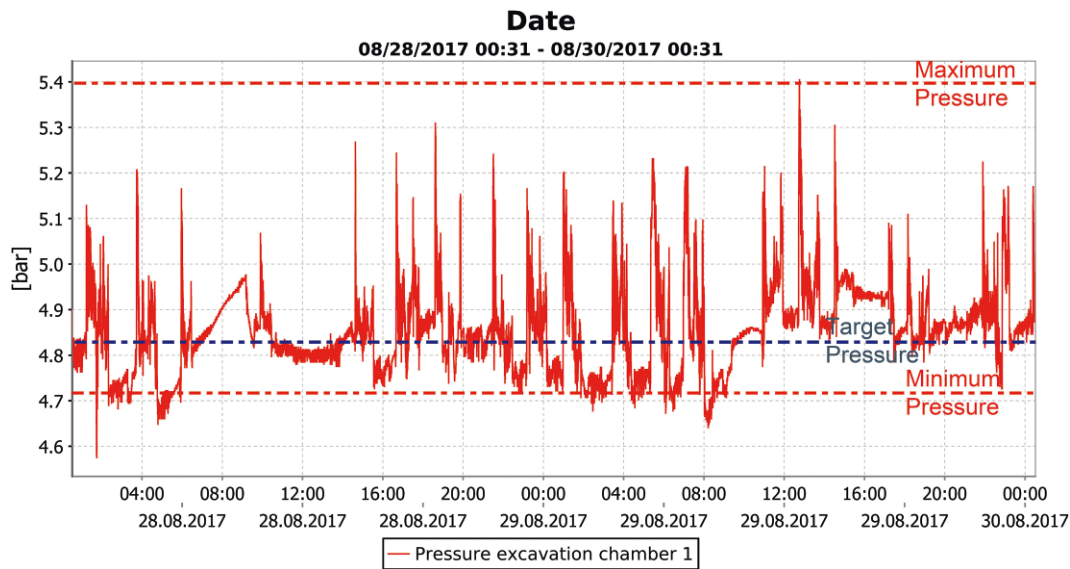
Fig. 10. North TBM – face pressure oscillation below the canal lower point

During excavation below the canal, the operation team encountered inevitable excavation chamber pressure peaks during pipe extension. To minimize these peaks, the slurry level was maintained at the manlock access level, while the evacuated slurry was discharged directly to the slurry treatment plant (STP). Figure 10 shows the oscillation of the actual face pressure of the TBM 1 (north) with fluctuation around the target value being occasionally higher than 10 kPa, but in general within the limits. No slurry blow-out or face instability was recorded during the passage below the canal.

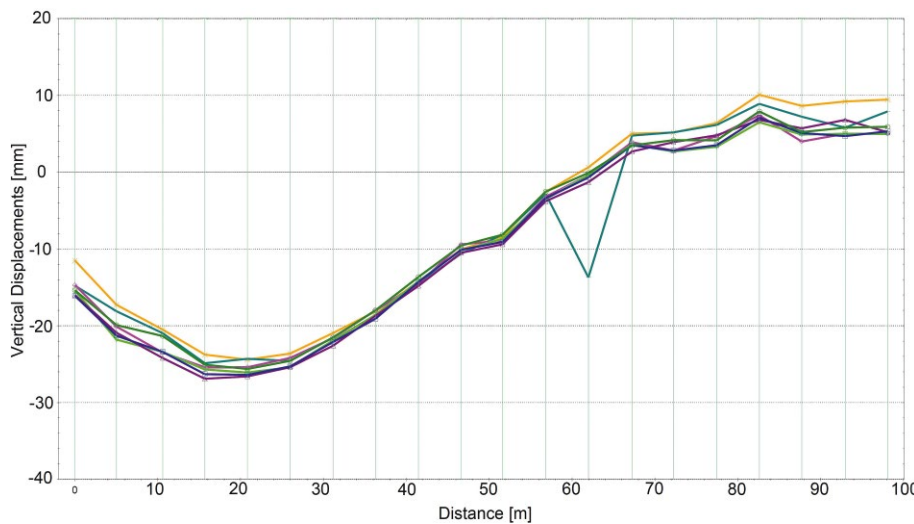
Fig. 11. Settlement profile of the railway line after tunnelling

Figure 11 shows the monitored settlements of the railway line which were within the expected values. During the crossing of the railway line, the operator applied precautionary measures such as reducing the speed of trains.

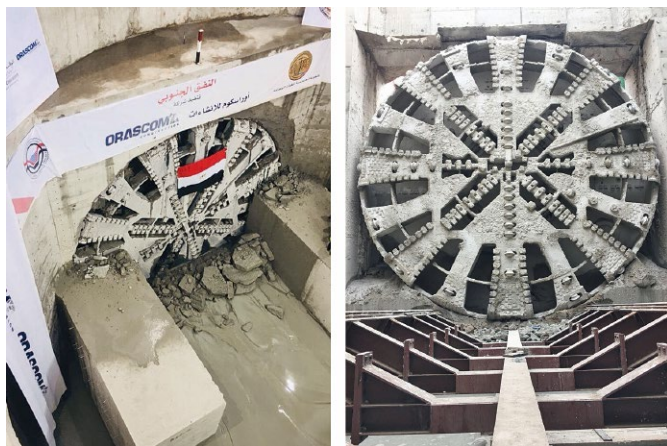
Fig. 14. South TBM breakthrough (left) and disassembly preparation at the second cell in the reception shaft for north TBM (right)
