# Shazar Caverns, Israel

Dr. Roberto Schuerch  
ETH Zürich, 12.12.2019

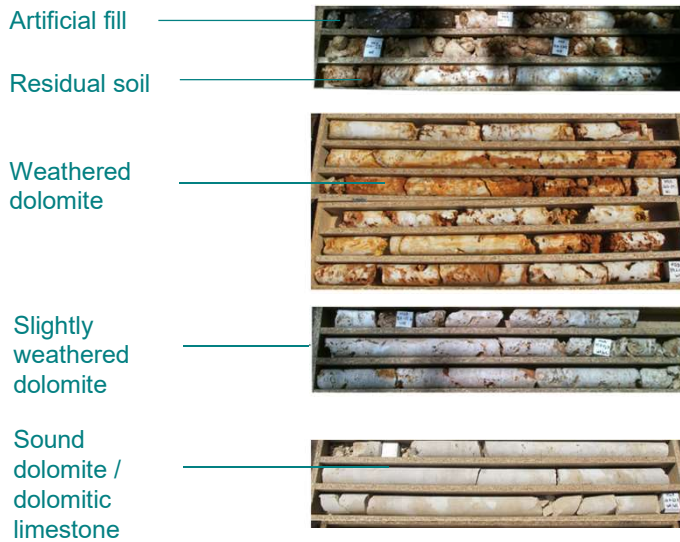
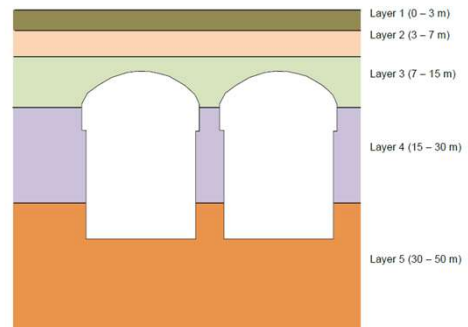
## INTRODUCTION – GEOLOGICAL CONDITIONS

$E$ [MPa]	$\nu$ [-]	$\varphi$ [°]	$\psi$ [°]	$c$ [kPa]	UCS [kPa]	$\gamma$ [kN/m <sup>3</sup> ]	$K_0$ [-]
Layer 1	Artificial filling	50	0.3	30	10	5	17	22	0.5
Layer 2	Residual soil (>50% clay)	250	0.3	35	15	40	153	22	0.5
Layer 3	Weathered dolomite/dolomitic limestone	500	0.25	35	15	260	1,000	24	0.5
Layer 4	Slightly weathered dolomite/dolomitic limestone	3,000	0.25	35	15	1,562	6,000	25	0.5
Layer 5	Sound dolomite/dolomitic limestone	20,000	0.25	35	15	10,411	40,000	25	0.5

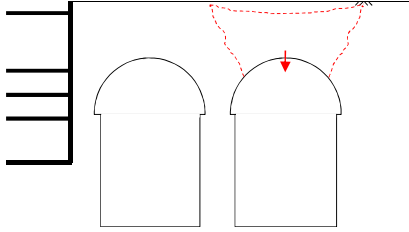
**Crater formation at the road surface**

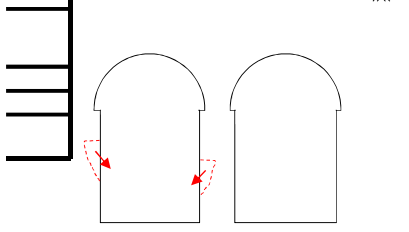
**Sliding of rock blocks**

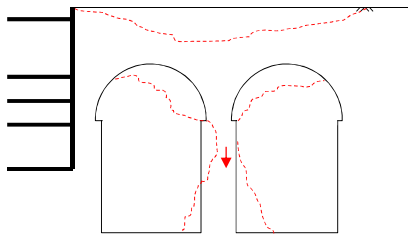
Instability of the rock pillar between the caverns

Central pillar "thin" compared to its height!

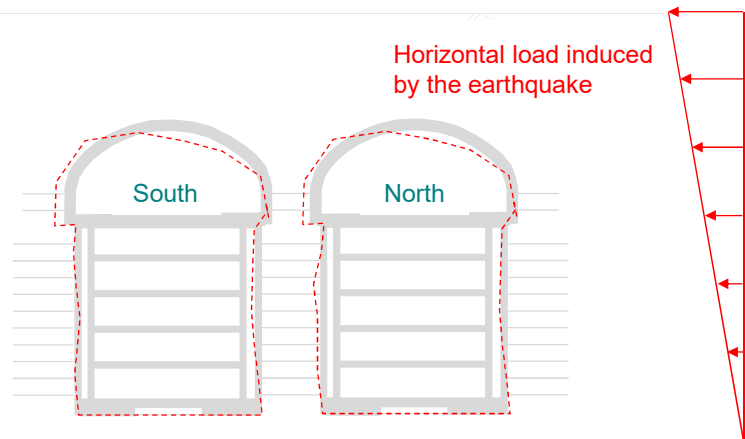
Instability of the pillar

Stage: before trench excavation

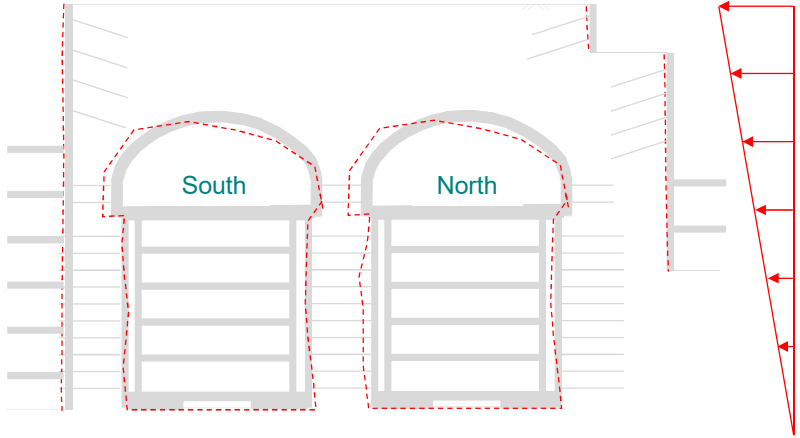
**Instability of the pillar**

*Stage: during trench excavation*

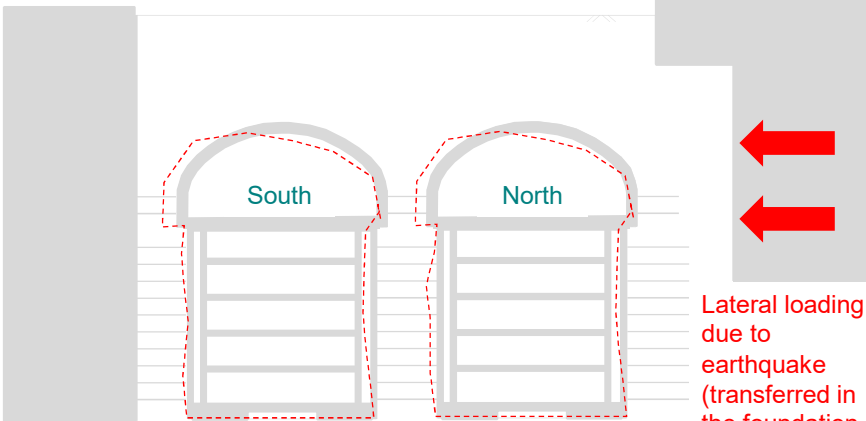
**Instability of the pillar**

*Stage: after buildings construction*

Lateral loading due to earthquake (transferred in the foundation area of the k-center)

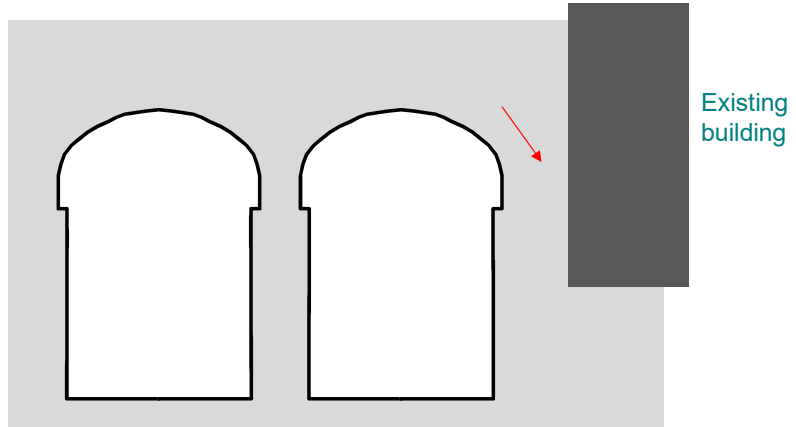
### Damages of the existing structures

- Additional load may cause inadmissible deformation or damages to the existing buildings

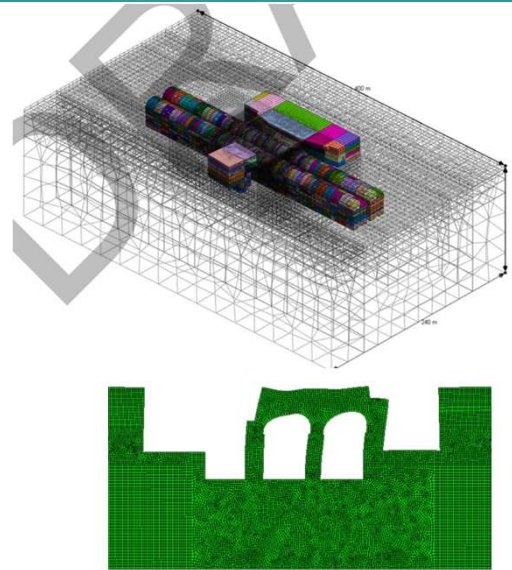
### Computational methods

- Static analysis (2D and 3D models)
- Seismic analysis (dynamic and pseudo-static 2D models)
- Validation through simplified analytical models

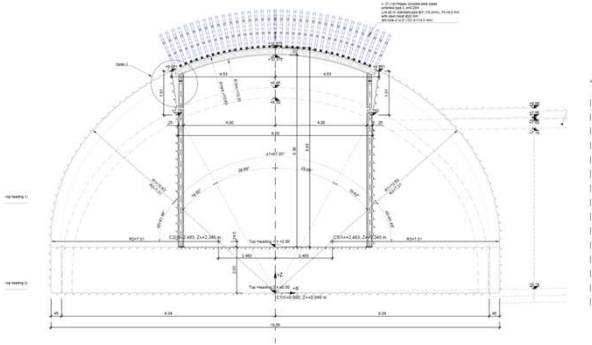
Central drift

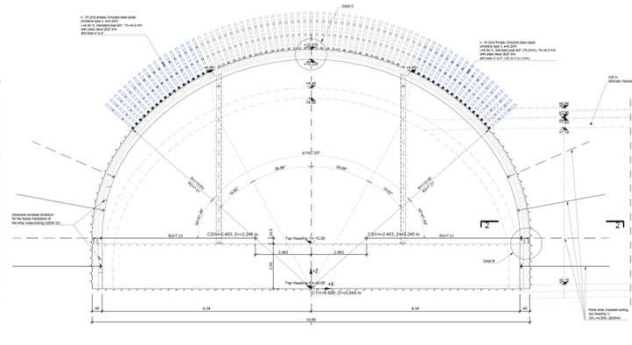
Enlargement

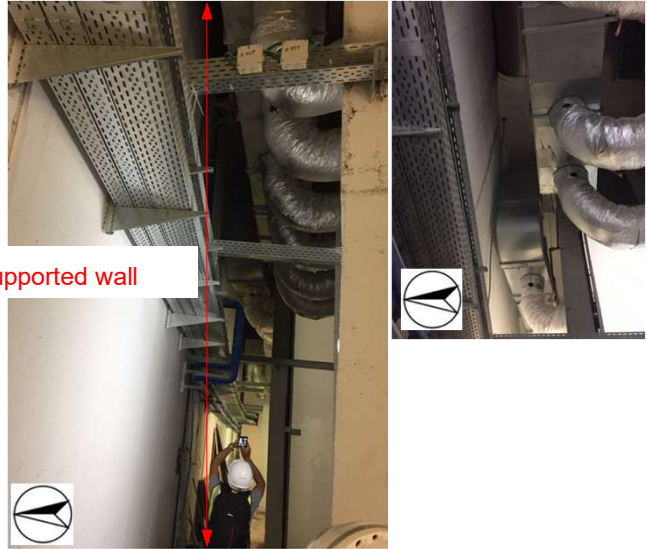
8.5 m high unsupported wall

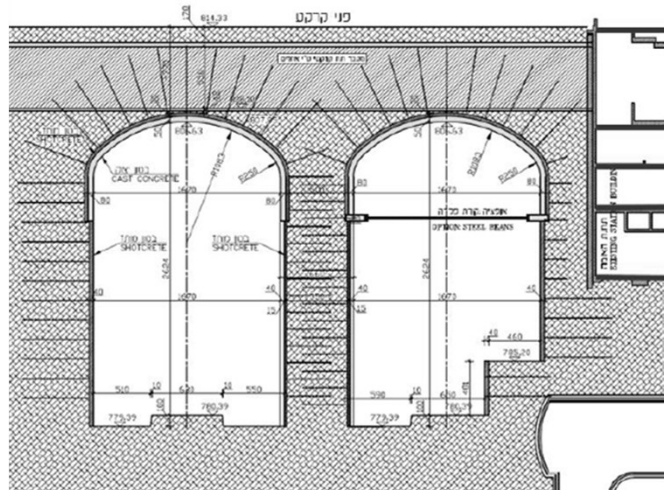
### Designer 1 – Original design

- Casting of the inner lining of the top-heading before benching
  - Installation of post-tensioned beams before excavation of the benching
- Conclusion: project not feasible without damaging the station
- Change of designer

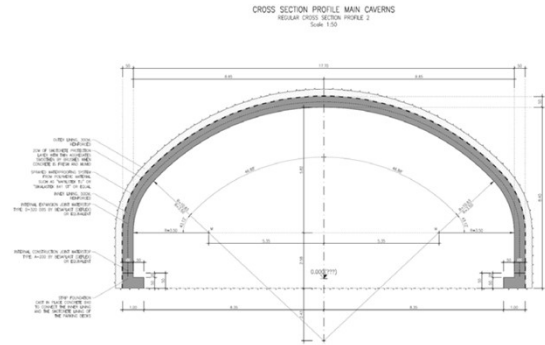
### Designer 2 – New design concept

- Casting of a thicker concrete lining before excavation of the benching
- Change of the top-heading geometry
- Change of the alignment (increase of the distance by about 2 m)

- Conclusion: project not feasible without damaging the station
- Change of designer

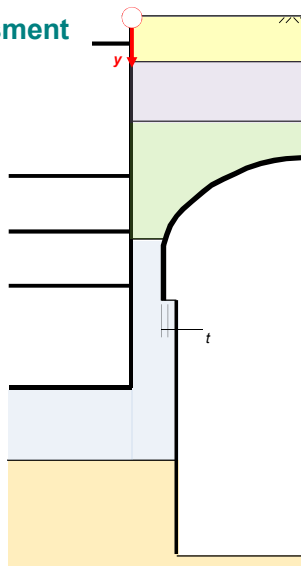
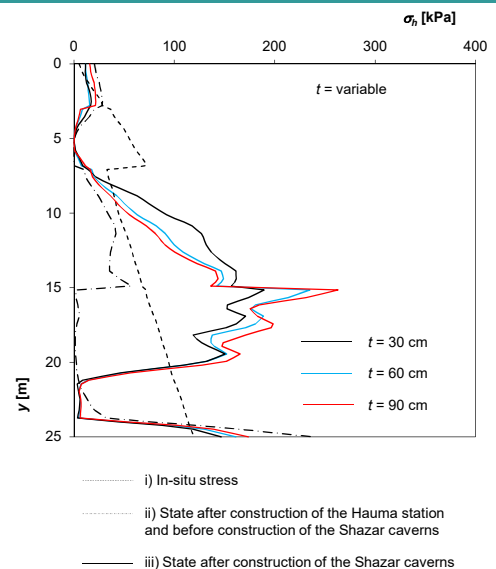
### Pini Swiss Engineers – Assessment

- Rock mass much stiffer than the support; not possible to decrease the load on the station by increasing the thickness of the support/inner lining
- Alternative solutions required

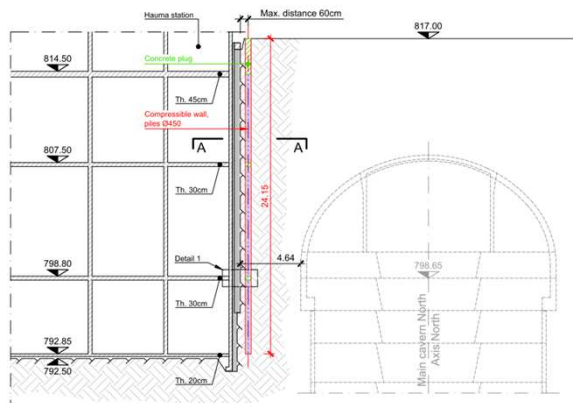
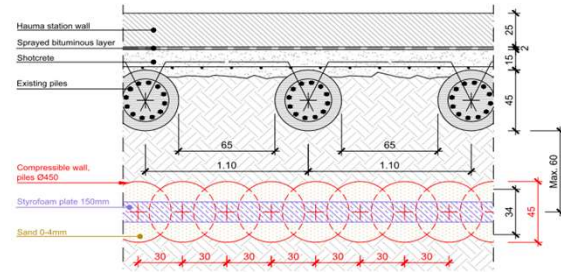
#### Solution 2: Disconnecting the rock mass from the Hauma's wall

Details of the compressible layer, horizontal cross section.

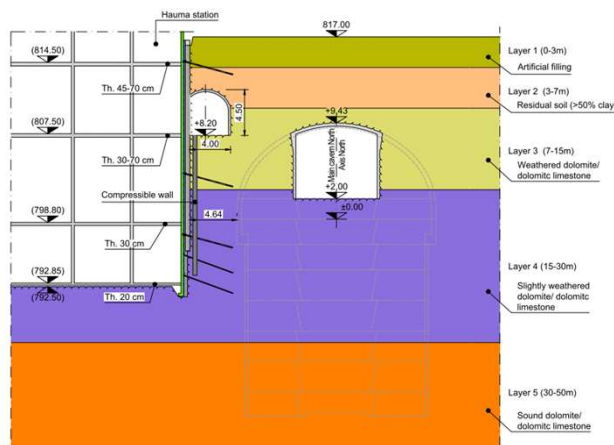
#### Solution 3: Disconnecting the rock mass from the Hauma's wall from an auxiliary tunnel

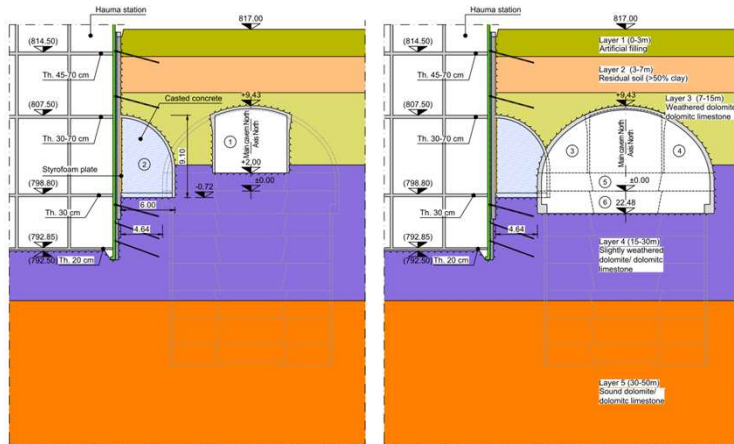
#### Solution 4: Installation of a compressible layer from a side drift

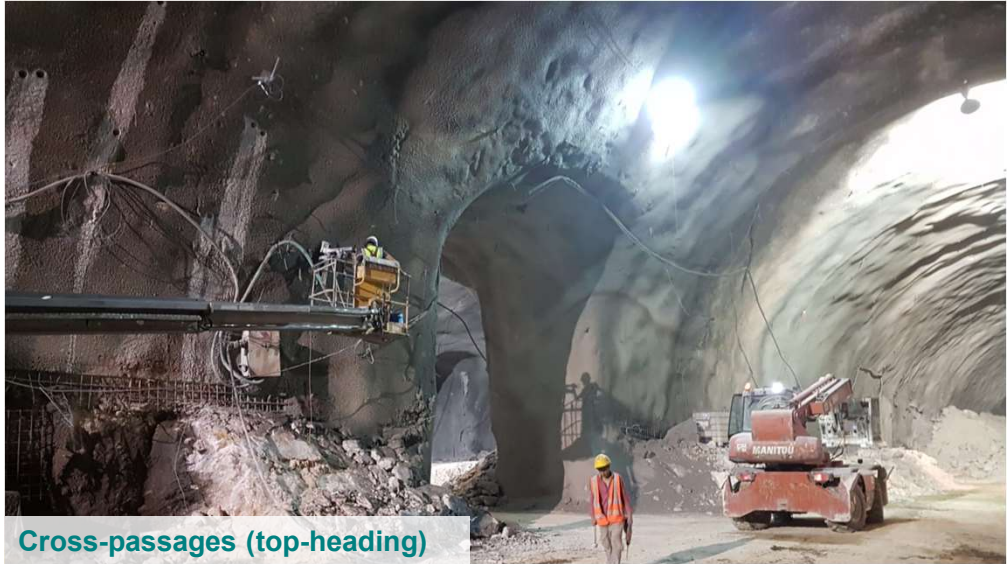
Cross-passages (top-heading)

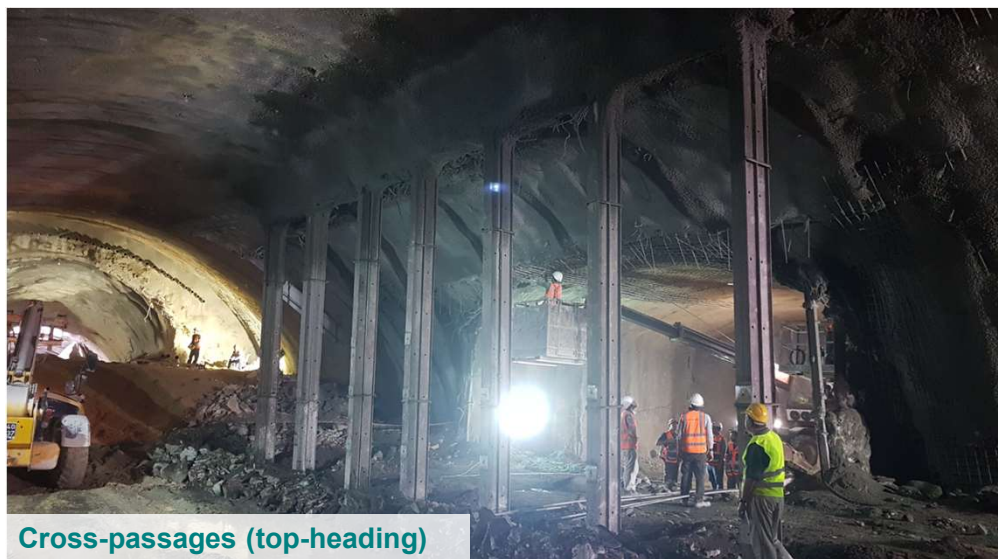
Cross-passages (top-heading)

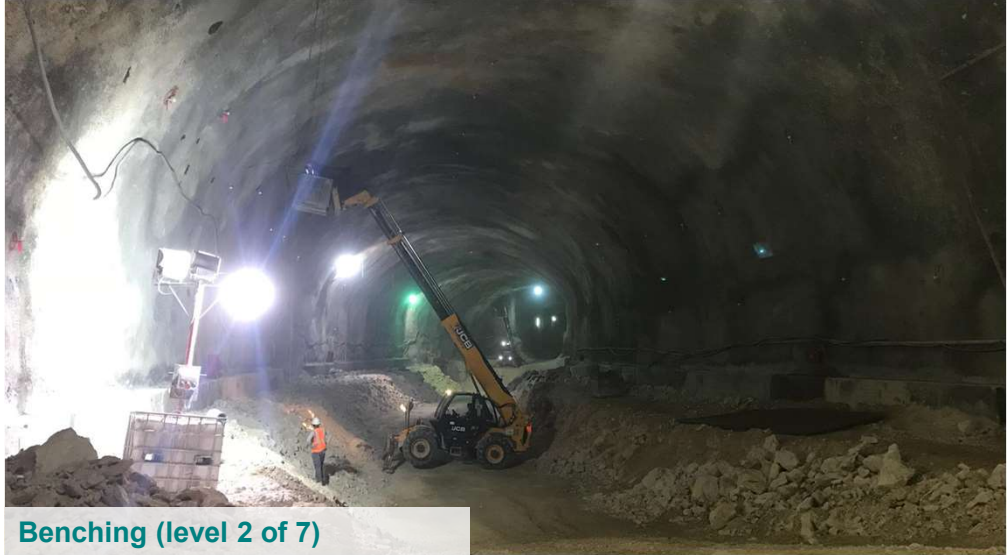
Benching (level 2 of 7)

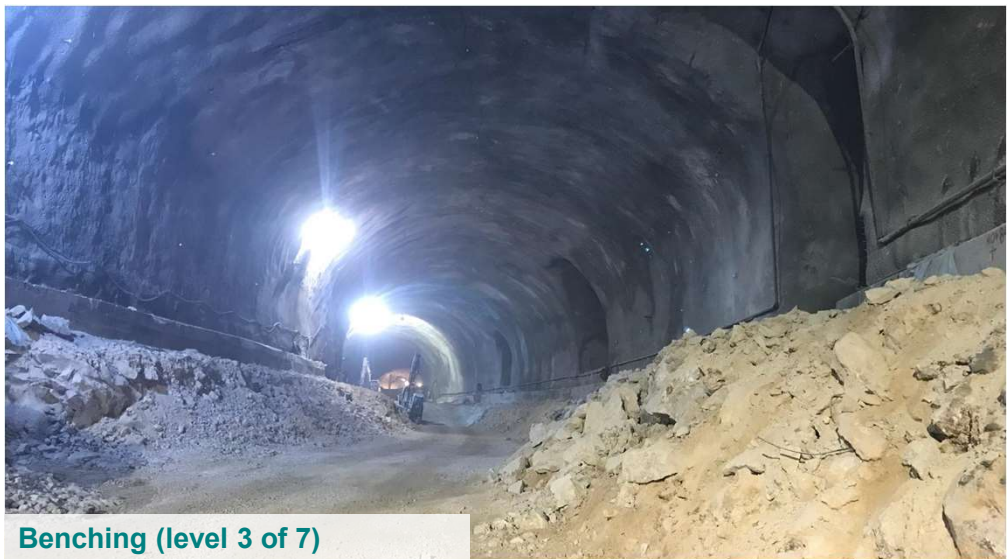
Benching (level 3 of 7)

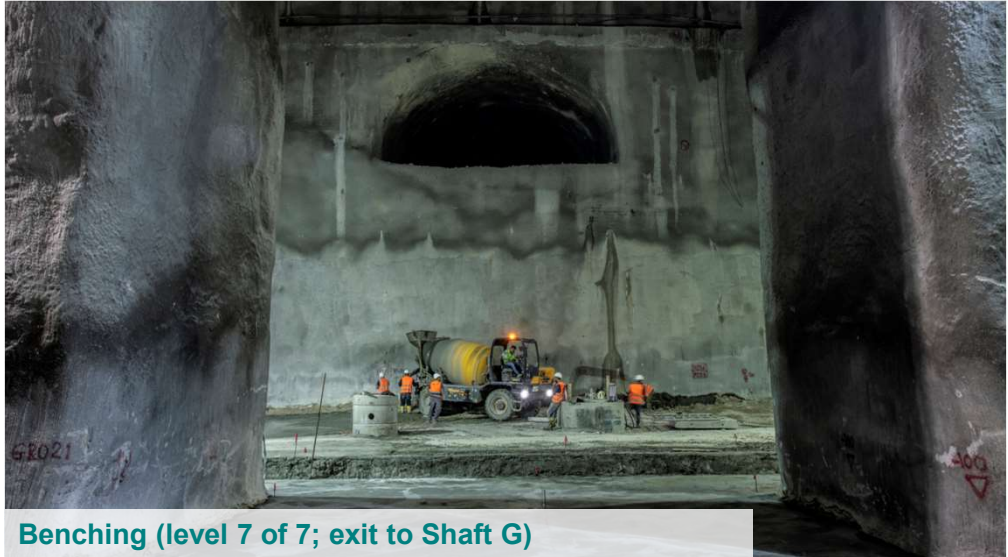
Benching (level 7 of 7; exit to Shaft G)

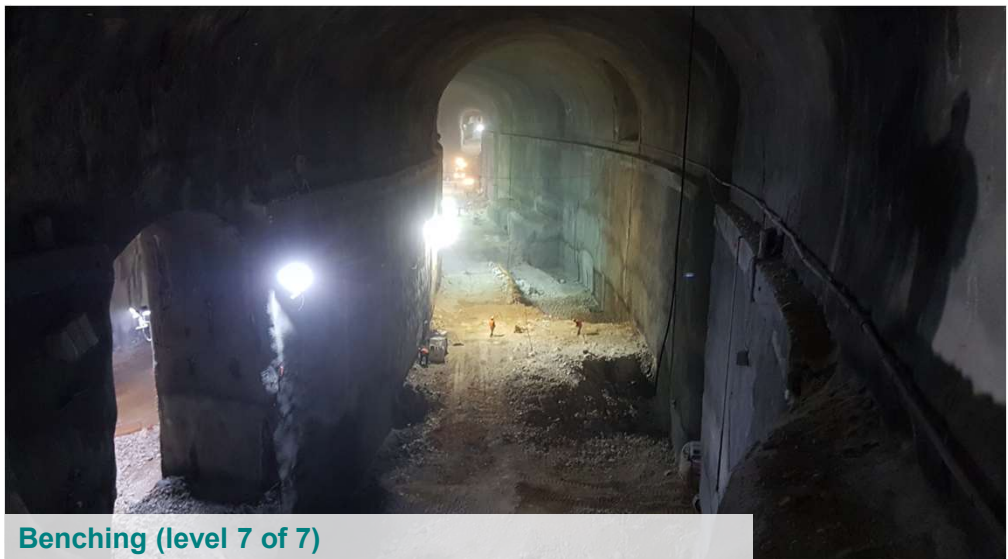
Benching (level 7 of 7)

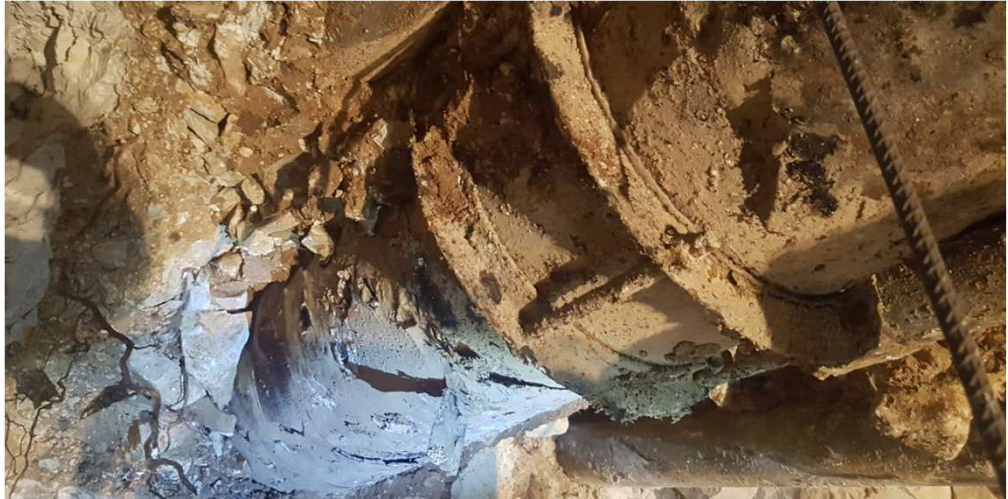
**A bit of luck helps...high pressure water pipe (not mapped!)**

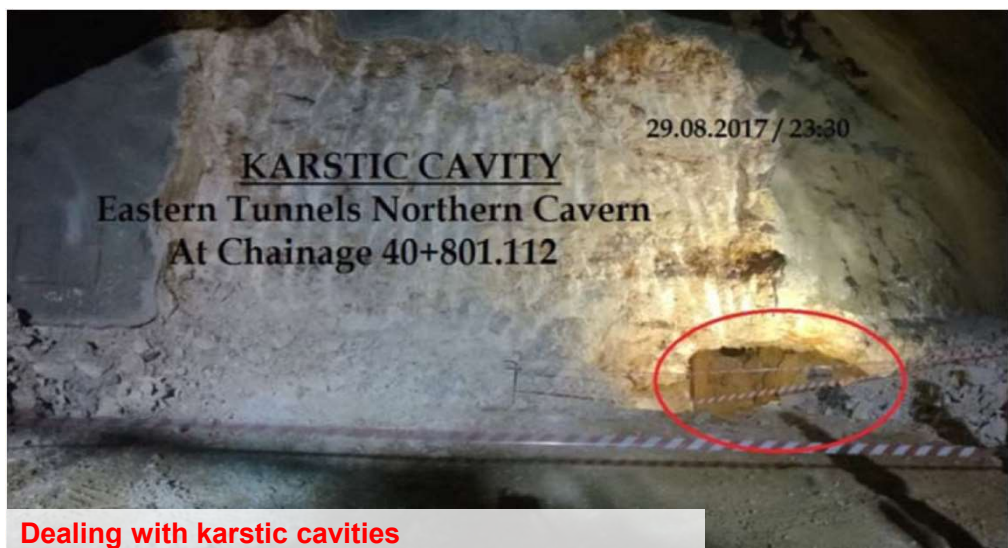
**Dealing with karstic cavities**

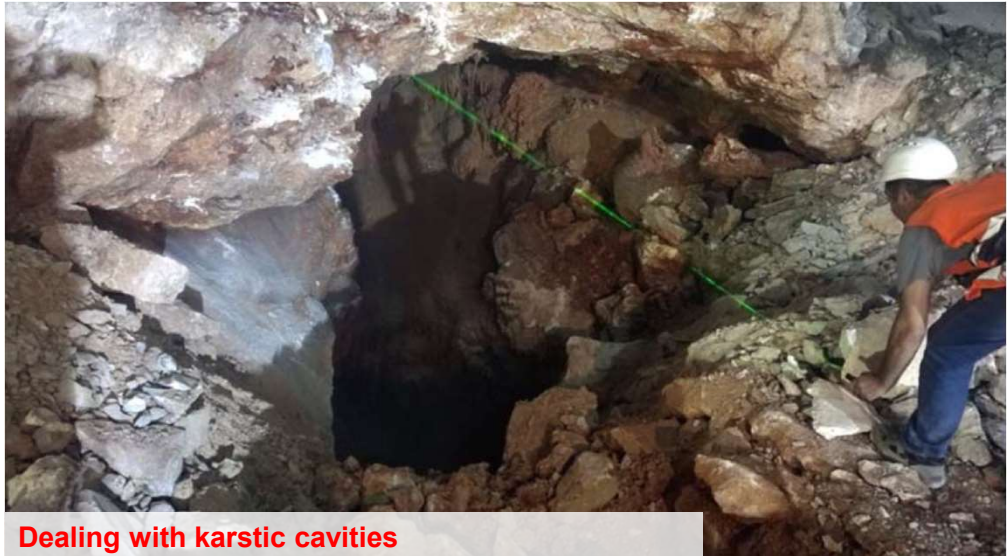
Dealing with karstic cavities

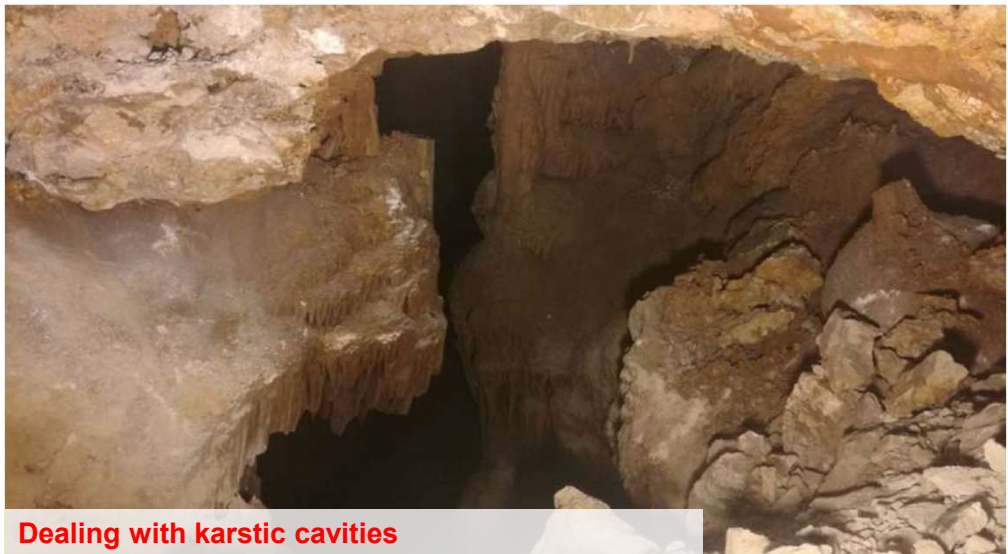
Filled with more than 750 m<sup>3</sup> of concrete

Dealing with karstic cavities
