DAS TAPOVAN – VISHNUGAD PROJEKT – MASCHINELLER VORTRIEB UNTER EXTREMEN BEDINGUNGEN

JOHANN BRANDL – GEOCONSULT ZT GMBH, AUSTRIA

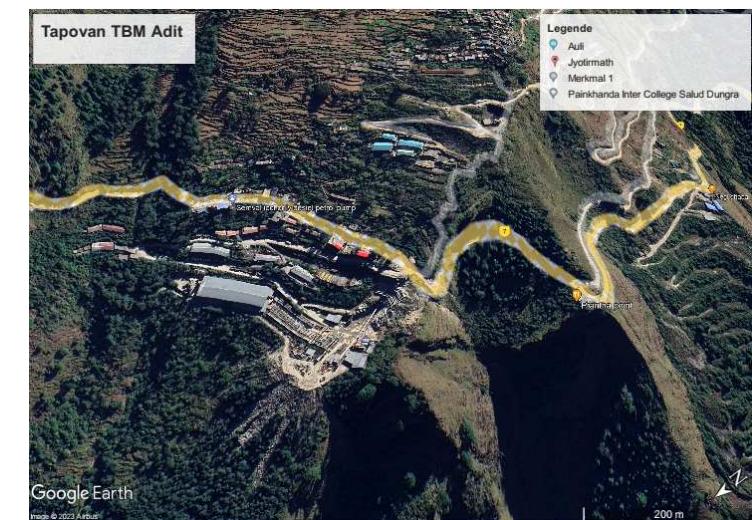
Projektslayout

- Capacity: 520 MW (4 x 130 MW)
- Headrace Tunnel: Internal Diameter 5.6 m, total length 12.1 km, 8.1 km with TBM , 4 km conventional excavation
- Powerhouse Cavern: Length 120 m, Width 22 m, Height 50 m
- TBM: Herrenknecht Double Shield TBM with 6.575 m Excavation Diameter

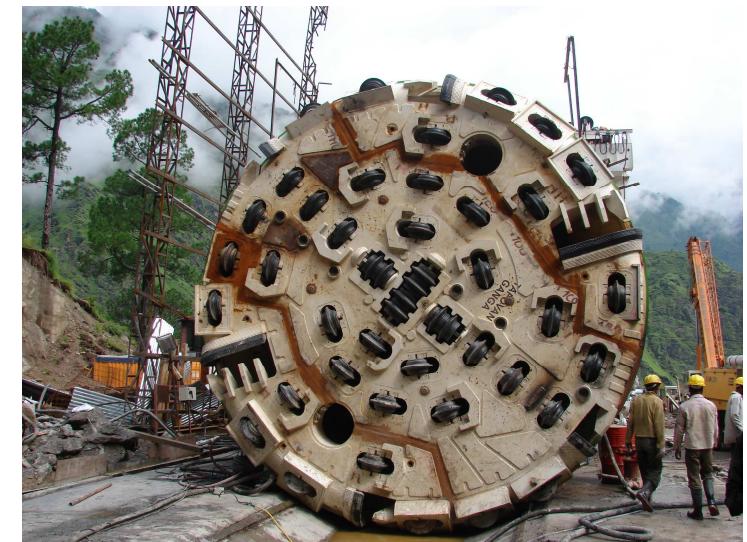
GENERAL	DATA
Machine type	TBM double shield
Total tunnel length	ca. 8.500 m
Installed power	3.581 kW
Length TBM + trailer	ca. 235 m
Weight TBM	502 t
Weight trailer	508t
Driveway	250 m

CUTTERHEAD / CUTTING WHEEL	DATA
Bore diameter	6.605 mm
Weight (with tools)	ca. 85 t
Disc cutters (individual)	38x
Disc cutters (double)	4x
Disc cutter diameter	432 mm
Track pitch	75 / 90 / 95 mm
Buckets	6x
Sprinkling	4x water

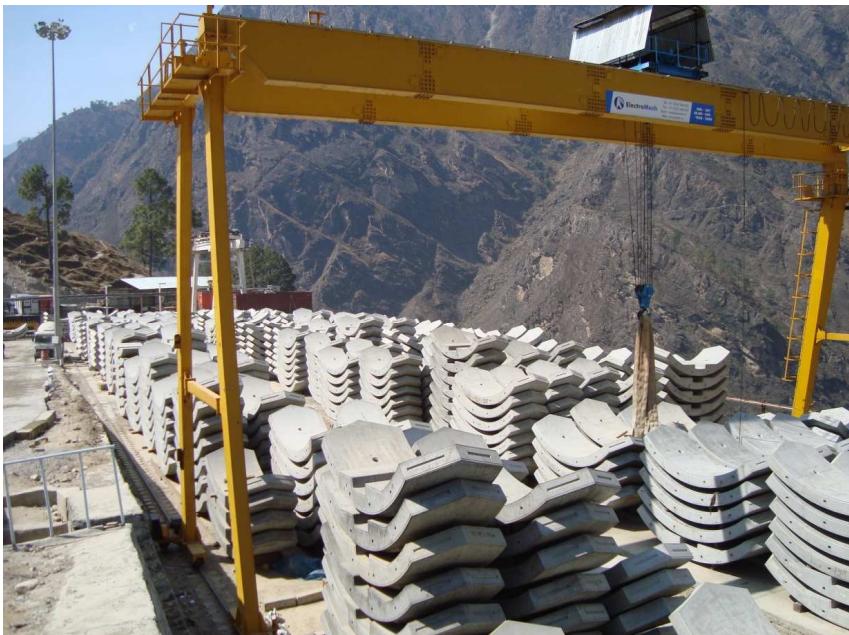
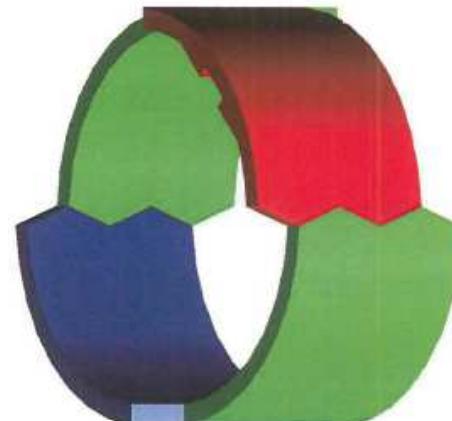
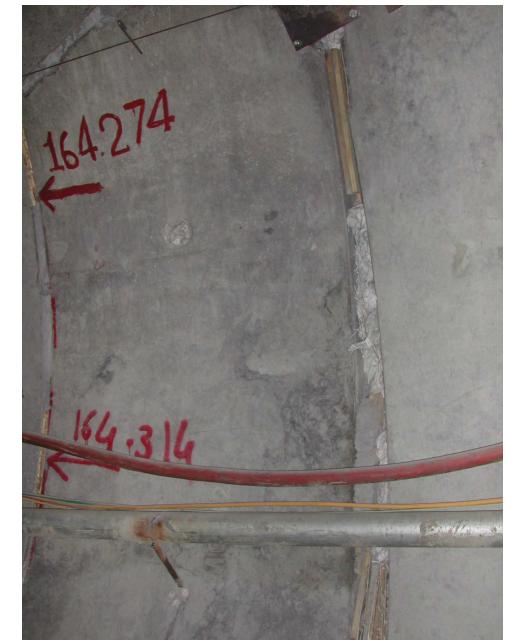
Technical Data – Segmental Lining

- Hexagonal Lining with thickness 300 mm
- Internal diameter 5640 mm
- Ring Length 1500 mm
- Concrete Quality M40
- Reinforcement Grade 90 – 100 kg/m³

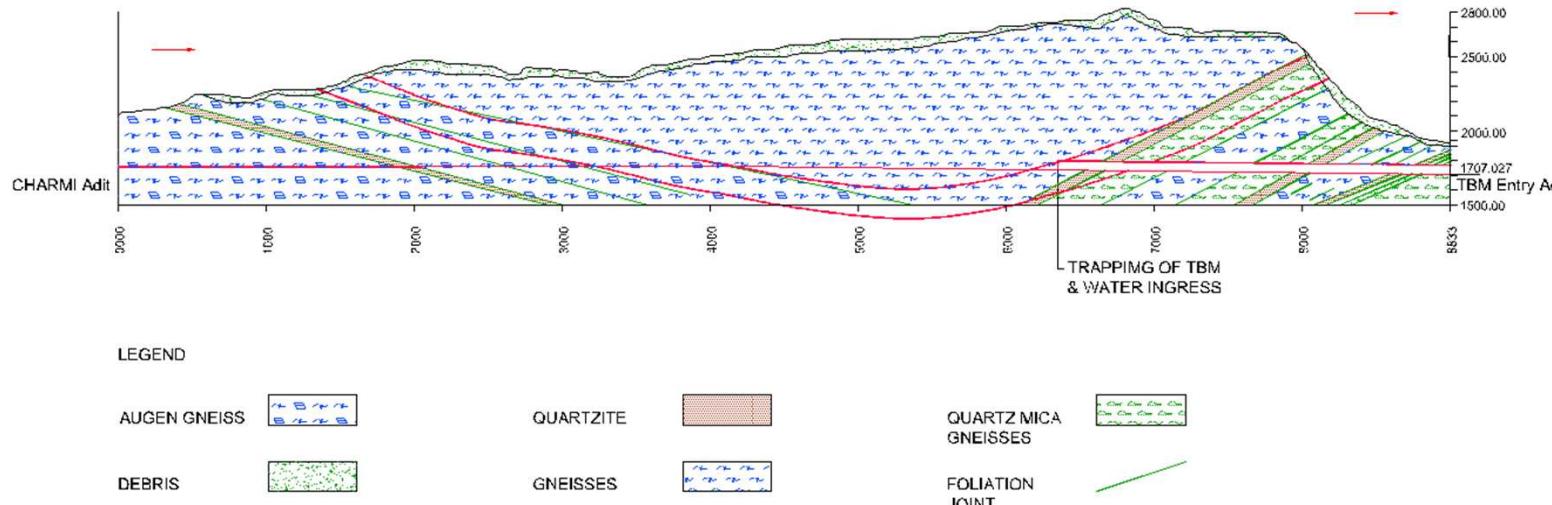
Geological Conditions

On the basis of limited surface and subsurface geological information, an attempt has been made to identify the tunneling conditions in different classes of rocks. About 80% of the head race tunnel is expected to be driven in very good to fair rock (i.e. Q-value $>$ or = 4) conditions. The remaining 20% tunnel excavation may encounter poor to very poor rock conditions (i.e. Q-value $<$ 4). The above classification is very preliminary in nature and is likely to change during excavation.

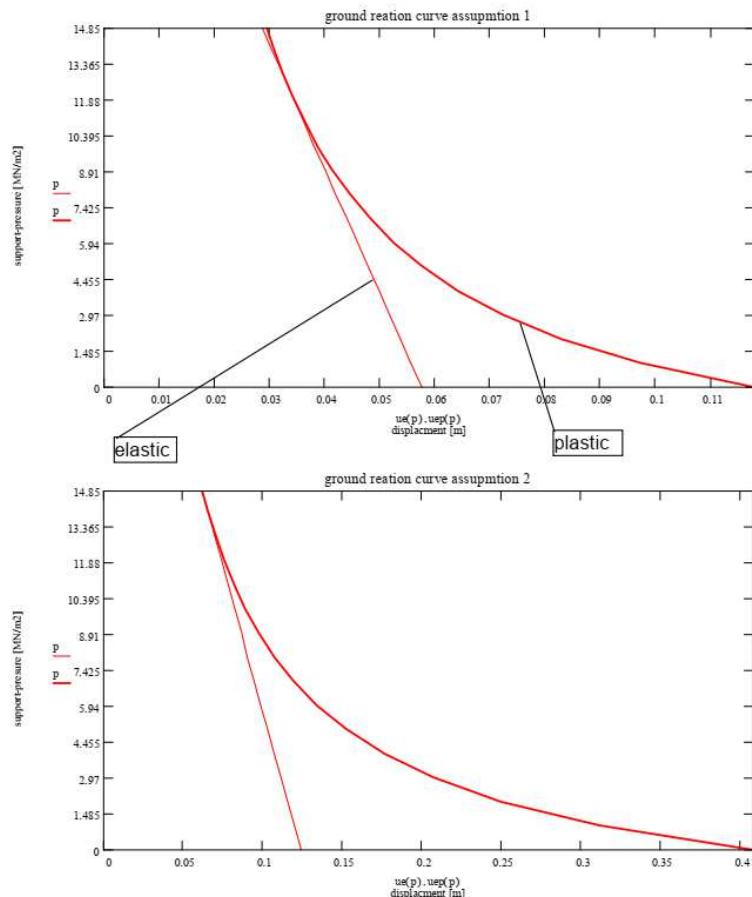
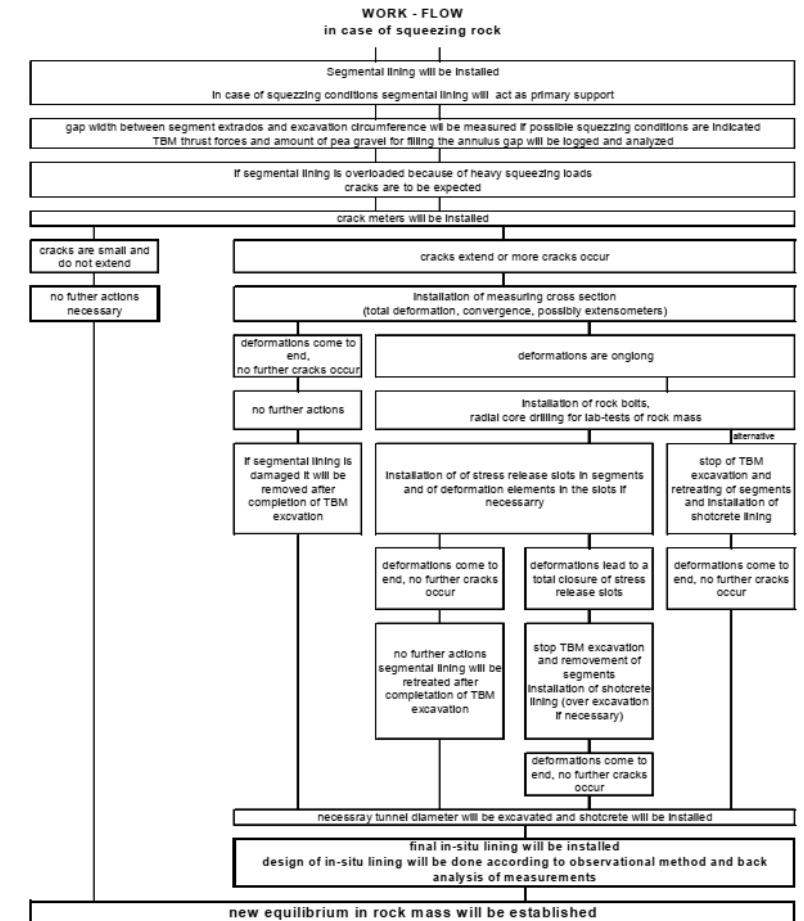
Squeezing Zones

Principle Idea: excavate through and „worry later“ (means any damages to the segmental lining is to be dealt with later but no stoppage of TBM!)

basis for design of segmental lining according to geotechnical report		not indicated at moment these are only hypothetic values			
			V					
			chainage	km~9100-11400				
			rock mass description	foliated coarse grained garnet, gneiss with schist				
			γ unit weight [kN/m^3]	27				
			h overburden < [m]	1100	150			
			K_0 [-] lower bound	0.7				
			K_0 [-] upper bound	1,5				
			vertical in situ stress [kPa]	29.700	4.050			
			σ_c intact UCS [MPa]	65-75 (70)				
			E intact [MPa]	15.000				
			ν poisson ratio [-]	0,2				
rock mass			GSI [-]	52				
	Hoek-Brown criteria		m [-]	20				
rock mass for structural analysis according to Hoek Brown criteria			friction angle [$^\circ$]	39,2	54,16			
			cohesion [MPa]	3,7	1,11			
			UCS [MPa]	4,7	4,7			
			global strength σ_{cm} [MPa]	15,6	6,9			
			E [MPa]	5.000				
squeezing potential according to Hoek			ratio σ_{cm}/p_0	0,52	0,23			
			strain ϵ [%]	0,73	0,07			
			squeezing potential	minor	<minor

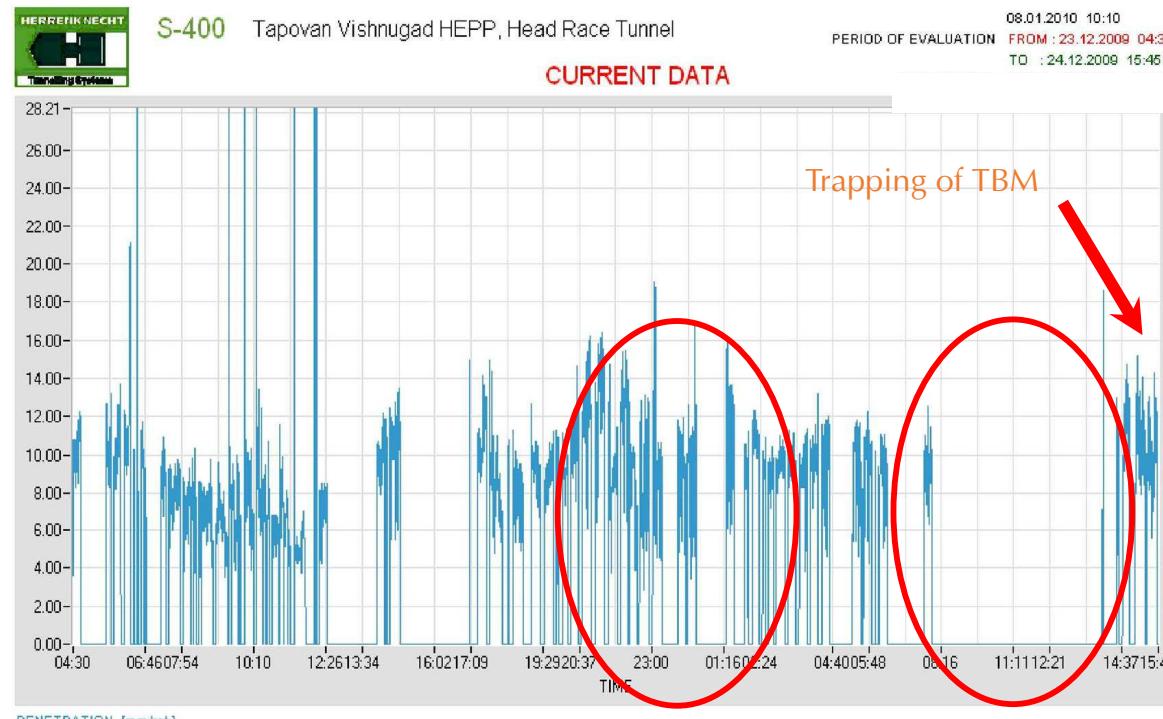
1st TBM Trapping (Dec. 2009)

- Während des Durchörterns der Störungszone kam es zu einer massiven Überbruchbildung (Indikationen dafür: hörbarer Nachfall während Meisselaustausches sowie blockiges Ausbruchsmaterial mit Wechsel der Lithologie)
- Kernzone der Störung liegt zwischen Ringen 1904 und 1907
- Störungszone besteht aus tonreicher Brekzie, die aufgrund des Überbruches mobilisiert wurde und so den Schild verdrückte (braun gefärbtes, trübes Wasser in Verbindung mit Schlamm, Sand, Kies)
- Dadurch Freisetzung hochgespannten Wassers (> 80 bar Druck); Auswaschen des Perlkieses; nachfolgend Blockieren der Einblasöffnungen durch vom Wasser transportiertem kleinstückigen Gebirgsmaterial
- Versagen des Firsttubbings bei Ring 1905 durch aufliegendes Verbruchsmaterial sowie Wasserdruck (vorherige Wasseraustritte aus Einblasöffnungen blockiert)

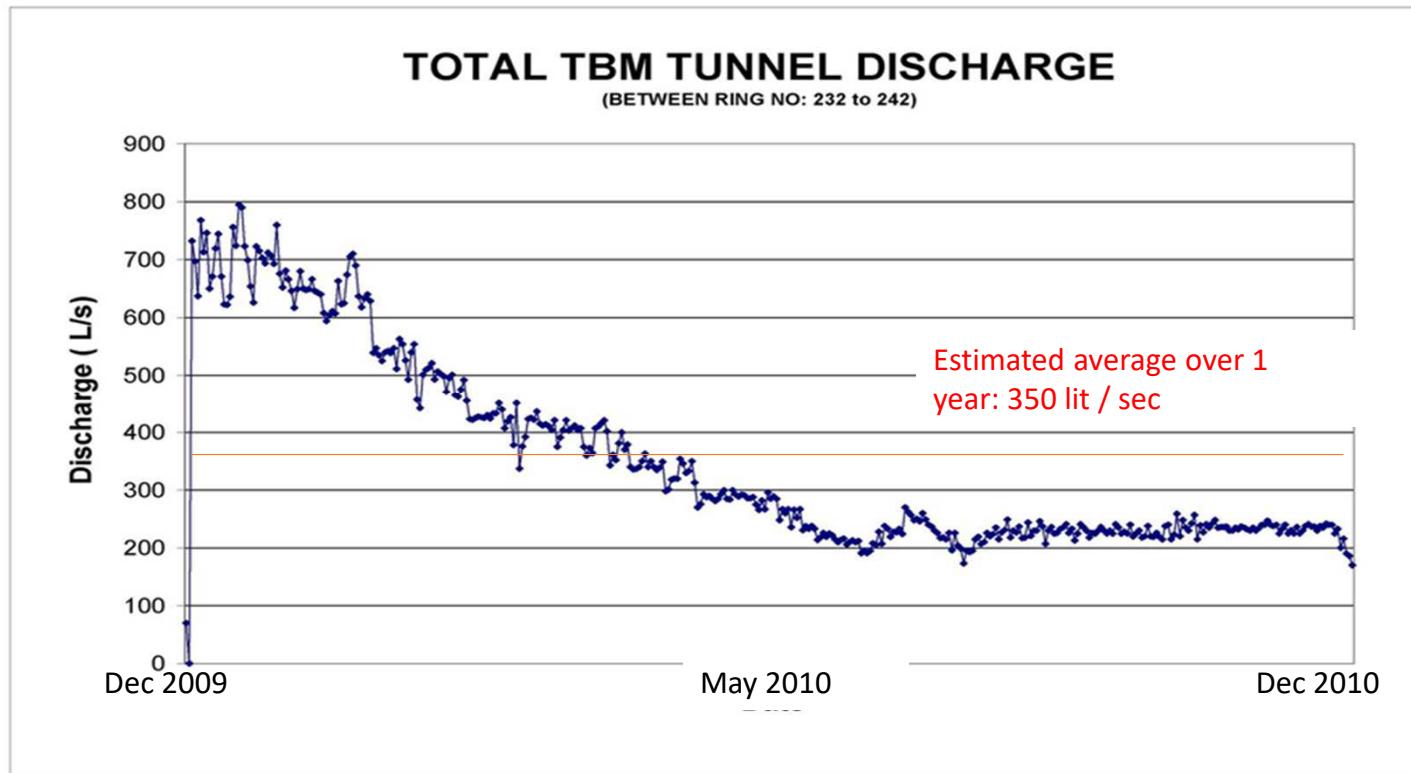
Total discharge in 1 year: 11 mio m³ water

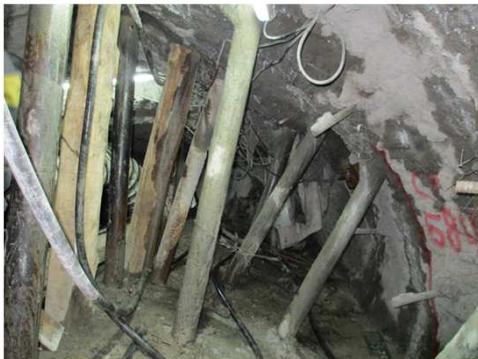
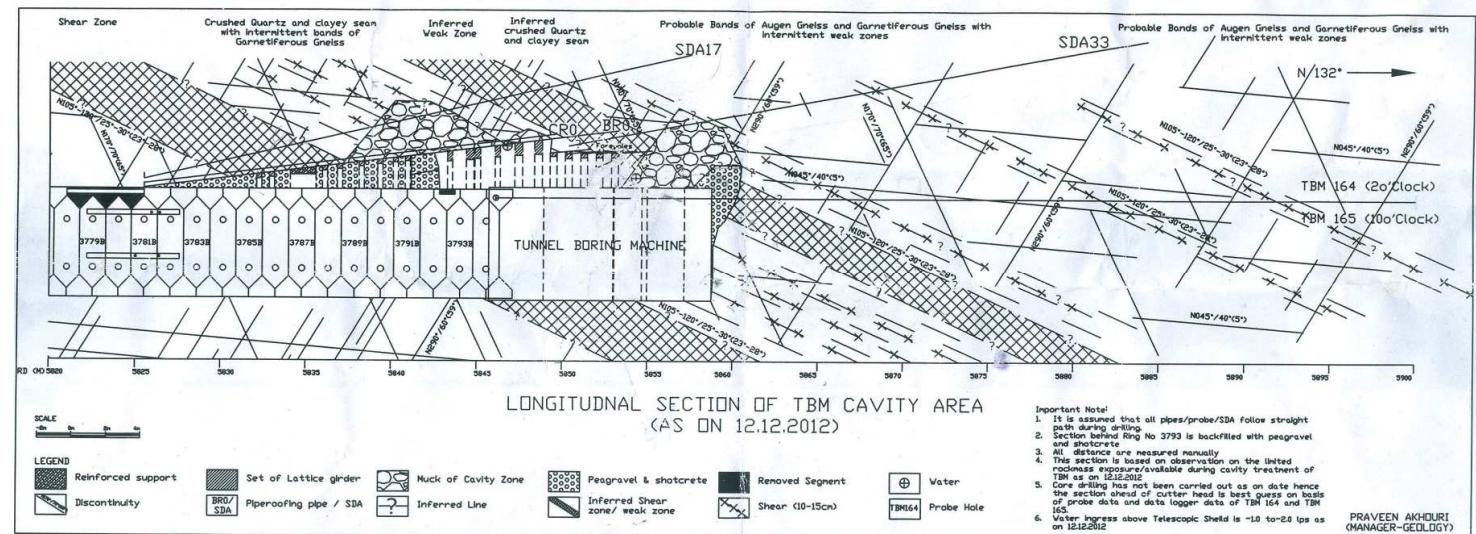
2nd and 3rd TBM-Trappings (Feb 2012)

- Low strength fault zone with soil like material
- Installation of double pipe roof (was not foreseen in contract and in BoQ)
- Excavation of working chamber to free the shield again
- Further advance of approx. 18 m

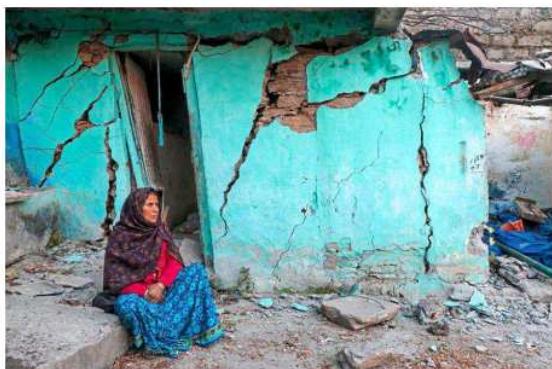
Foto: AFP/BRIJESH SATI

Durch das eine Wohnzimmer geht ein Riss. In einem anderen bröckelt die Wand ab. Auch in der lokalen Badminton-Halle klafft eine riesige Erdspalte. Und der Straßenasphalt ist an vielen Stellen zerrissen. Vor allem in den vergangenen zwei Wochen haben sich die Risse und Spalten überall in Joshimath rasant vermehrt.
