River Design and Restoration in an Urban Environment

Exploitation of the Potential in Victoria (Seychelles)

Master's Thesis
Spring Semester 2019

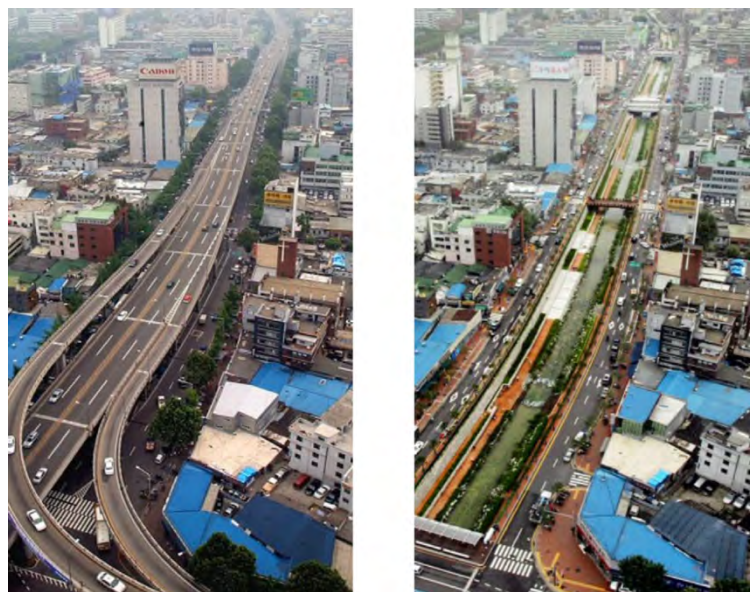
Figure 3: State of the Cheonggyecheon river before (left) and after (right) the restoration project (Woo, 2010).

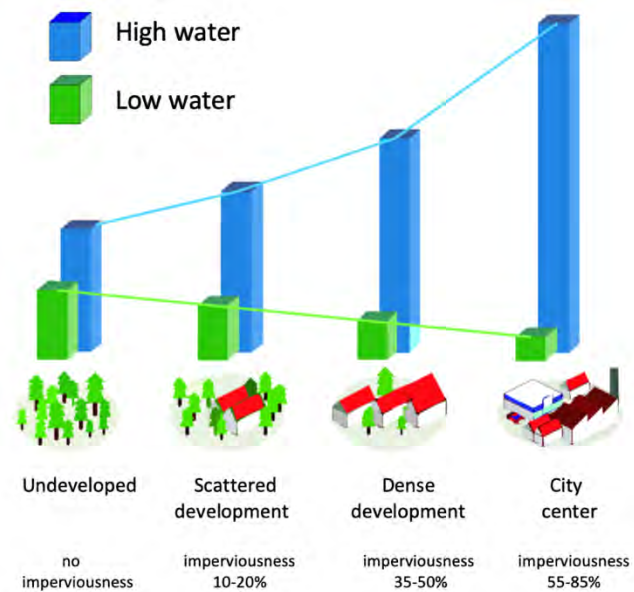
Figure 4: Illustration of the discharge spread (König, 2011, p. 18).

In urban areas, a large number of impervious surfaces and the increasing drainage density of storm sewers lead to a spread of runoff. The water is no longer infiltrated and retained naturally into the soil and is transported away quickly (Bernhardt and Palmer, 2007; König, 2011). This increases respectively decreases the volume and velocity of the flood runoff respectively the low water runoff (see Figure 4).

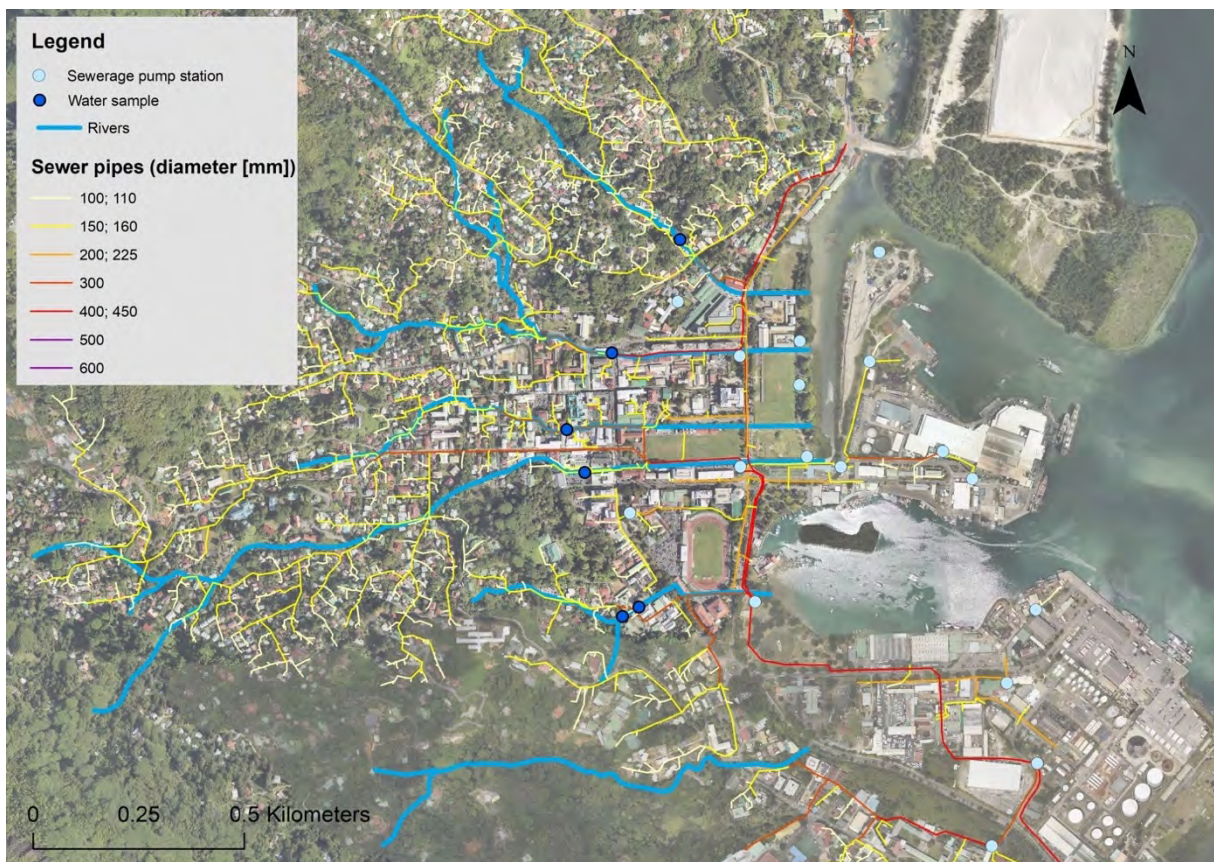
Figure 9: Sewerage network around Victoria (data provided by PUC, 2019¹¹).

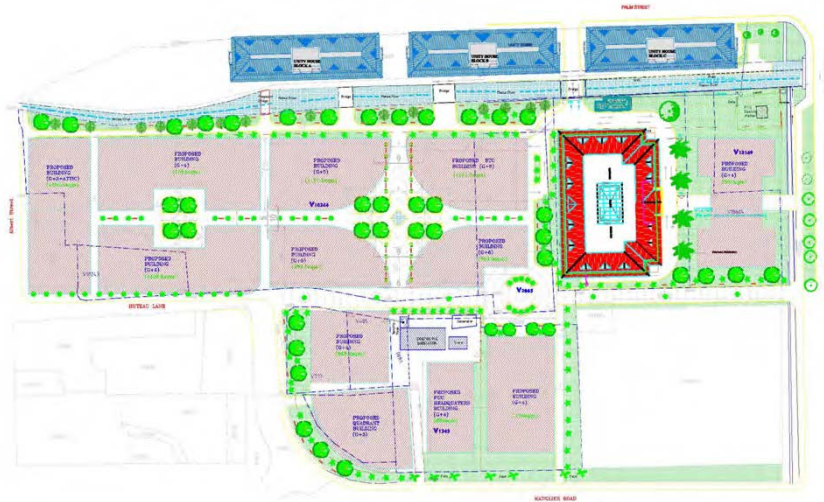
Figure 14: Concept plan of the financial district (Low et al., No date-a, p. 19).

(Low et al., No date-a). The masterplan and concept plan have already been approved (see Figure 14). However, it has been criticized that a proper connection towards the market is missing and the reconfiguration of plots should be taken into consideration to get more open space (Arup, 2015e).

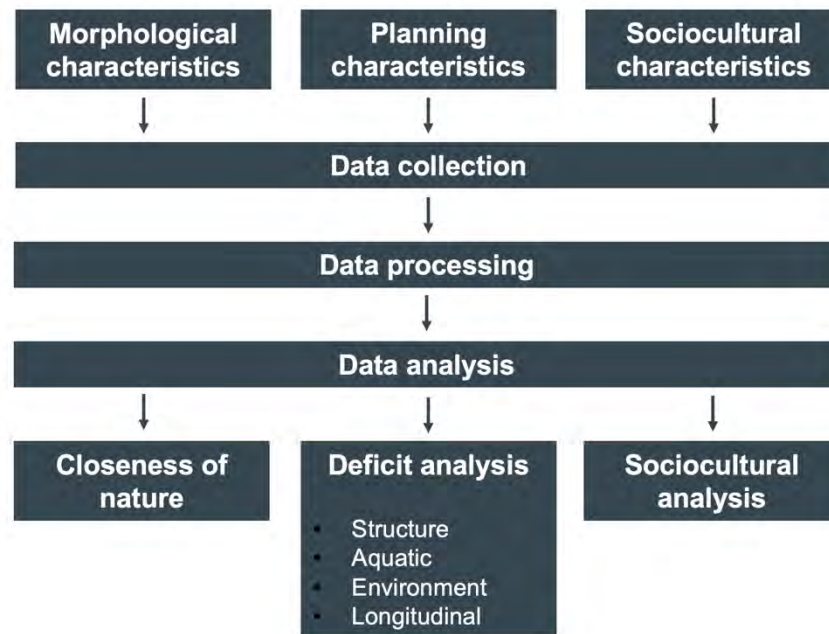
Figure 15: Procedure of the river assessment.

The procedure of the assessment is shown in Figure 15 and is explained in more detail below. It should be noted that the whole chapter is a complete analysis of the current river state and no further comments are made. The evaluation criteria have been derived from the methods mentioned above and are listed on a standardised data form (see Appendix N and Appendix O). A selection of representative characteristics and conditions within and in the immediate vicinity of the rivers has been taken. Some parameters of the three methods needed an adaption to local conditions and were changed accordingly. A few necessary features of other evaluation systems were included for the assessment. Certain characteristics are listed on the data form but were not further consulted in the standardized evaluation process (marked grey in Appendix N and Appendix O). Nevertheless, they contain useful information and can be included in the evaluation in a descriptive way. These evaluation criteria can be classified into morphological, sociocultural and planning aspects, as well as building constructions and falls. More detailed information can be found in chapter 2.2.4. Once the data have been collected, the information is further processed for the analysis.

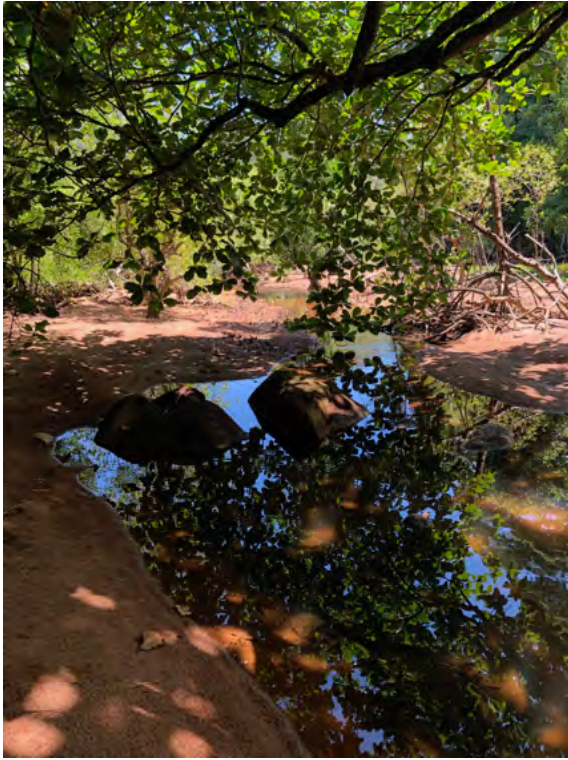
Figure 16: Natural flowing waterway in the influence area of salt water (Grand Anse, own source, 14/04/2019).

For the reference state, a natural stretch of water with a small to very small gradient was taken near the sea. A suitable place was found in Port Glaud/Grand Anse on the western part of Mahé. Two different, naturally occurring rivers states can be taken as a reference. In the area of influence of seawater, the reference condition is considered as the one showed in Figure 16, in the area in which only freshwater occurs, the reference condition was determined as the one illustrated in Figure 17.

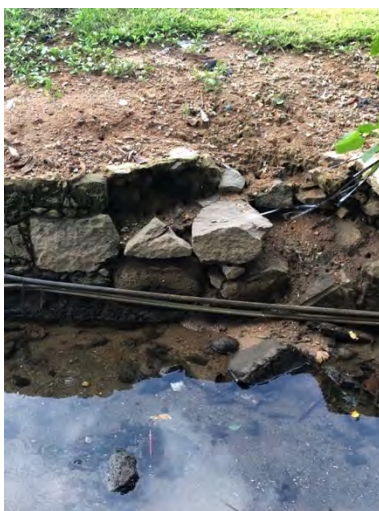
Figure 24: A permeable bank bed in a poor condition (Rivière Maintry, own source, 14/04/2019).

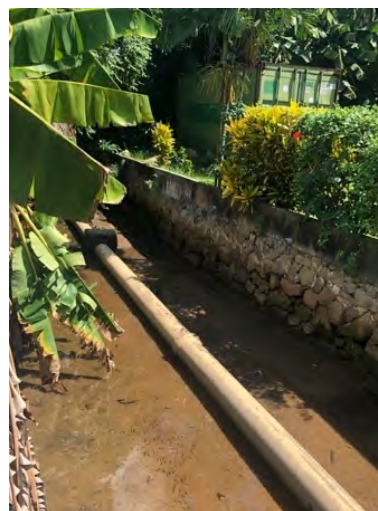
Figure 25: A bank bed in medium condition (English River, own source, 13/04/2019).

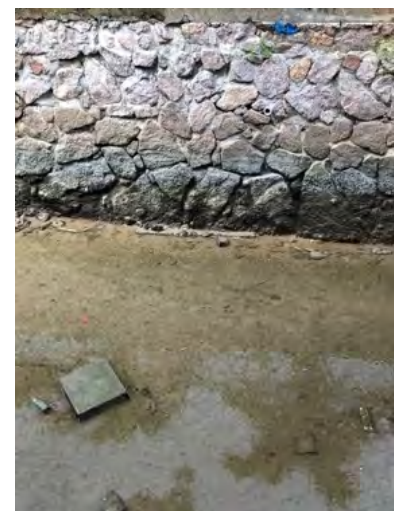
Figure 26: An impermeable bank bed in a good condition (English River, own source, 18/04/2019).

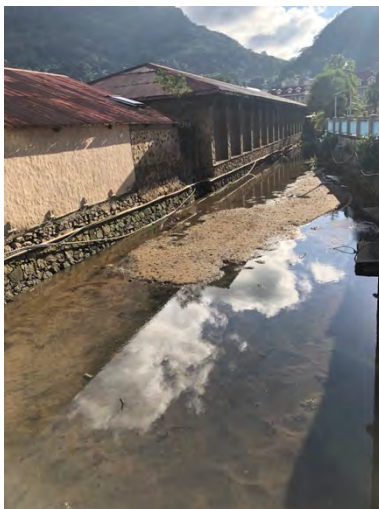
Figure 29: Further channel structure (gravel accumulation) in Rivière Moussa (own source, 27/03/2019).

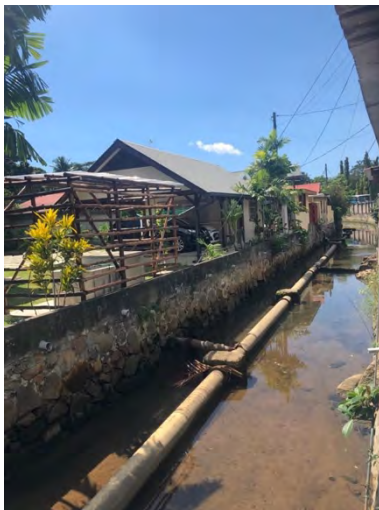
Left

Figure 30: One central laying clear visible loose sewage pipe (English River, own source 13/04/2019).

Pipelines can block wood and other objects (e.g. waste), especially during high water, which can lead to flooding. In addition, the presence of pipes, especially those inside the water, poses major problems during maintenance work such as de-silting processes (statement of CAMS²³). The data form distinguishes between longitudinal and transverse pipes. A further distinction is made between no pipes, inside the water and outside the water. Longitudinal pipes are further divided into left, right and central. For transversal pipes, the first number gives the position (inside or outside the water) and the number in brackets the number of pipes. If they are bundled, they are recorded as one pipe but listed on the form for building structures where the size is mentioned. If longitudinal pipes are embedded in concrete on the ground, it was added to the criterion of construction of river bed and was not rated as a pipe again. Transversal pipes from a diameter of approximately 30cm were listed again in the building structures as they are larger point structures. Pipelines below a bridge or a culvertisation were not considered, as they are often difficult to recognize. Pipes are only taken up from a diameter of approximate 5-10cm. For smaller pipes, it is assumed that they can be transferred easily and the influence on the river is comparatively small. Different arrangements of pipes are demonstrated in the pictures below.

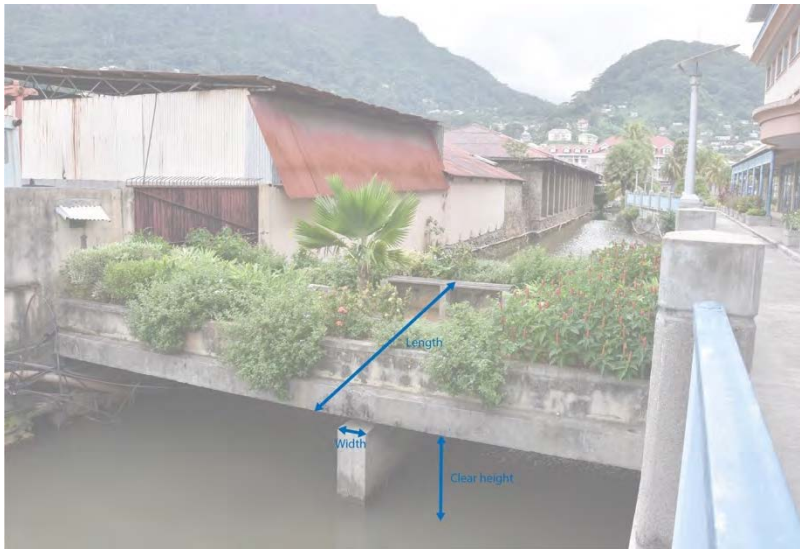
Figure 41: Small picnic area above the river illustrating the clear height, width and length of an object (Rivière Moussa, own source, 10/03/2019).

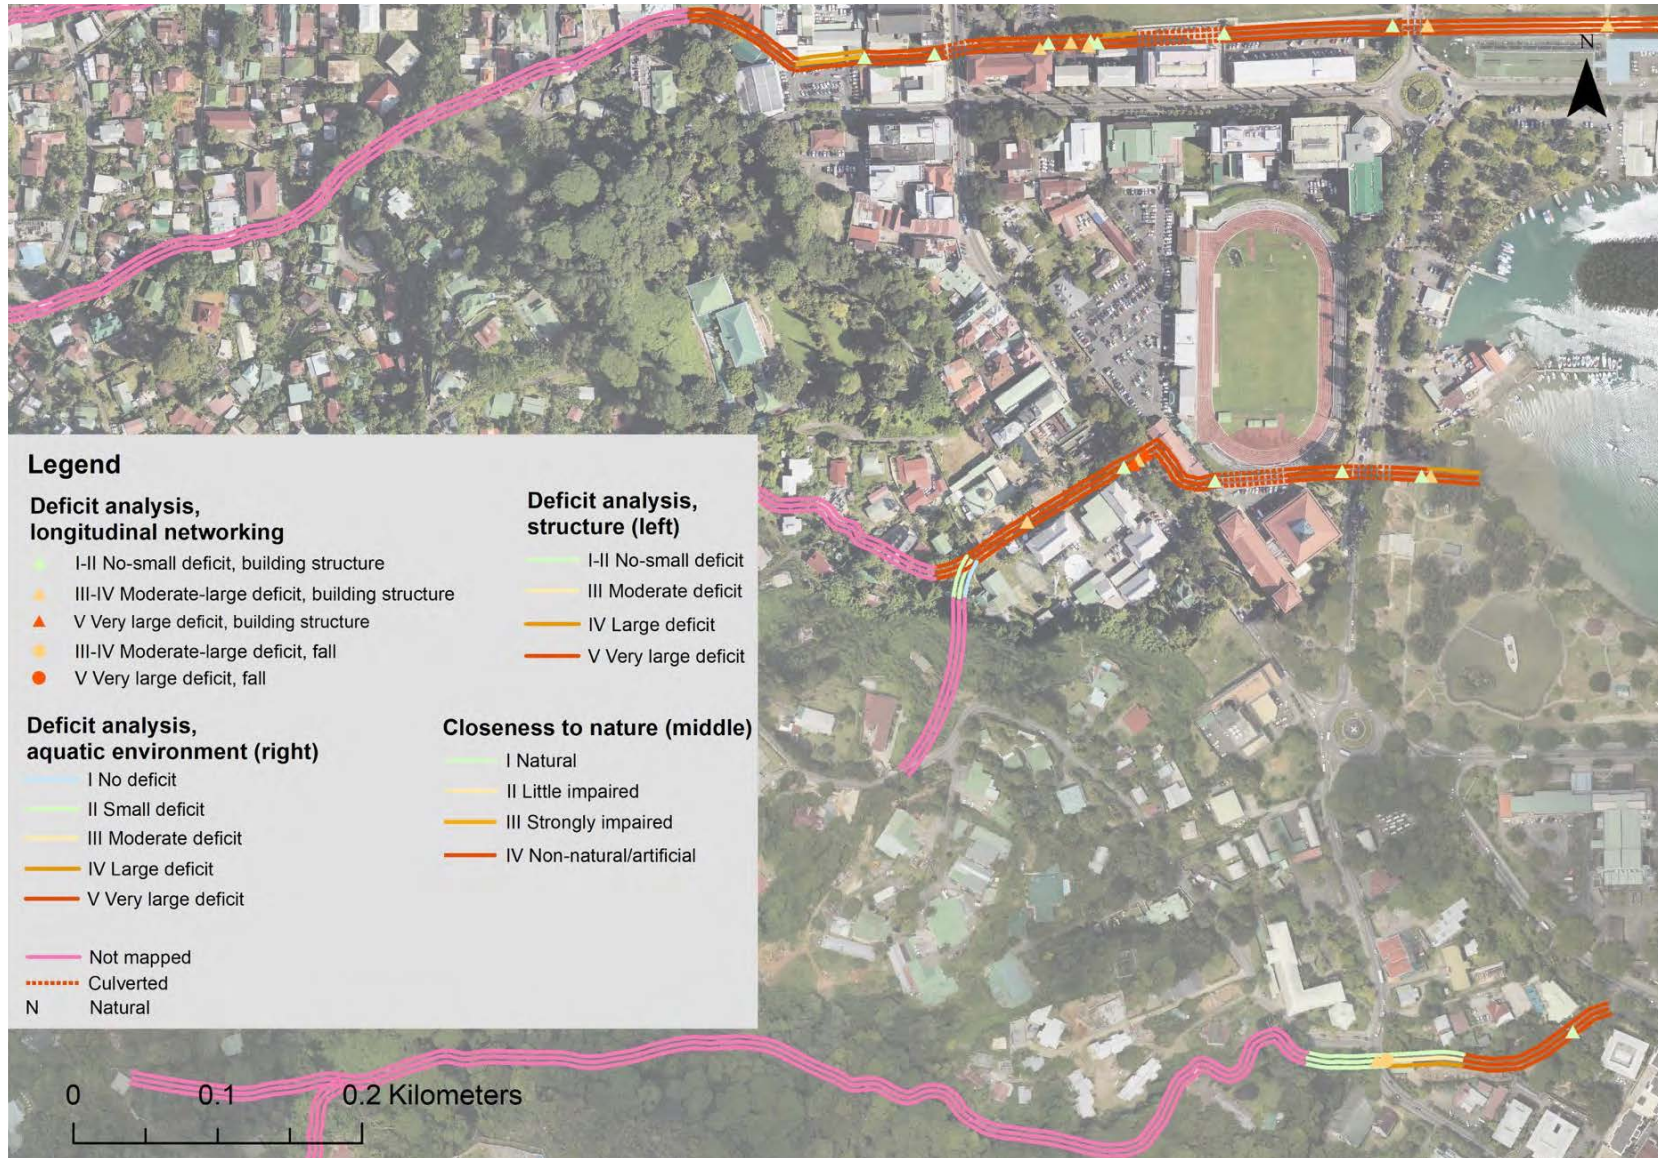
Figure 46: Closeness to nature and deficit analysis of Rivière St. Louis, La Poudrière River and Rivière Trois Frères.

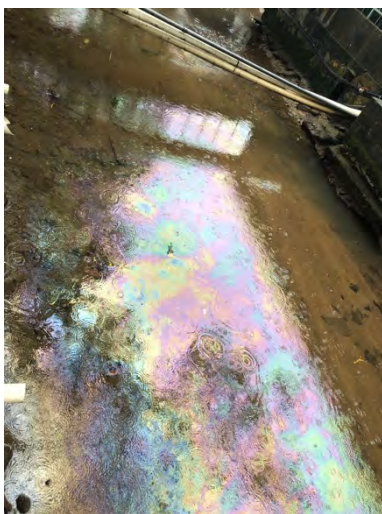
Figure 55: Dirty surface of Rivière St. Louis (own source, 13/04/2019).

Another big problem mentioned by everyone is the lack of space within the city due to the existence of infrastructure. Many stretches of water have adjacent buildings, walls or sewer pipes, which makes it difficult to implement relatively simple improvements. The great development in recent years, also within the catchment area of the rivers, has resulted in a large amount of impervious floor area and consequently in more runoff. This increases the erosion force and water availability becomes lower in the dry months as water is no longer stored in the soil, as one expert said. Developments in recent years, including the catchment area, have additionally led to a major source of pollution (see Figure 55). Solid waste, detergents, bad sewage treatment and many further factors have led to poor water quality, which was highlighted by all respondents.

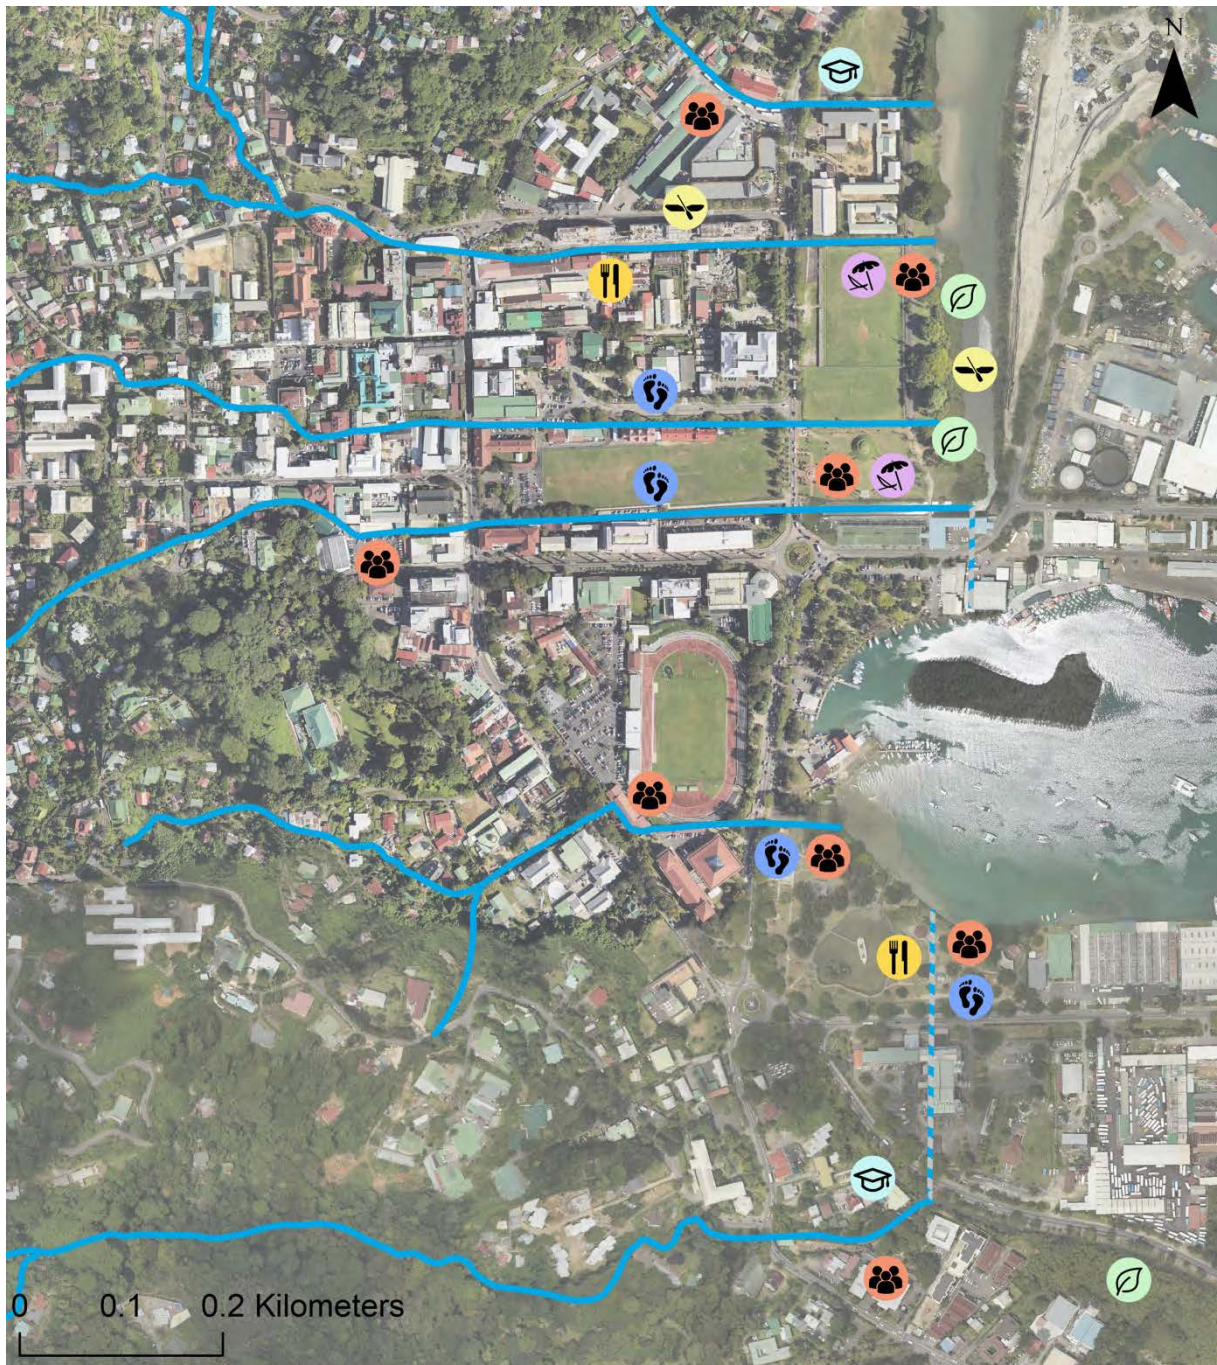
Figure 83: Mapping of possible improvement measures.

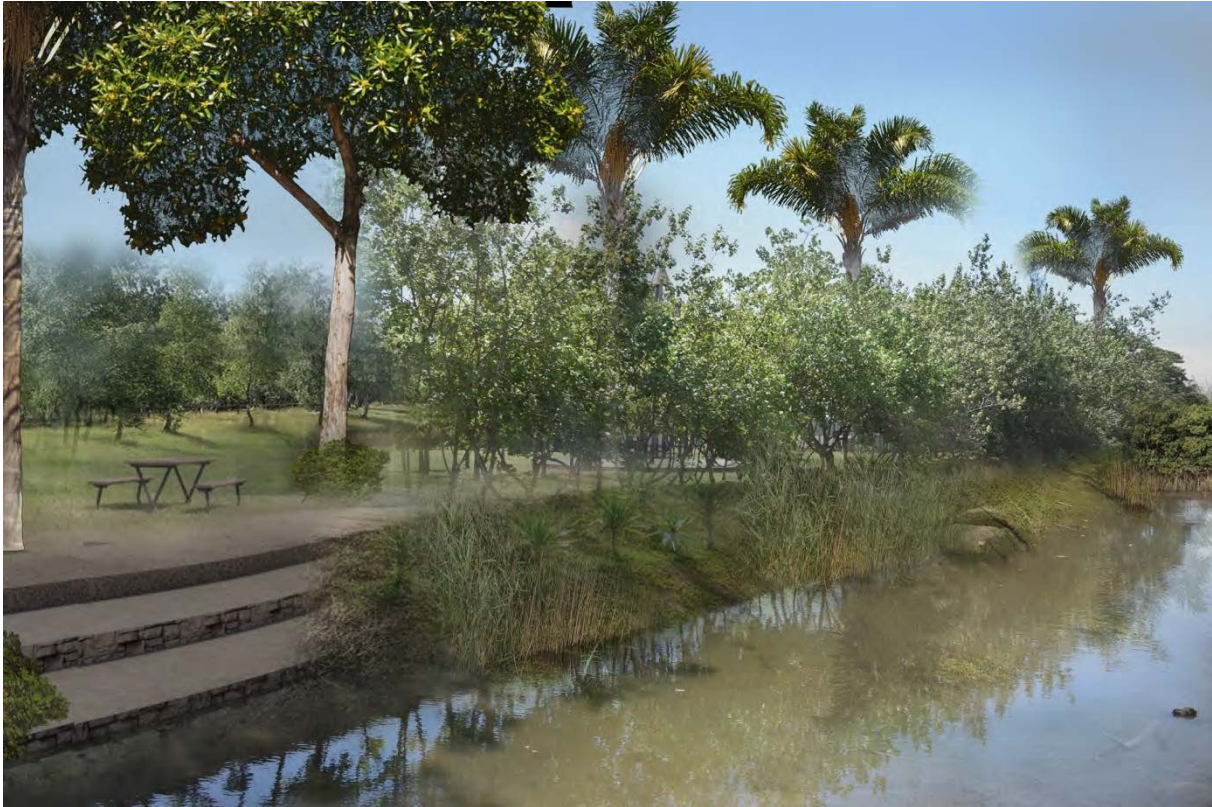
Figure 88: Possible improvement measures at Peace park along the Rivière St. Louis (own source).

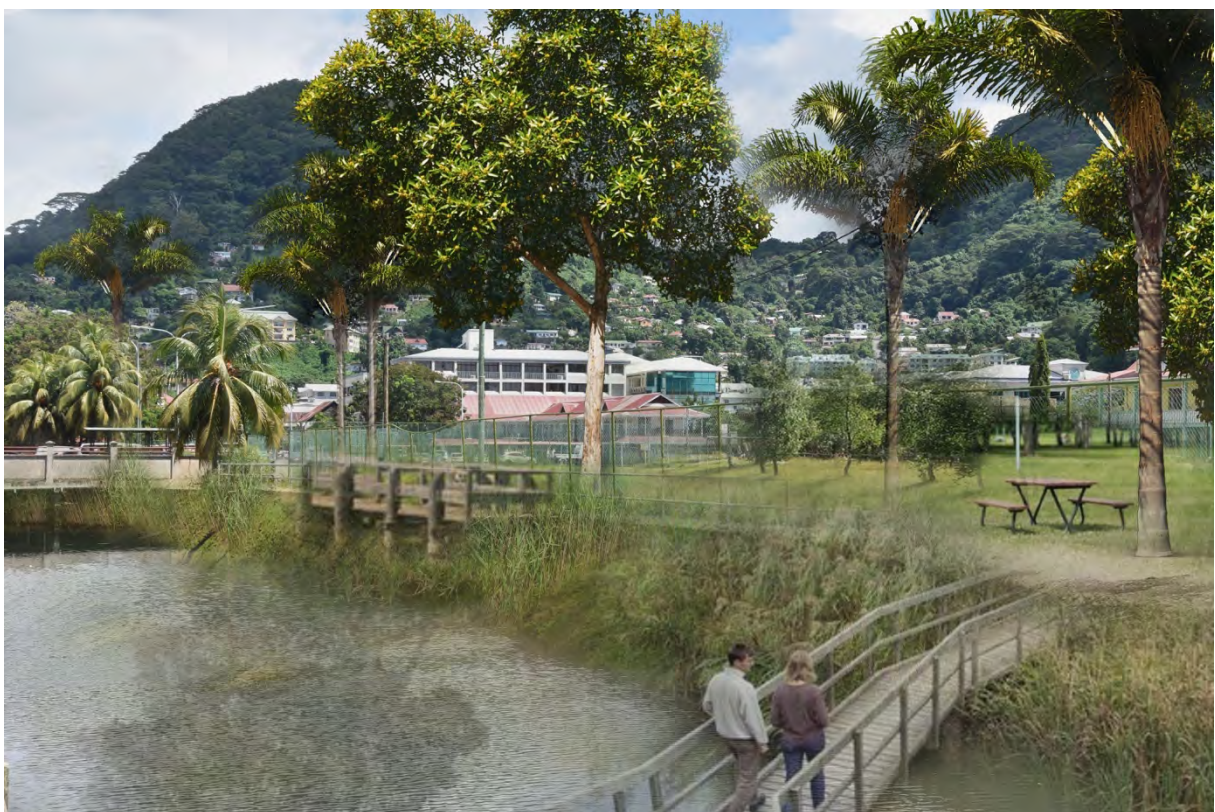
Figure 90: Future opportunities for improvement along the Freedom Square (own source).

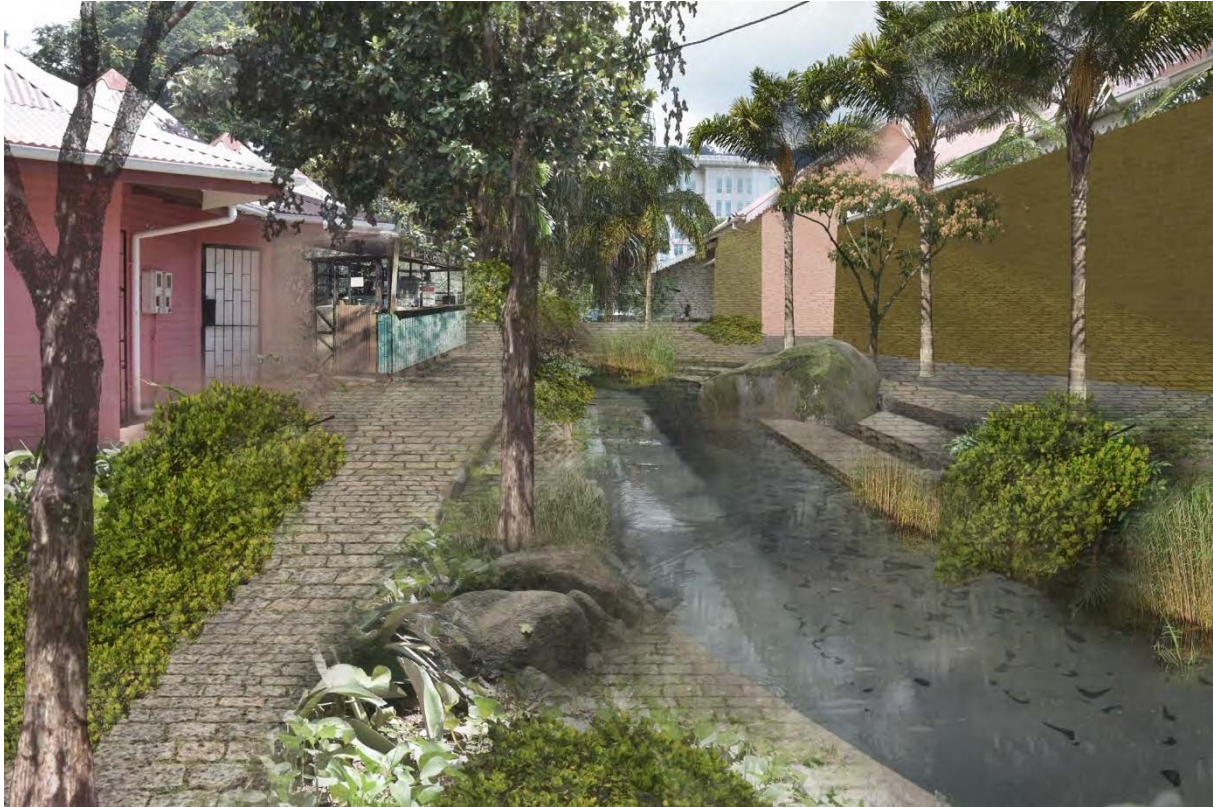
Figure 93: Possible improvement measures along the tourist kiosks (own source).

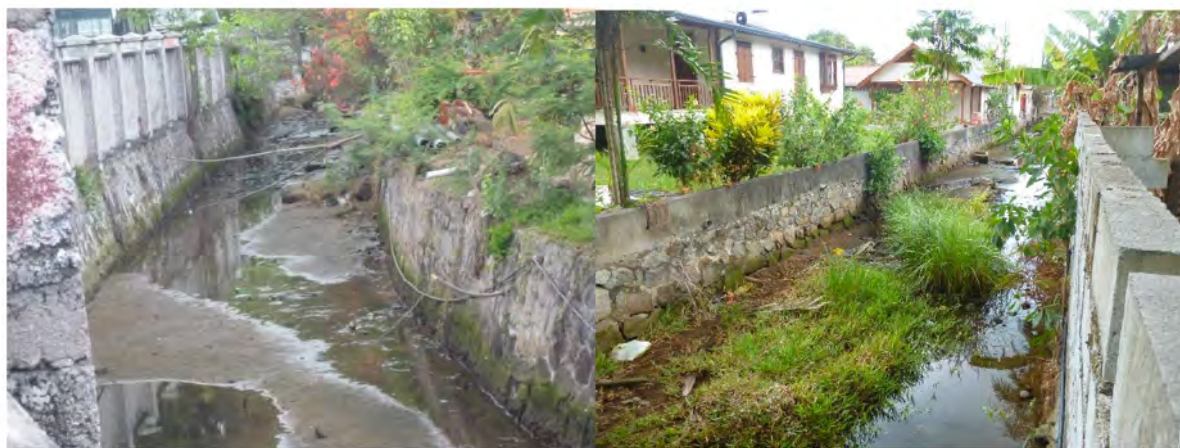
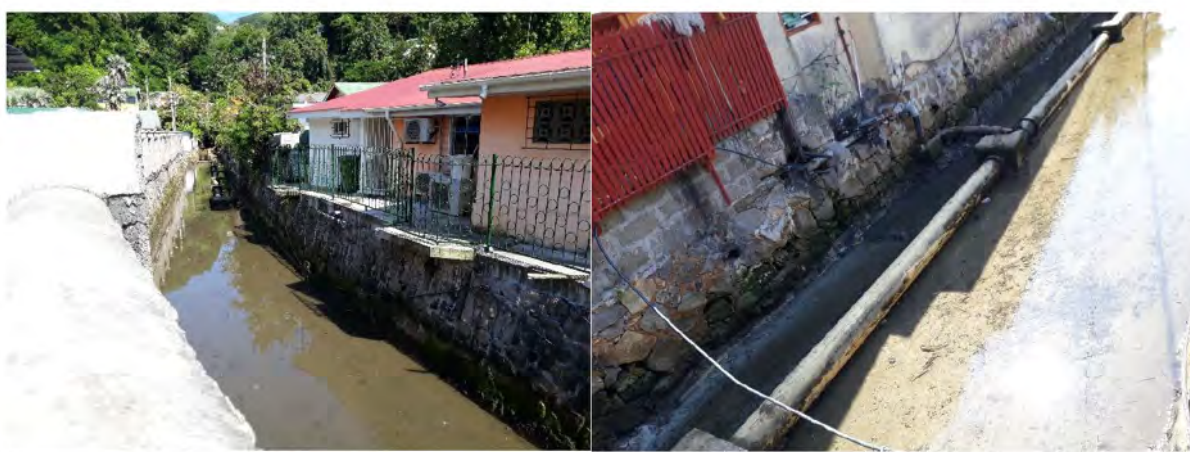
Appendix G: Pictures before and after silt-removal at English River (Payet, 2016).

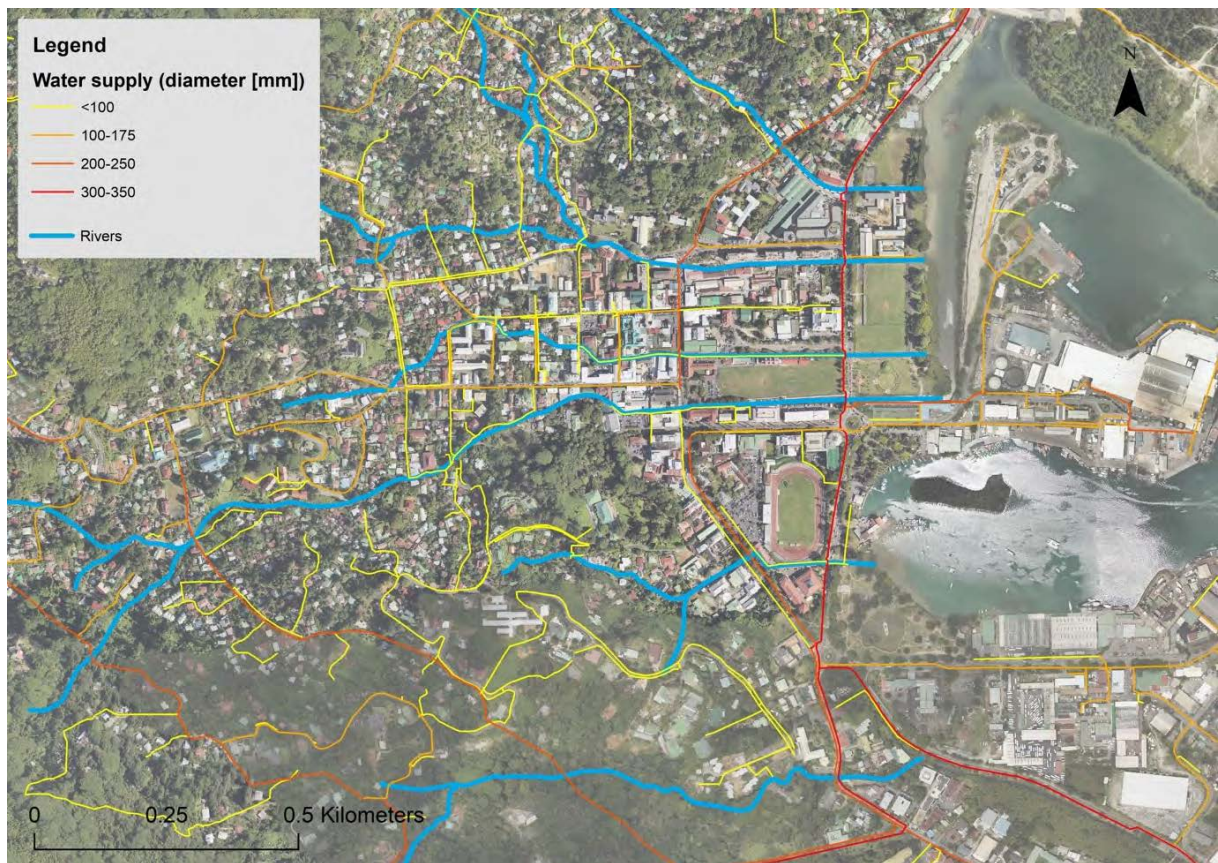
Appendix J: Water supply network of Victoria (data provided by PUC, 2019²⁸)
