Lining of pressure tunnels

Kolloquium «Untertagbau für Wasserkraftanlagen»
ETH Zürich, Professur für Untertagbau

Zürich, 12.12.2013

Rehabilitation of Estí pressure tunnel (Panamá)

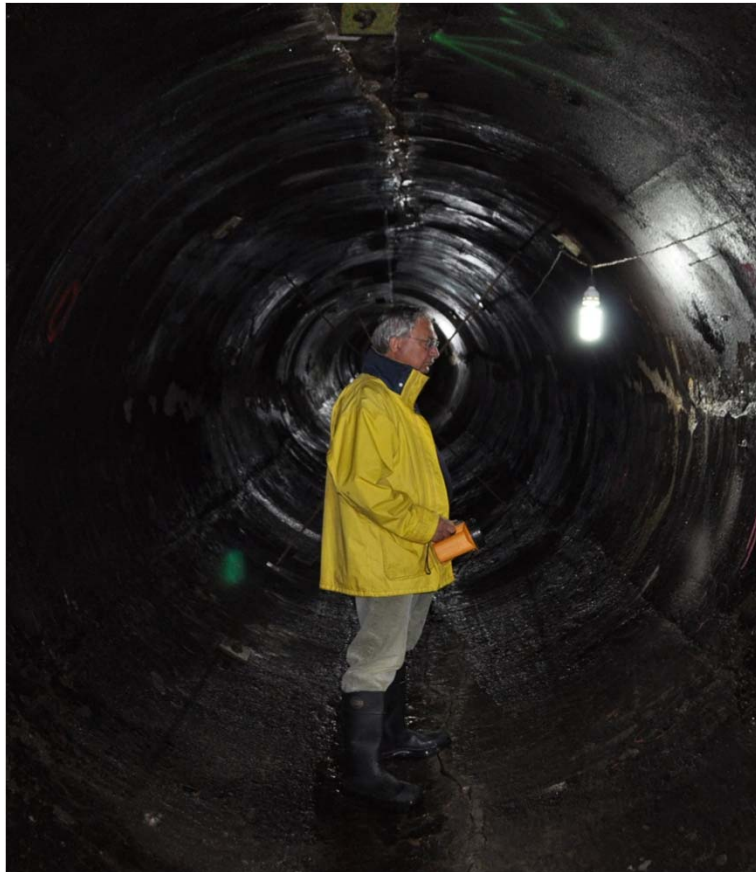
Pucará headrace tunnel in the damaged zone (2011)

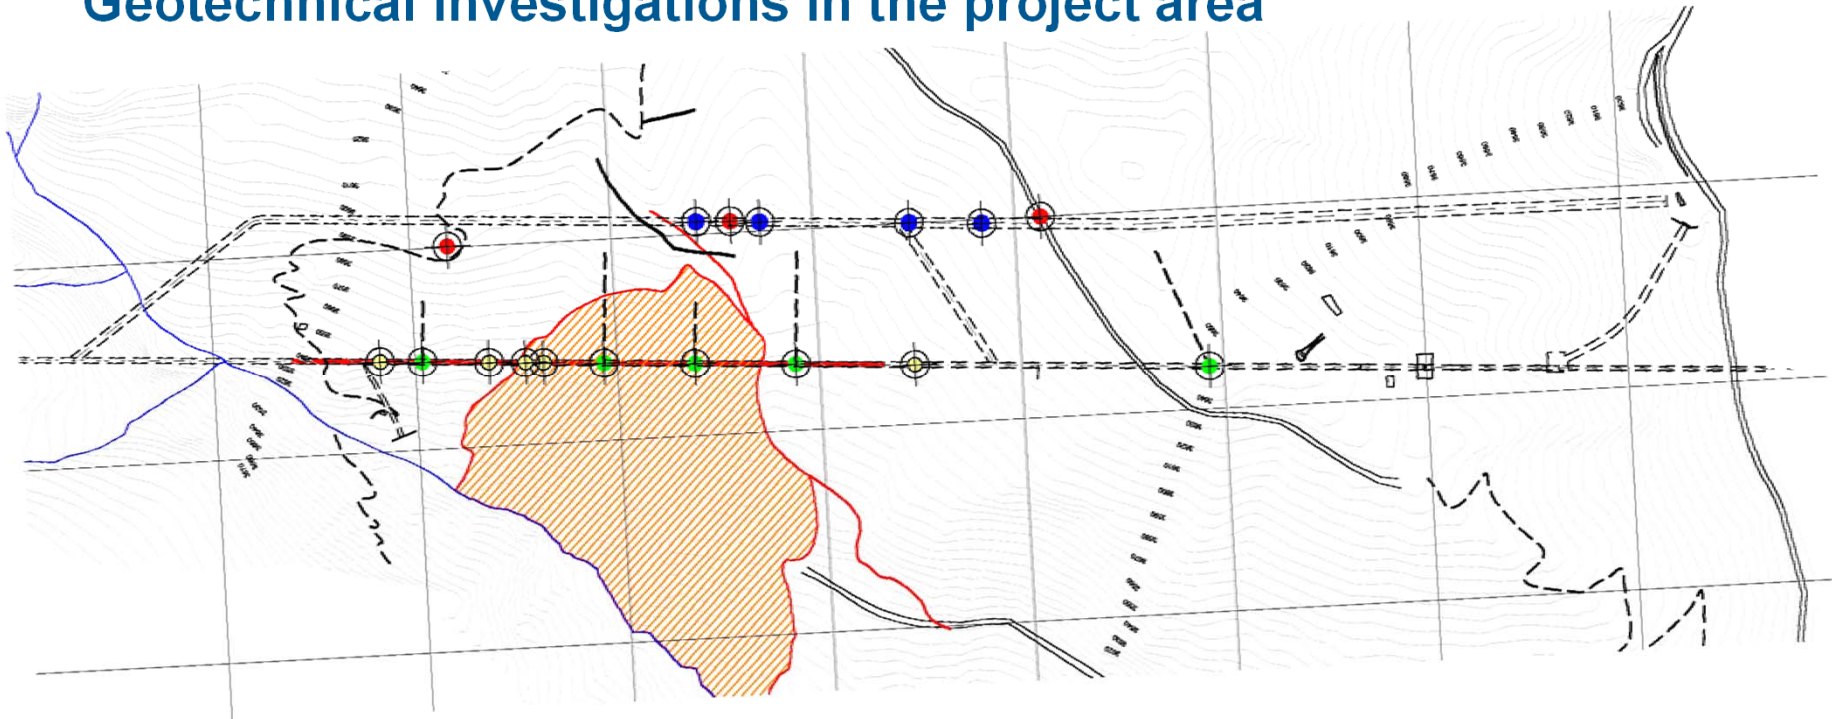
Geotechnical investigations in the project area

- vertical boreholes from the surface (70-100 m)
- sub-horizontal (10°) boreholes from the existing tunnel (15, 30, 55, 60 m)
- sub-vertical (30°) boreholes from the existing tunnel (12 m)
- boreholes from the bypass during construction

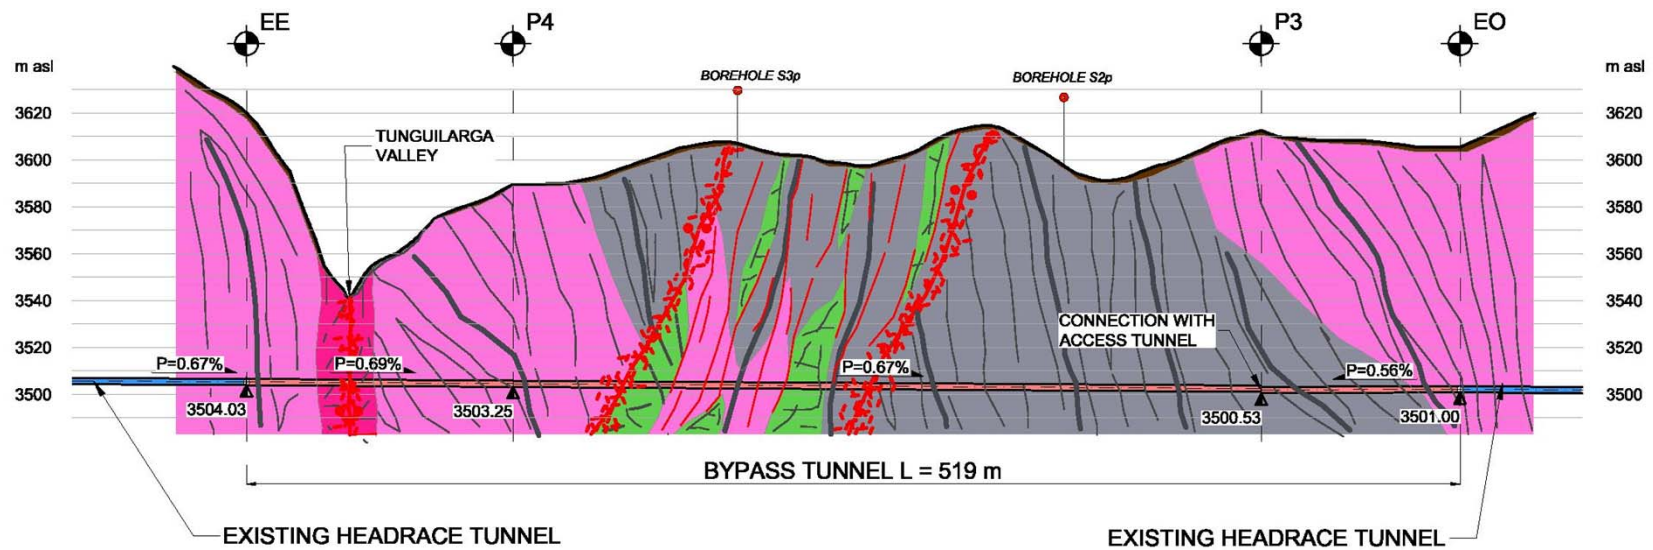
Geotechnical characterisation of the project area

UG	Class	Tunnel length	
UG3	III	23 m	4%
UG4	IV	251 m	48%
UG5	IV	120 m	23%
UG6	IV-V	112 m	22%
UG7	V-VI	14 m	3%

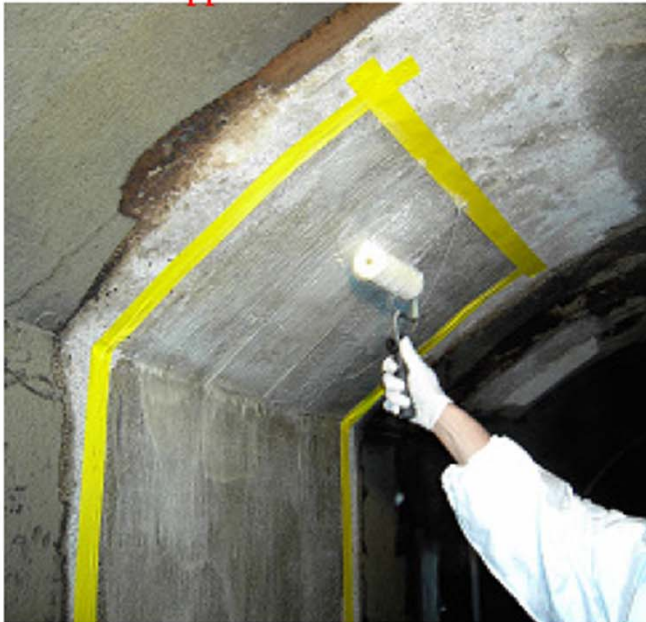
Application 1^{ère} couche

Study of alternatives : carbon fiber tissue and resin
In situ tests (Sika Travaux et Freyssinet CH)
